## TSUNAMI DAMAGE TO OIL STORAGE TANKS

Y. Goto

### ABSTRACT :

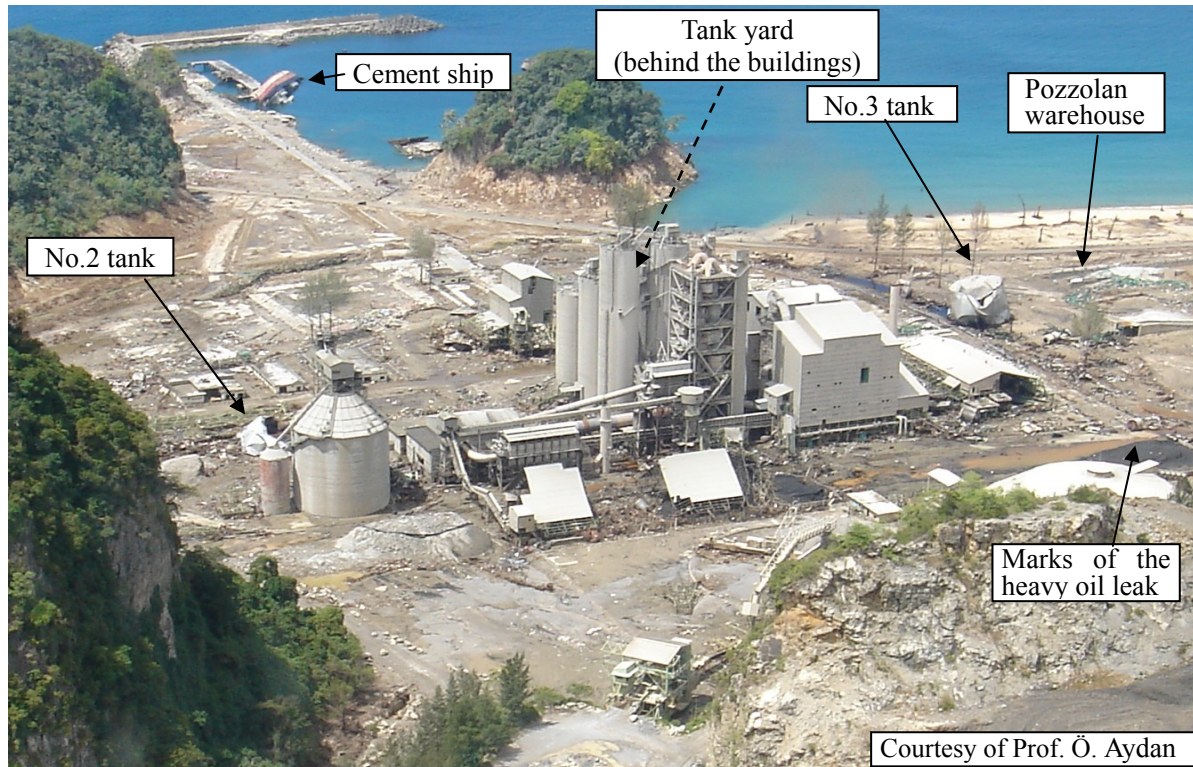
Photo 1 Factory after suffering calamity as seen from ridge

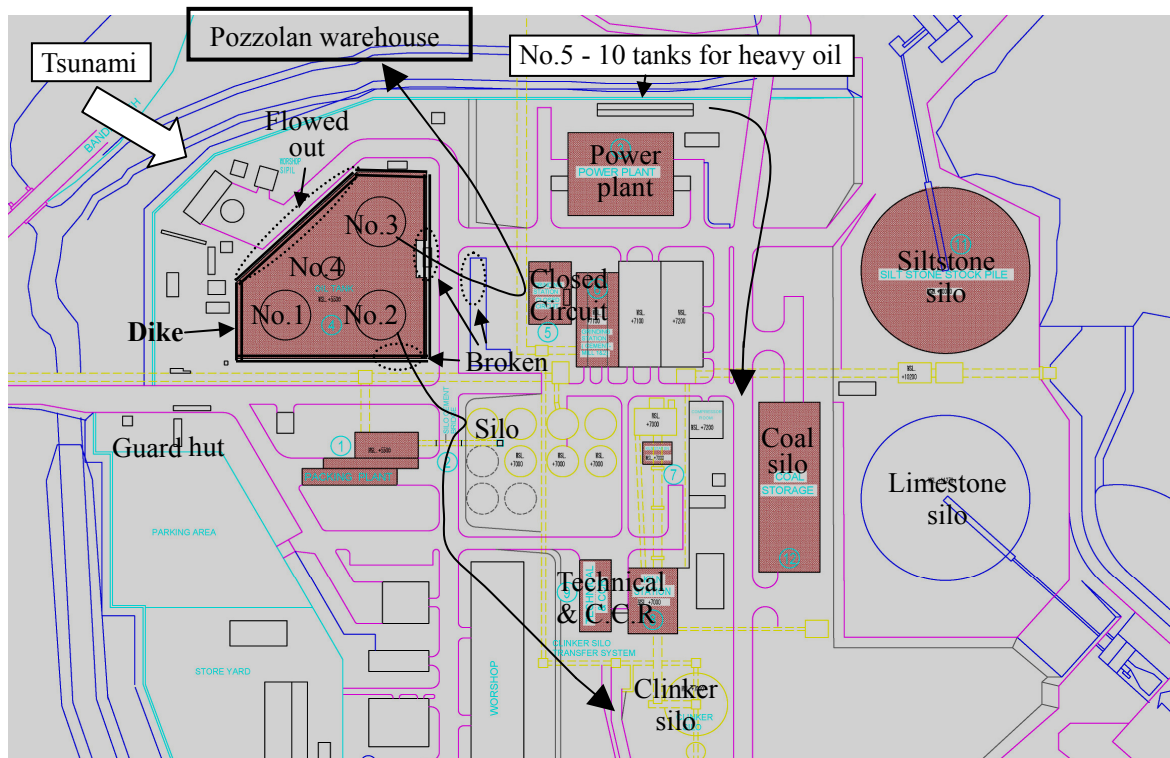
Figure 1 Central part of cement factory and movement locus of tanks

The layout of No.1-No.4 tanks and the configuration of the spilled oil containment dike are shown in Figure 1. No.5-No.10 tanks had been located beside the power generation plant. The spilled oil containment dike was a reinforced concrete structure, height 2.25 m, base width 250 mm, and crest width 160 mm. The main reinforcement was DΦ13 mm 0.1 m pitch and comprised single reinforcement located at the tank yard side in the wall section. Distribution bars were Φ9 mm. There was no tide embankment.

Spilled-oil containment dikes are designed to resist hydraulic pressure from the interior, but not usually from the exterior. As a result, the side exposed directly to the run-up wave toppled off its base, and was sucked out by the receding tide. No.2 and No.3 tank rode on the tsunami, and collided with and broke through the dike. They collided with silos and steel framed buildings, and were moved about 80 and 200 m from their original location, and were badly deformed. Although No.1 had been filled with water and remained inside the dike, the incoming tide crashed into it and flattened it. A cement ship had also moored in the harbor and was loading. It capsized, and a part of the pier was damaged by its impact.

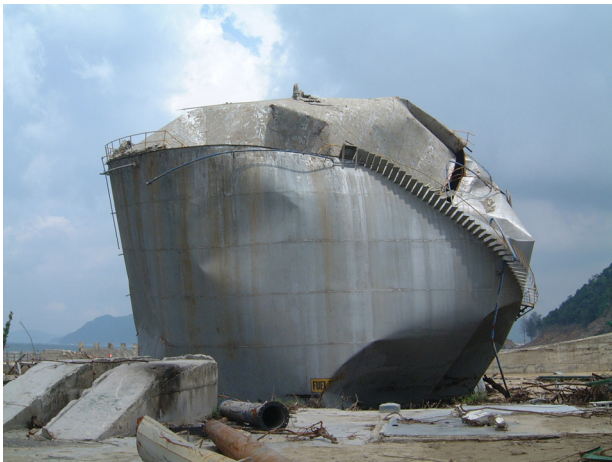
| No. of tank | Specification | | | | Liquid level at the tsunami | Installation year | Criteria applied | Damage notes |
|---|---|---|---|---|---|---|---|---|
| Tank 3 | Distillate | 23.30 | 14.62 | 6,000 | 50% | 1981 | API650 | Broke through dike, collided with neighboring structures and seriously deformed. |

Photo 2 No.3 tank. 50% full of distillate

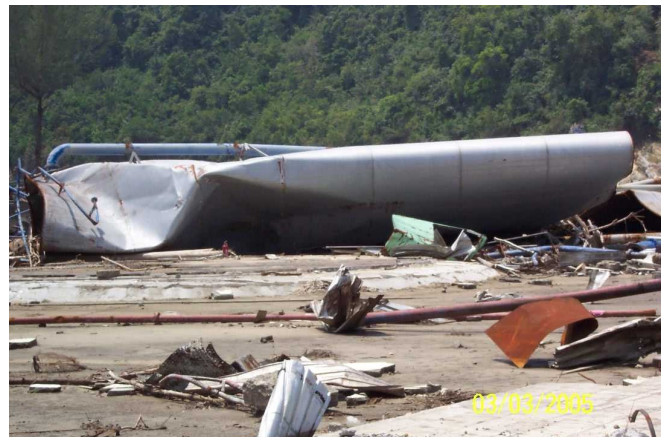
| No. of tank | Specification | | | | Liquid level at the tsunami | Installation year | Criteria applied | Damage notes |
|---|---|---|---|---|---|---|---|---|
| Tank 1 | Water | 23.30 | 14.62 | 6,000 | 100% | 1981 | API650 | Smashed and flattened within diked enclosure. |

Photo 3 No.1 tank remained inside the dike  
(Courtesy of Penta-Ocean Construction Co., Ltd)

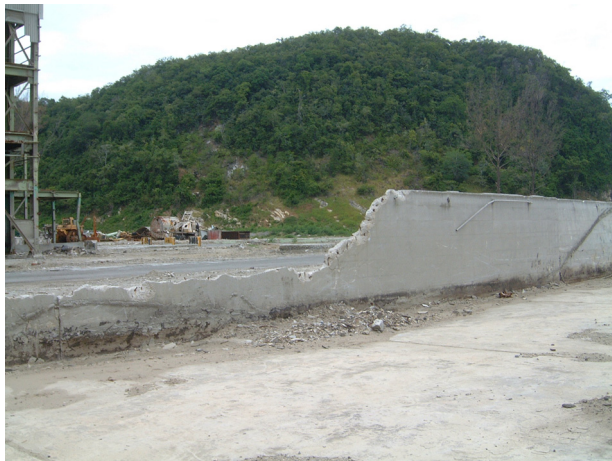
| No. of tank | Specification | | | | Liquid level at the tsunami | Installation year | Criteria applied | Damage notes |
|---|---|---|---|---|---|---|---|---|
| Tank 2 | Distillate | 23.30 | 14.62 | 6,000 | 75% | 1981 | API650 | Broke through dike and collided with neighboring structures. Original shape lost. |

Photo 4 This part of the dike was broken through  
by No.2 tank.

- 4) Conventional oil-spillage prevention dikes are designed for hydraulic pressure from the inner side. However, in the tsunami danger zone they should also be designed for tsunami pressure from the outer side.

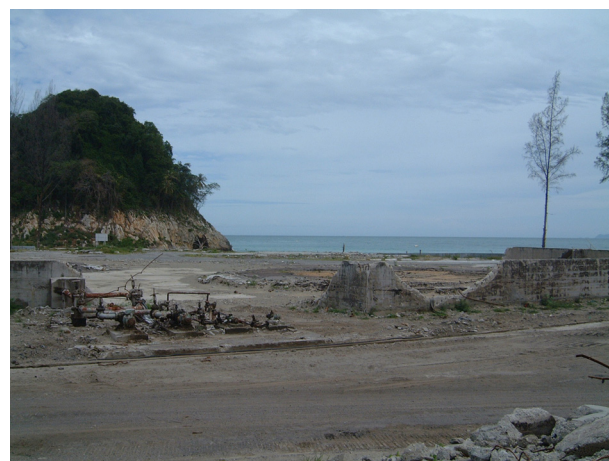
Photo 5 The part where No.3 tank broke  
through the dike viewed from outside.

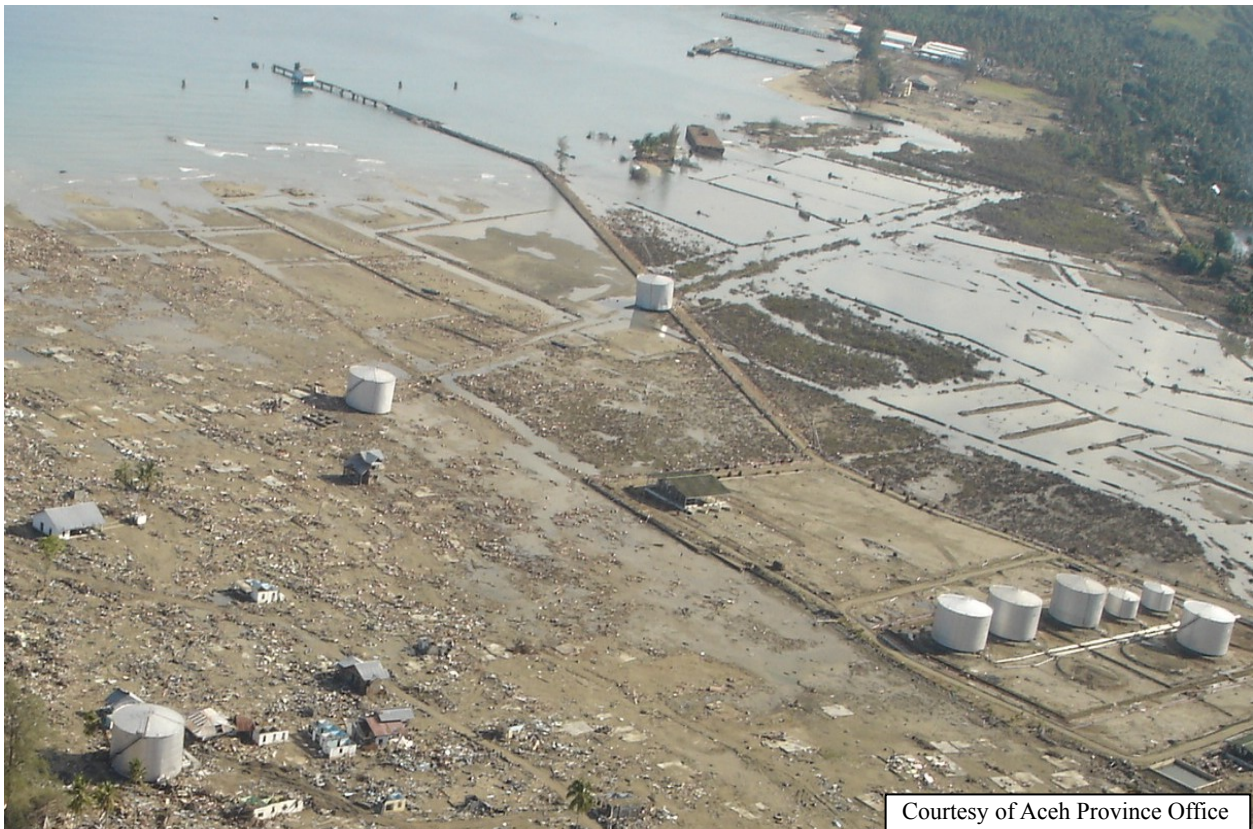
Photo 6 Three tanks drifted about 300 m and one moved 0.7 m

The height of the tsunami in the Krueng Raya area was assumed to be 4-6 m. Dr. Tomita of the Port and Airport Research Institute reported that the height showed a variation<sup>6)</sup>. It was 4.8 - 5.7 m for No.2 tank, about 5.1 m for No.5 tank, and about 4.9 m for No.6 tank. Since the mound height was 1.0-1.1 m from foundation level, when calculating the buoyant force that had acted, it is necessary to deduct the height. Although the pier had been inundated, it did not suffer damage. Moreover, the pump hut on the pier was not washed out. The dynamic pressure of the tsunami in this area had the impression of being smaller than that in the cement factory.

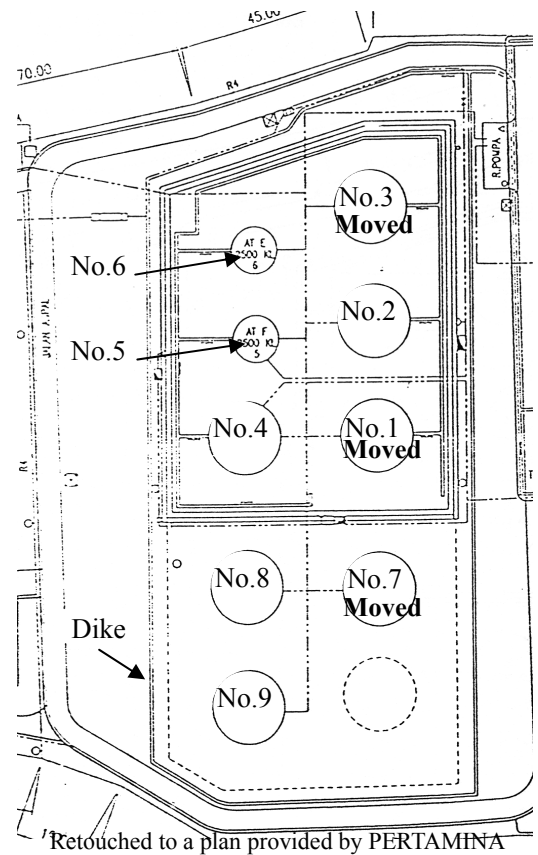
Figure 2 Tank layout

The owner of the terminal is PERTAMINA (an Indonesian public oil corporation). It is managed by a branch office in Band Aceh. The spilled oil containment dike was made from earth fill. As shown in Figure 2, it encloses the tank yard. It is 317 m long and has 2.5 m trapezoid base width, 0.8 m trapezoid surface length, and 1.2 m height. There was no tide embankment.

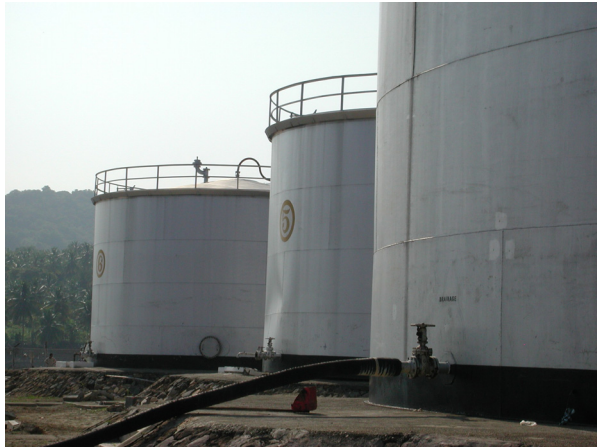
All of the oil in the ground piping, about 10 kl, leaked out. No gasoline leaked from No.7 tank, even though it moved a large distance. Neighboring residents gathered and took the gasoline away for their own use. Estimated damage was 30 million USD. Although No.5 tank moved about 0.7 m, since no oil leak was seen, it was being used as it was. This terminal was an important oil supply base for the Banda Aceh area. Fuel for airplanes that were carrying out rescue operations had to be sent to the Banda Aceh airport in a hurry.

Photo 7 Side wall of No.5 tank caved in a little  
(Courtesy of Mr. Furukawa of Kajima)

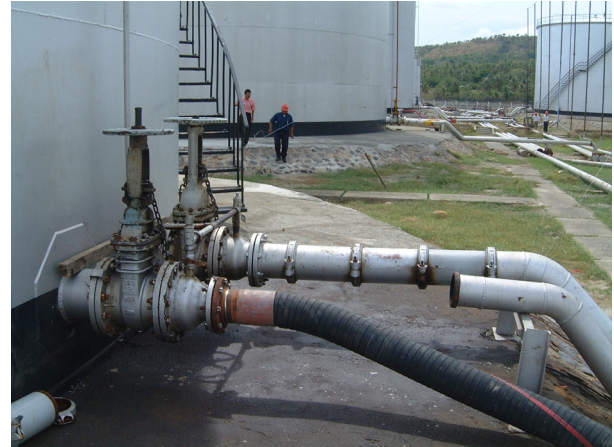
Photo 8 Pipe attachment part. The intake side pipe separated and a temporary pipe was attached.

- 3) It is hard to prevent piping on the ground surface from being moved by a tsunami. It is more effective to provide a flexible joint that enables piping to be broken off the tank side valve when an unusually large force is applied to a tank from the piping. The flexible joint serves as a fuse. However, when a tsunami warning is received, even during cargo work, a mechanism is required for positively shutting the valve on the tank side.
