# DESIGN LOAD EVALUATION FOR TSUNAMI SHELTERS BASED ON DAMAGE OBSERVATIONS AFTER INDIAN OCEAN TSUNAMI DISASTER DUE TO THE 2004 SUMATRA EARTHQUAKE

Y. Nakano<sup>1</sup>

## ABSTRACT :

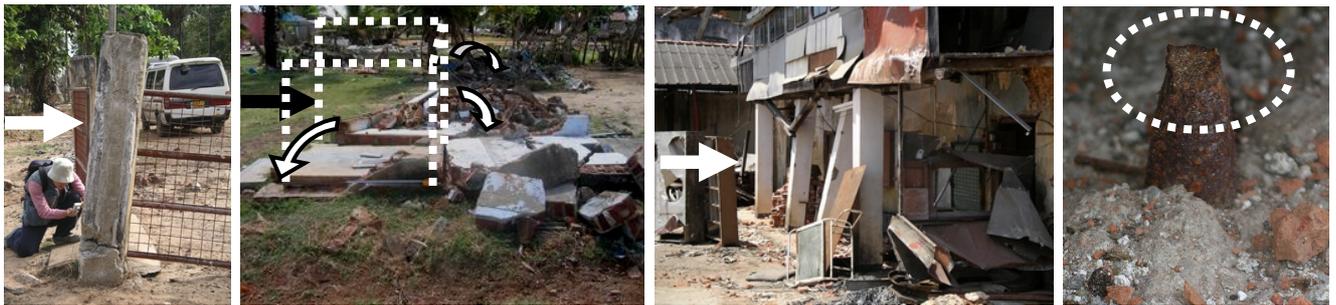
| ID | Description of structures | Structure type <sup>#1</sup> | Location | $M_y, M_u, M_r$ (kNm) | $V_u$ (kN) | Inundation depth $\eta_{max}$ (m) <sup>#2</sup> | Coeff. $a$ <sup>#3</sup> | Damage <sup>#4</sup> | Remarks |
|---|---|---|---|---|---|---|---|---|---|
| S01 | Column at entrance gate | RC | Trincomalee | $M_y$ : 20 | — | (3.0) | 1.98 | ○ (×) | Possibly damaged by drifting debris |
| S08 | Wall of outhouse (1) | B | Trincomalee | $M_r$ : 35 | — | 1.3 | 2.38 | × | Bond failure of mortar between brick units considered in $M_r$ |
| S16 | Cantilever columns of automobile factory's office | RC | Galle | $M_y$ : 26<br>$M_u$ : 33 | — | 2.4 | 1.76<br>2.04 | ○<br>○ (×) | No damage unless hit by a bus |

(1) S01: RC columns (2) S08: Brick outhouse (3) S16: Cantilever RC columns with rebar fracture

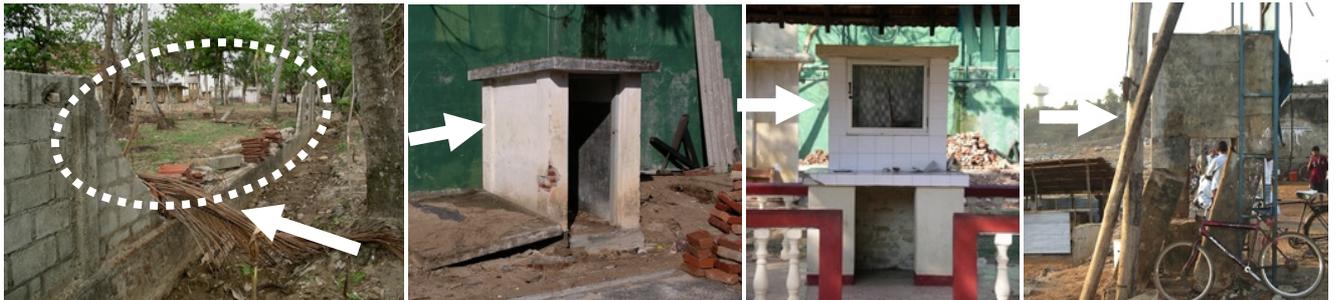
| ID | Description of structures | Structure type <sup>#1</sup> | Location | $M_y, M_u, M_r$ (kNm) | $V_u$ (kN) | Inundation depth $\eta_{max}$ (m) <sup>#2</sup> | Coeff. $a$ <sup>#3</sup> | Damage <sup>#4</sup> | Remarks |
|---|---|---|---|---|---|---|---|---|---|
| S19 | Fence wall (2) | RC+B | Galle | $M_u$ : 135 | — | 2.35 | 1.01 | × | CB walls neglected in $M_u$ |
| S25 | Wall of outhouse (4) | B | Galle | — | 130 | 1.6 | 3.68 | ○ | Located just behind S23 / Entry perpendicular to tsunami direction |
| S26 | Mausoleum of Buddha (3) | B | Galle | — | 182 | 1.6 | >5.0 | ○ | Located just behind S23 |
| S32 | Columns supporting elevated water tank (3) | B | Hambantota | — | 9.5 | 2.95 | 0.54 | × | Bond failure of mortar between brick units considered in $V_u$ |

(4) S19: CB fence wall w/ RC column (5) S25: Brick outhouse (6) S26: Mausoleum (7) S32: Elevated water tank

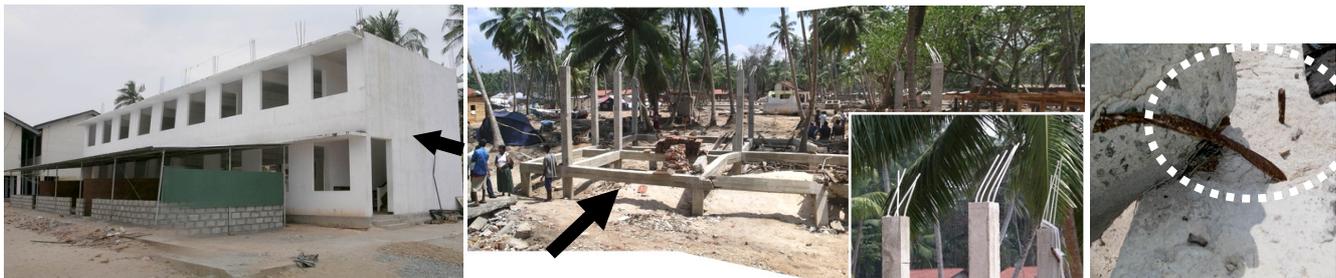
| ID | Description of structures | Structure type <sup>#1</sup> | Location | $M_y, M_u, M_r$ (kNm) | $V_u$ (kN) | Inundation depth $\eta_{max}$ (m) <sup>#2</sup> | Coeff. $a$ <sup>#3</sup> | Damage <sup>#4</sup> | Remarks |
|---|---|---|---|---|---|---|---|---|---|
| S53 | School building | RC+B | Matara | — | 1316 | 2.85 | 2.31 | ○ | 2-story RC building / Seismic capacity evaluation performed |
| S57 | Cantilever columns (1) under construction | RC | Hikkaduwa | $M_y$ : 18<br>$M_u$ : 23 | — | (9.0) | 0.54<br>0.59 | × | Of all 15 columns, 8 totally collapsed and 7 heavily damaged |

(8) S53: 2-story RC school (9) S57: RC columns under construction (rebars bent and some columns failed)

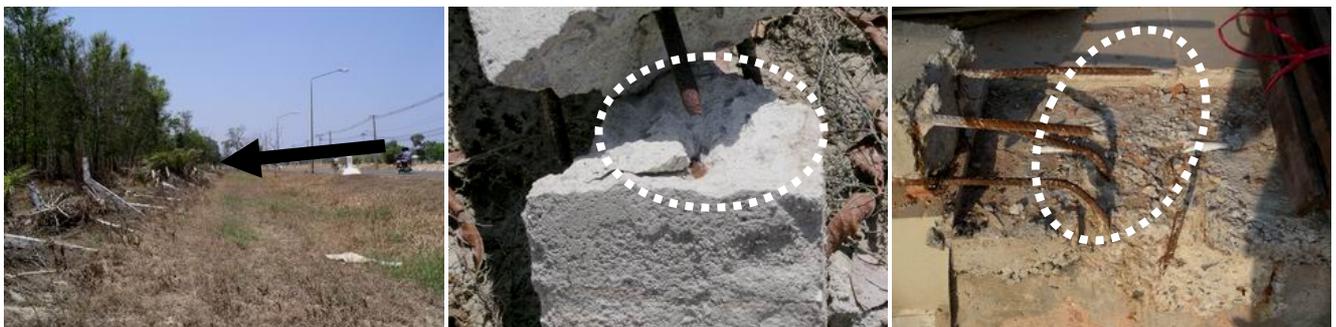
| ID | Description of structures | Structure type <sup>#1</sup> | Location | $M_y, M_u, M_r$ (kNm) | $V_u$ (kN) | Inundation depth $\eta_{max}$ (m) <sup>#2</sup> | Coeff. $a$ <sup>#3</sup> | Damage <sup>#4</sup> | Remarks |
|---|---|---|---|---|---|---|---|---|---|
| T09 | Fence columns (2) | RC | Navy Base | $M_y$ : 4.5<br>$M_u$ : 6.3 | — | 2.65 | 1.14<br>1.39 | × | Pull-out, yielding, and fracture of round rebars observed / Approx. 1km from coastline |
| T15 | RC columns of La Flora Khao Lak Hotel | RC | Bang Niang, Phang Nga | $M_y$ : 12.9<br>$M_u$ : 19.9 | — | 5.0 | 0.70<br>0.87 | × | Just on coastline |

(10) T09: RC fence columns of Navy Base (rebar fractured) (11) T15: RC columns under construction
