## CONSIDERATION OF DAM SAFETY AFTER WENCHUAN EARTHQUAKE IN CHINA<sup>1</sup>

Chen Houqun

In this paper in view of the dam safety some special features of the Wenchuan Earthquake on May 12, 2008 in China are noted. The damages and behavior of dams, especially for the 4 dams with a height over 100m, in the area affected by the earthquake are briefly described. The lessons concerning dam safety learnt from the devastating quake are preliminarily drawn. As the seismic safety of high dams during strong earthquake is the problem caused wide attention around the world, some critical problems related to the dam construction in China are considered and discussed after the Wenchuan earthquake, such as: “Why the dam construction is necessary in China as a seismic country?”, “How to evaluate the seismic safety of high dams built in the western region of China with seismogenic structures?”, “Whether the reservoir impounding of the Zipingpu and the Three Gorges Projects could trigger the Wenchuan Earthquake?”, “What is the major challenge has to be faced for Chinese dam engineers of seismic aspects?”. Finally, the corresponding tactics with response to the challenge are suggested.

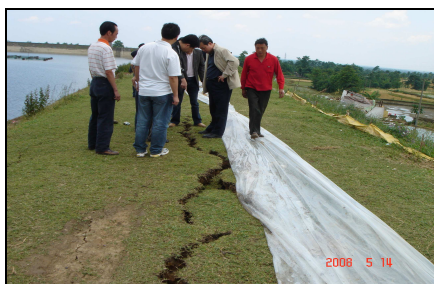
Sichuan Province is rich in water resource and hydropower potential and has a large number of reservoirs as mentioned above. It is the most important hydropower energy base of China. A total of 1803 dams were reported to be damaged to different extent during the devastating quake. But most of them ( about 95%) are small homogeneous earth dam for water supply and irrigation with a storage capacity less than 5Mm<sup>3</sup>. The main damages of these dams during the quake are cracking, slop sliding, crest settlement, leakage, failure of spillway and outlet, and so on. Fig.3 shows one of the damaged dams with crest cracking.

Fig.3 Damaged small dam with crest cracking

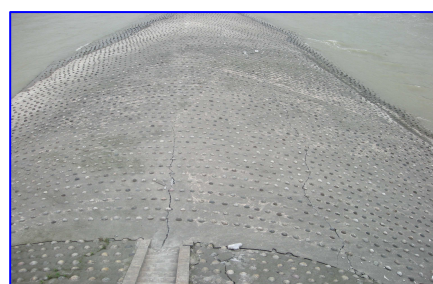
cracks of (2-3) cm on the weir surface (Fig.4) and local damage at the support of the headstock gear for sluice were detected.

Fig.4 small cracks of (2-3) cm on the Dujiangyan weir surface

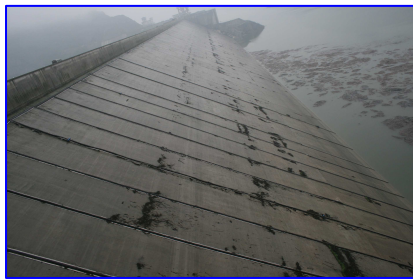
After earthquake the maximum settlement of 734.6 mm at dam crest and the horizontal deflection to downstream of 179.9mm have been measured. The cross canyon deflections of both banks are pointed to the river with a total value of 101.6mm to squeeze the dam. The face slabs were partially dislocated along the construction joints and broken away from the bed course with a maximum bulge of about 150 mm (Fig.5). Cracks between road at crest and downstream slope protection have obviously appeared (Fig.6).

Fig.5 Damages of face slabs

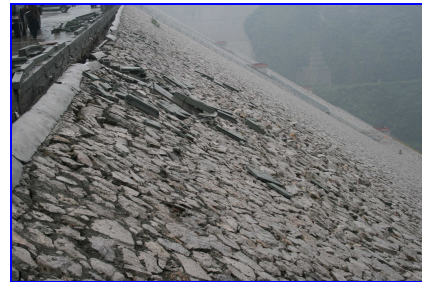
Fig.6 damages of downstream slope protection
