## NON-STRUCTURAL COMPONENT PERFORMANCE IN 4-STORY FRAME TESTED TO COLLAPSE

### ABSTRACT :

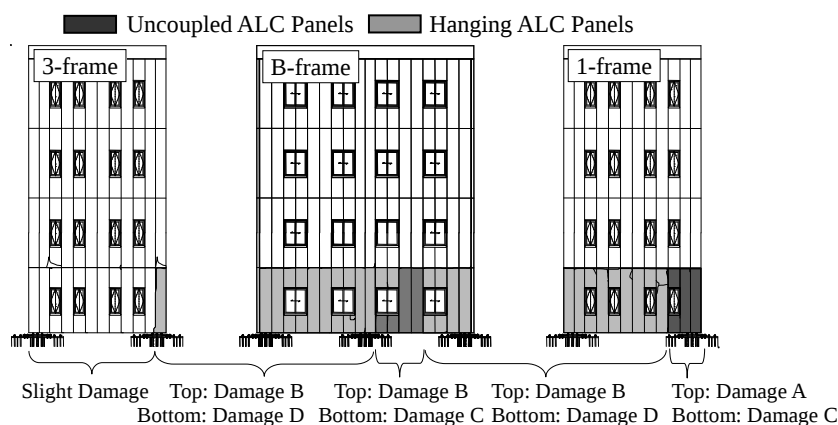
Figure2 Damage to the ALC panels after test by 1.0 Takatori records

performance of external walls such as water-resistance, heat-insulation and sound-insulation did not spoil. Under 1.0 times the Takatori records (maximum story drift at the 1st story: X direction 0.08 rad, Y direction 0.19 rad), severe damage was observed at the 1st story. The ALC panels hatching as shown Figure 2 fell off or hanged. Figure 3a shows the damage to the ALC panels at Line 1 of the 1st story after 1.0 times the Takatori records. In the top and bottom of these ALC panels, two kind of damage to the fastener was observed as shown Table 1. Figure 3b shows Damage B, and Figure 3c shows Damage C. On the ALC panels falling off, the top of the panel has Damage A and the bottom of the panel has Damage D. On the hanging ALC panels, the top of the panel has Damage B and the bottom of the panel has Damage C or D.

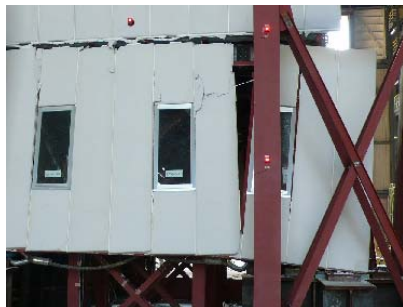
(a) Damage to the ALC panels at 1-frame

Figure3 ALC panels after test by 1.0 Takatori records

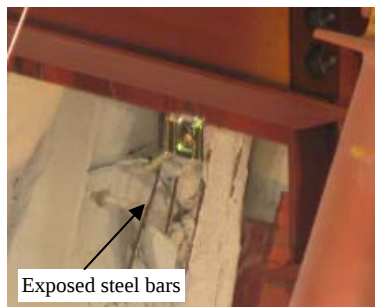
(b) Damage B

| | Damage B | Crash of the ALC panel and exposure of the reinforcing bars |

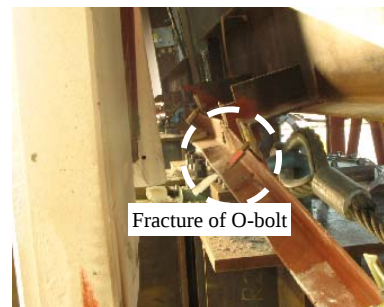
(c) Damage C

| Bottom | Damage C | Fracture of the O-bolt fastening the ALC panel |

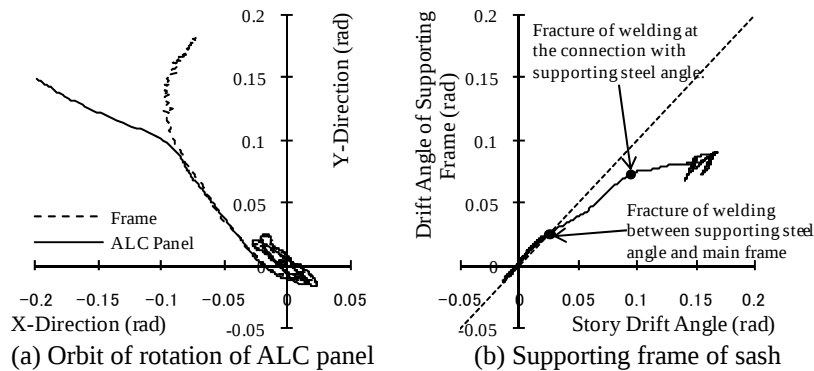
Figure 5a shows the orbit of the story drift and the rotation of the ALC panel at the 1st story. After the story drift reached to 0.080 rad for the X direction and 0.083 rad for the Y direction, the behavior of the ALC panel was not accommodated to the story drift. It is understood that Damage D was occurred at this point and the ALC panel hanged. Figure 5b shows the relationship between the drift angle of the supporting frame of the sash and the inter-story drift angle. Since the drift angle of the supporting frame of the sash was not increase after the instance, it is expected that Damage D occurred at this point. In addition, it is confirmed by the video that Damage A and C occurred simultaneously.

Figure5 Deformation of the external wall at 1st story by 1.0 Takatori records

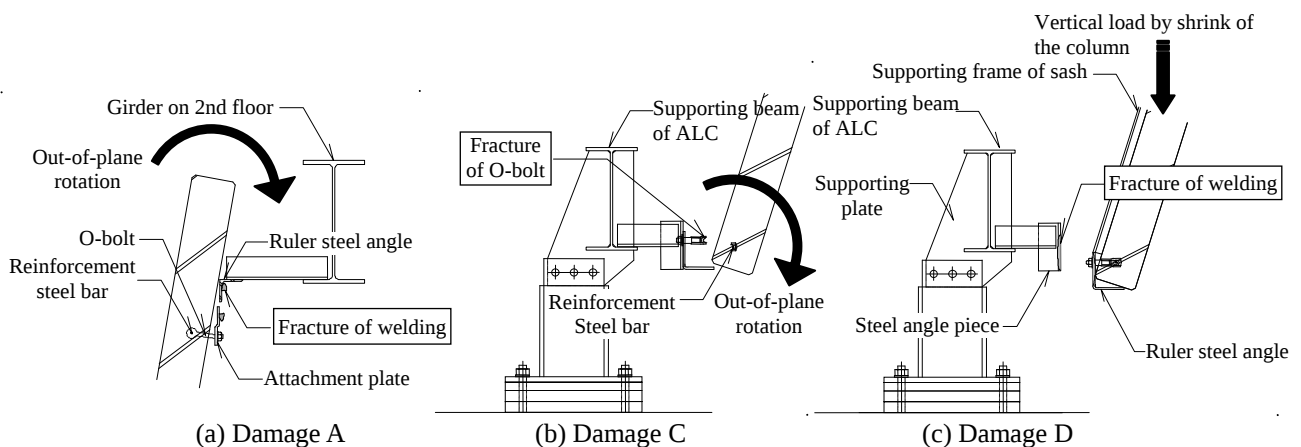
In the component test to investigate the simple behavior of the ALC panel (Matsuoka, et. Al. 2007), the ALC panels did not fall when the in-plane rotation angle reached to 0.15 rad. However, in the present shake test, the some ALC panels fell off or hanged until 0.12 rad rotation in bi-axial direction during 1.0 times the Takatori records. Figure 6 shows the observed damage mechanism of the fastener of the ALC panel. On Damage A and C, the welding or the O-bolt fractured because of the shear or tensile force induced by the out-of plane rotation of the ALC panels. On Damage D, the welding fractured because of the vertical force induced by the shrinkage of the 1st story column with the local buckling. Thus, the out-of plane rotation or the vertical load which were not observed in the component test might contribute to the damage to the fastener in the present shake test.

Figure6 Damage mechanism of the ALC panels

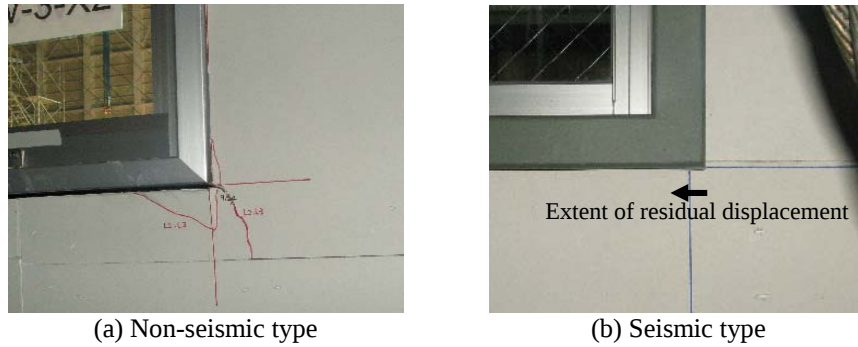
On the non-seismic type of the internal finishing drywalls attached on the inside of the ALC external wall, the gypsum board met the window frame under the small story drift and some local crushing and cracks were observed as shown in Figure 7a. On the seismic type of the internal finishing drywalls, the window frame did not meet the gypsum board until 0.05 rad of the story drift because of 10.5mm gap, so no damage was observed as shown in Figure 7b. However, when the deformation exceeded the gap, the gypsum board was damaged, and the larger gap remained.

Figure7 Internal walls around window frame after test by 0.6 Takatori records
