CHARACTERISATION OF SLOPE FAILURES DURING THE 2004 NIIGATA-KEN CHUETSU AND THE 2007 NIIGATA-KEN CHUETSU-OKI EARTHQUAKE

H. Toyota¹ and A. Onoue²

ABSTRACT :

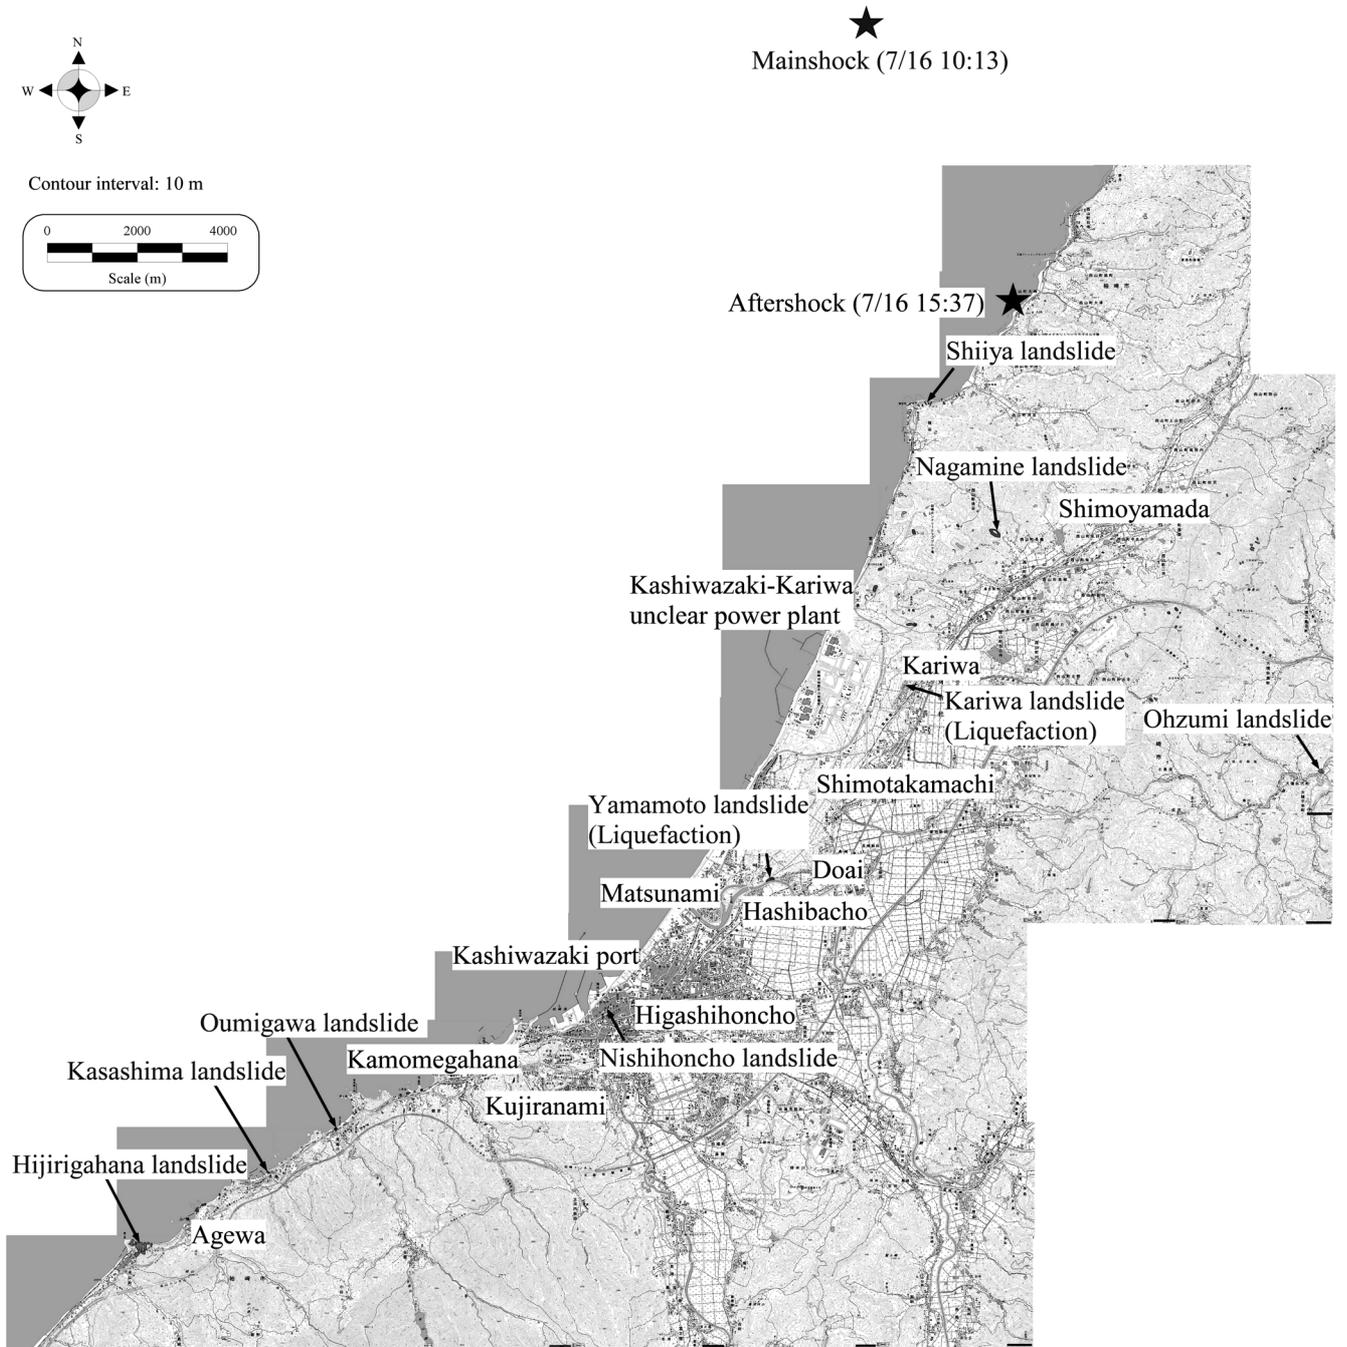
Figure 4 Landslide locations during the Chuetsu-oki Earthquake (provided by GSI)

Figure 4 shows the locations of landslides during the Chuetsu-oki Earthquake, based on the map provided by the Geographical Survey Institute. According to Ministry of Land, Infrastructure, Transport and Tourism as of 6 Aug. 2007, total number of slope failures is 108 during the Chuetsu-oki Earthquake. This number is considerable small comparing with 3,000 over during the Chuetsu Earthquake. The slope failures concentrated in the step slope of coastal terrace from Shiya to Hijirigahana, which is quite long distance. Although almost of all slides were surface collapses, large mass movements rarely occurred in inland part such as Nagamine or Ohzumi. On the other hand, the landslides are hardly seen in inland part, which expands in the southwest of the Kashiwazaki plain and is formed by Yoneyama Formation.

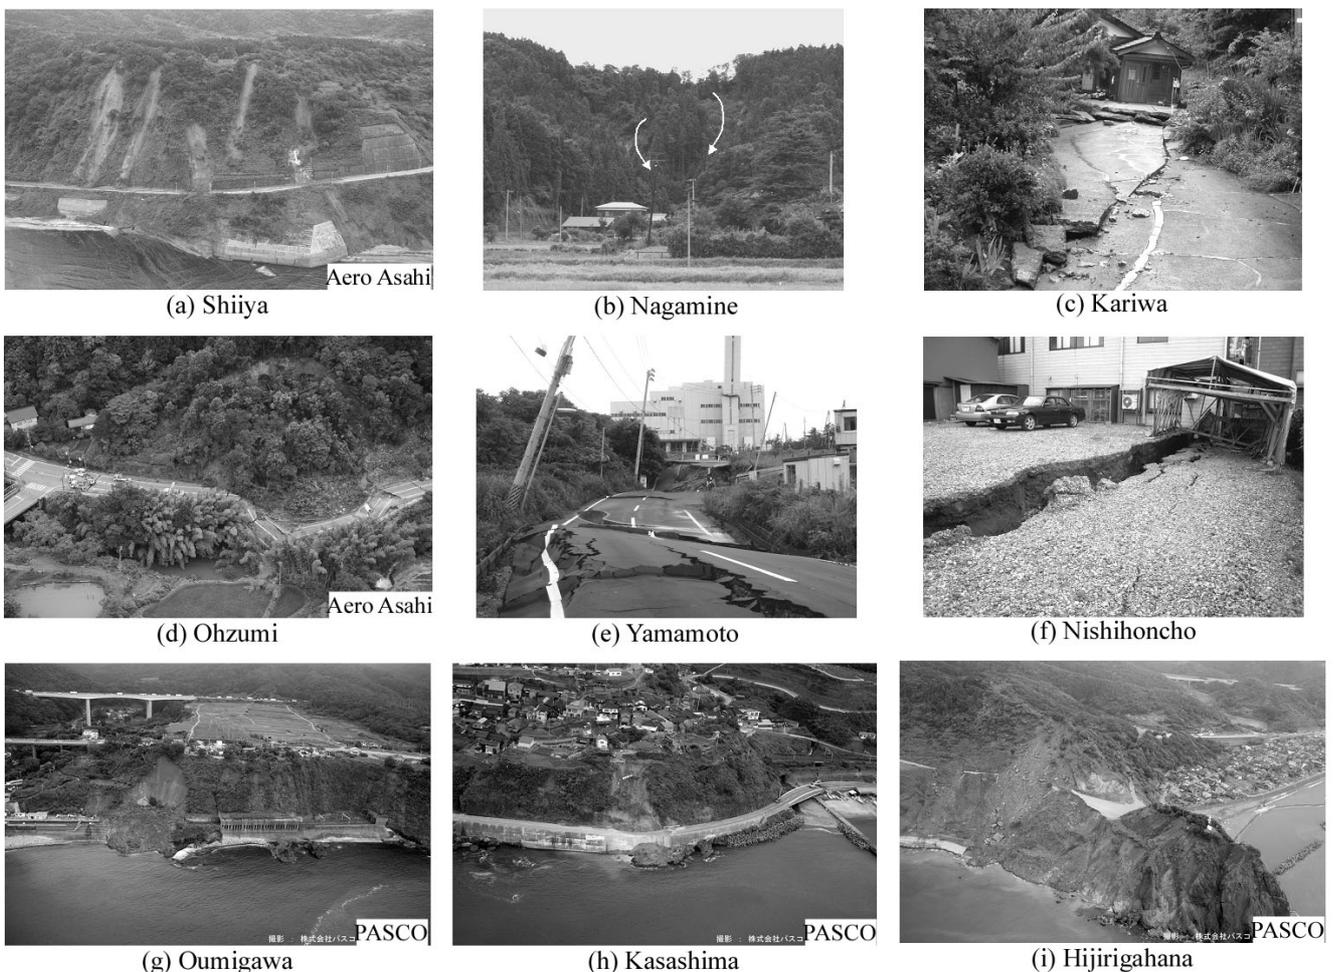
Figure 5 Representative landslides during the Chuetsu-oki Earthquake

Figure 5 shows the photographs of representative landslides during the Chuetsu-oki Earthquake. Several surface slope failures, which are about 10 m in width, about 3 m in thickness and 70 m in maximum length including sliding mass, occurred in Shiiya and the soil mass blocked the national road No. 352 as shown in Fig. 5 (a). This place is a cape that juts out into the sea and the steep slope of about 45 is a reverse-dip slope composed by alternation of sandstone and mudstone of the Shiiya Formation. Toyota et al., 2004 reported that similar slope failures in which weathering surface had collapsed in same geology and topography. It is understood that this type of slopes is in danger of earthquakes as well as heavy rainfall. Large scale of landslide occurred in Nagamine of Nagaoka city (Fig. 5 (b)). It is the only slide that broke out in a valley topography in all slides selected in the paper, whereas other slides occurred in convex topography. This place is designated specified as debris flow designated area. The slope is about 20° and the width is about 100 m and the length is about 210 m and the thickness is about 10 m. The dip slope is formed by alternation of sandstone and mudstone of the Nishiyama Formation. The slide occurred at the both side as shown using arrows in the Fig. 5 (b) and the smooth mud stone of about 30° and light grey colour appeared after the soil flew down. There is no apparent sign of movement in the soil mass remained in the centre. Lateral spreading due to liquefaction occurred at the edge of Arahama dune slope, where the dune is crossing with soft alluvial deposits, in Kariwa of Kariwa village and houses were damaged as shown in Fig. 5 (c). This area also had the same damage during the Chuetsu Earthquake. Some houses that seismically reinforced after the Chuetsu Earthquake suffered slight damage. It is considered that the cause of this damage was problematic ground composed of loose sandy soil with high underwater level.

Mass movement landslide occurred in Ohzumi of Nagaoka city (Fig. 5 (d)). The landslide broke out at inland area by East comparing other major slope failures (Fig. 4). The size of moving soil mass was about 10m thickness, about 100 m width and length. The soil mass moved down with cut of National highway, route No. 8, and temporarily closed Kuro River, which streams at the bottom of the slope. The dip slope structure that inclines with the slope of about 25° is composed from thin sand and silt layers of Uonuma Formation. There was no damage during the Chuetsu Earthquake in spite of large tremor as the same as the Chuetsu-oki Earthquake. It might be considered that degradation and formation of slip surface progressed during the Chuetsu Earthquake in this slope. The unstable surface of moving mass was cut and removed for emergency repairs. Then, the road was quickly opened to traffic with two-lane a week after the earthquake. More than 2 m difference in level due to slide occurred at Yamamoto of Kashiwazaki city (Fig. 5 (e)). As shown in the centre of figure, chimney of a waste incineration centre fractured by the strong earthquake shaking. This area is located in the edge of Arahama dune bounded on Sabaishi River. It is considered that this deformation was caused by the lateral spreading due to liquefaction because of high underwater level. Yamamoto estate near this area was also damaged by liquefaction. More than 50 cm subsidence whose width is more than 100 m was formed in Nishihoncho 2-chome of Kashiwazaki city (Fig. 5 (f)). This area was inside Arahama dune enclosed with U River and the sea. The sliding area looks large because apparent damage was not seen in the retaining wall constructed on the steep slope and some displacement appeared in the gentle slope area located at the bottom of the steep slope. Although it is considered that the slide was induced by liquefaction of bottom of the slope, there were not liquefaction traces nearby. The slope failure occurred at the place adjacent to JR Oumigawa station (Fig. 5 (g)). The railway was buried by collapsed soil mass. Cracks appeared at the top of the slope and threaten people who live on the top of the slope. Sea cliff of about 45°, which is formed in a convex topography in plane surrounded by Tanne River and the sea, crumbled down in the range of about 40 m in width, about 50 m in length and about 5 m in thickness. The bedrock is mud and silt stone of Yoneyama Formation covered by river-bed and literal deposits. This slope is designated specified as prevention area of slope failure. Water soaks out from boundary of strata in knick line of the slope. It is considered that the strongly weathered surface broke down because collapsed soil was very soft without rock blocks and included plenty of water. Figure 5 (h) shows a slope failure occurred at a sea cliff of about 35° in Kasashima of Kashiwazaki city. The road was buried by collapsed soil mass and some people who live near the top of the slope had to evacuate. The slope is designated specified as prevention area of slope failure and the geology and the topography of this area are also similar as those of Oumigawa. The size of the failure was about 30 m in width, about 30 m in length and about 3 m in thickness. Weathered upper part of knick line of the slope mainly collapsed as shown in the figure. The base rock had appeared after the failure in the lower part of the slope. Slope failures took place in Hijirigahana, which is a cape in Yoneyama of Kashiwazaki city. Several failures occurred in a dip slope side that faces the sea and a failure, which threatened inhabitants in the bottom of the slope, also occurred in a reverse-dip slope side that lies in opposite side over the

ridge (Fig. 5 (i)). These failures are more than 30 km away from the epicentre. The size of the largest slide occurred in the dip slope was about 25° slope, 90 m wide, about 200 m long and about 10 m thick in upper part but thinner in lower part. Smooth sliding surface of grey mudstone that has about 28° inclination clearly appeared with striations, which present a frictional trace by sliding. According to Kashiwazaki city hall, in the same place, small slope failures had repeatedly occurred at every natural disaster such as heavy rainfall or the Chuetsu Earthquake. The same type of slope failure in Yokowatashi of Nagaoka city was reported by Onoue et al. (2006) during the Chuetsu Earthquake. Thus, rock sliding along smooth bedding plane and joint surface easily occurred during earthquakes.

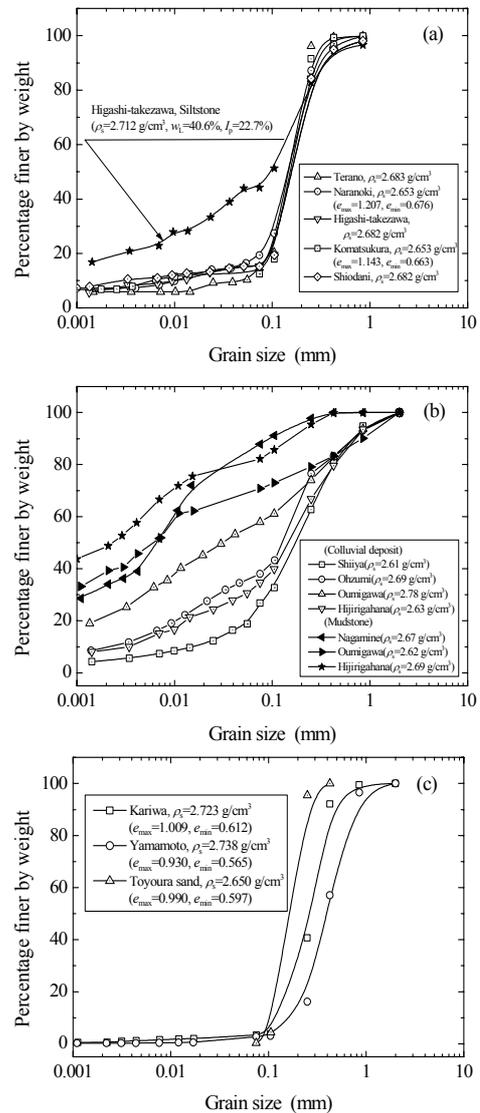
Figure 6 Grain size distributions obtained from failure sites: (a) Slopes (Chuetsu Earthquake), (b) Slopes (Chuetsu-oki Earthquake), (c) Arahama dune (Chuetsu-oki Earthquake)

Figures 6 (a), (b) and (c) show grain size distribution of the soil samples taken from slope failure sites in the Chuetsu and the Chuetsu-oki Earthquakes. All samples from the main scarps risen during the Chuetsu Earthquake are sand including less than 10% fines (Fig. 6 (a)). This means that sandy natural slopes are more fragile than clayey natural slopes during earthquakes. The exposed mudstone at Higashi-takezawa is composed mainly of silt; that is, siltstone. These results agree with information from the geological map, which shows alternation of sandstone and mudstone strata. The maximum and minimum void ratios based on Japanese industrial standards (JIS A 1224) are respectively 1.207 and 0.676 in Naranoki sand and 1.143 and 0.663 in Komatsukura sand. Figure 6 (b) shows grain size distribution of colluvial deposits and mudstones taken from natural slope failure sites in the Chuetsu-oki Earthquake. Mudstones contain much fine than colluvial deposits. Furthermore, the colluvial deposits have much fine content than those of Fig. 6 (a). This means that silty and clayey deposits were predominant in natural slope failure points during the Chuetsu-oki Earthquake comparing with the cases in the Chuetsu Earthquake. This aspect might be the reason why the number of failure sites in the Chuetsu-oki Earthquake is smaller than that in the Chuetsu Earthquake. Figure 6 (c) shows grain size distribution of soils in Kariwa and Yamamoto formed Arahama dune, which was damaged by liquefaction in the Chuetsu-oki Earthquake. For comparison, grain size distribution curve of Toyoura sand, which is Japanese standard sand, is also demonstrated in the figure. Those are pure sand whose fine content is less than 5%. The maximum and minimum void ratios based on JIS A 1224 are respectively 1.009 and 0.612 in Kariwa sand and 0.930 and 0.565 in Yamamoto sand.

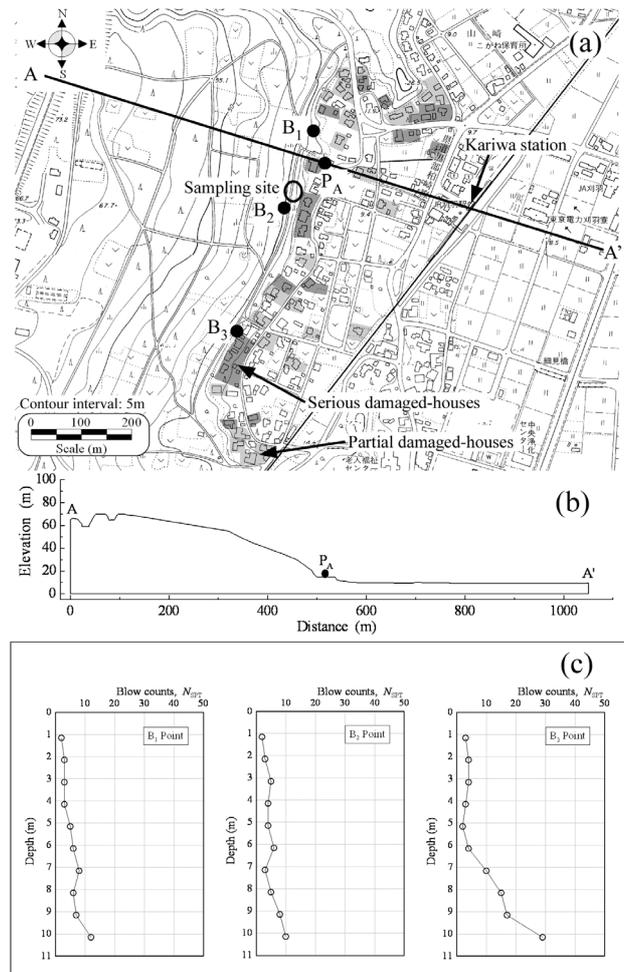
Figure 7 Topography map of Kariwa: (a) Plane figure, (b) Cross section, (c) Penetration resistance (Provided by Niigata Prefecture)

Mechanical properties of soils obtained from the residential area, Kariwa (Figs. 4 and 5 (c)), damaged by liquefaction were examined in detail. Topography map in plane and cross section of Kariwa and the N -values (N_{SPT}) of the ground are shown in Figs. 7 (a), (b) and (c), respectively. Point P_A in the figures show house that suffered a severe damage due to lateral ground displacement. An area of serious damaged-houses is coloured

dark grey, while that of partial damaged-houses are light grey. Points B₁, B₂ and B₃ in the figures shows boring investigation point where the standard penetration test was conducted. This area is composed of Arahama dune, which formed a gentle slope of about 10% behind the residential area. From the result of the standard penetration test (Fig. 7 (c)), it is clear that Arahama dune is very soft as far as 10 m depth. Disturbed samples were obtained from the damaged site of Kariwa because the soil was too weak to get block samples. Reconstituted specimens were made using the dry deposition method (Ishihara, 1993). Dry soil was filled in a cone-shaped slender funnel with a nozzle about 12 mm in diameter. This funnel was the same as that used for determining the maximum void ratio based on JIS A1224. The sand was accumulated in the mould with zero height of fall at a constant speed until the mould became filled with the sand. Then, the side of the mould was hit by hammer to make a given density of specimen. The dune was very loose because in-situ void ratios based on the core cutter method were 0.81 ($D_r=50\%$) to 0.85 ($D_r=40\%$). The grain size distribution curve, e_{max} and e_{min} of the soil are shown in Fig. 6 (c). Cyclic undrained triaxial tests of constant deviator stress amplitude were performed with constant axial strain rates of 0.1 %/min to examine the basic liquefaction behaviour of the soil. Furthermore, Cyclic constant volume direct (box) shear tests of constant deviator stress amplitude were also conducted with constant shear displacement rate of 0.1 mm/min to examine effects of initial shear due to slope on liquefaction. Specimen size and the testing procedures are the same as those in Komatsukura sand in triaxial tests. In direct (box) shear tests, specimens of $d=60$ mm in diameter and $h=20$ mm in height were used for testing in dry state without water saturation. After applying a certain vertical stress, cyclic constant volume direct (box) shear of constant deviator stress amplitude were performed with constant axial strain rates of 0.1 mm/min.
