ZONING FOR LIQUEFACTION AND DAMAGE TO STRUCTURES DURING THE 2005 FUKUOKA-KEN SEIHO-OKI EARTHQUAKE

ABSTRACT :

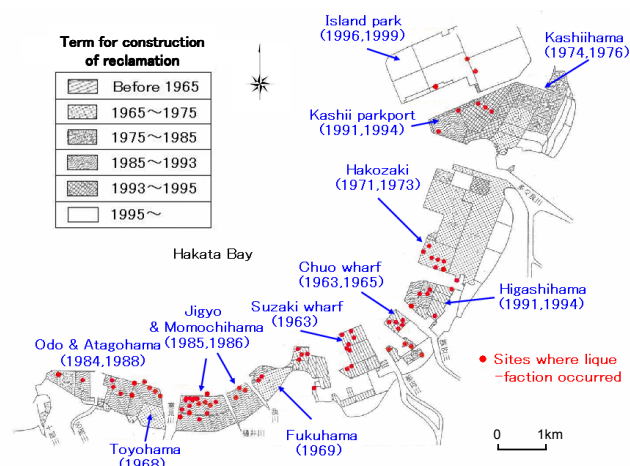
In a survey performed immediately after the earthquake, the occurrence of liquefaction was identified by the presence of sand boils on the ground surface. Figure 1 indicates the distribution of the sites where liquefaction occurred in the Hakata Bay area. The periods during which the reclaimed lands were constructed are also shown in Figure 1. From this figure, it can be observed that the sites that exhibited liquefaction are mainly distributed in the reclaimed lands of the Hakata Bay area and are interspersed with reclaimed lands. Therefore, the degree of severity of liquefaction due to the earthquake is not regarded to be as high as that observed in past earthquakes, for example, the 2000 Tottori-ken Seibu Earthquake (e.g. Yoshimoto et al., 2002). On the contrary, the occurrence of liquefaction in alluvial ground was almost negligible. It may be considered that the occurrence of liquefaction is related to the characteristics of earthquake motion and the magnitude of the liquefaction strength of soil, although there is a possibility that liquefaction occurred in the alluvial ground; however, sand boils did not appear onto the ground surface.

Figure 1 Distribution of sites where liquefaction occurred in the reclaimed lands of the Hakata Bay area

1) In general, it is more difficult for liquefaction to occur if the duration of sedimentation is long. However, the trend of liquefaction resistance is not observed as shown in Figure 1. For example, although Chuo wharf and Hakata wharf were constructed almost forty years ago, heavy damages to port and harbor facilities were induced by liquefaction in the reclaimed lands. On the contrary, structures in Higashihama, Kashii Park Port, and Island City, were minimally damaged, although these reclaimed lands were constructed fairly recently, from a few years to twenty years ago.

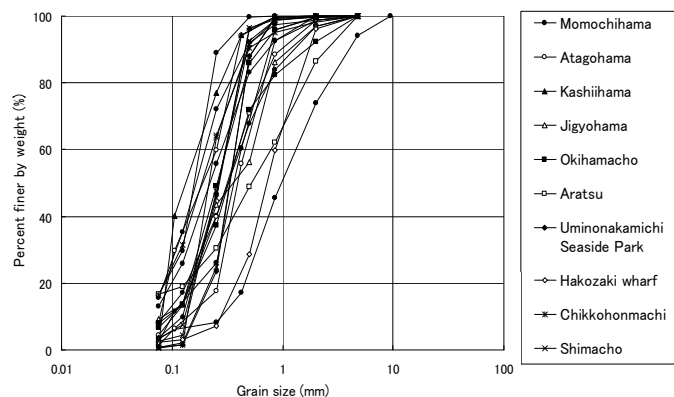
Figure 2 shows the grain-size distribution curves of sand boils observed at several reclaimed lands in the Hakata Bay area. The particle size D_{50} is 0.15–1.06 mm and the uniformity coefficient U_c is 1.7–7.1. The boiled sand is classified as a relatively well graded middle sand to a poorly graded fine sand, provided that certain sand samples are excluded from the sand boils. Further, it was observed that the color of the sand boils was different in the reclaimed lands.

Figure 2 Grain-size distribution curves of sand boils

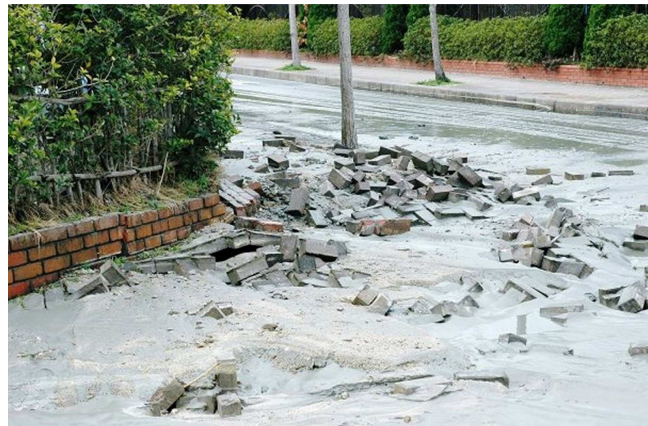
3) In Atagohama, the lower layer and its upper layer are composed of clayey soil and sandy soil, respectively, which were soils dredged from the bottom of Hakata Bay, while the surface layer is composed of mountain sand. An exceptional phenomenon was observed in Atagohama, as shown in Photo 1. According to oral testimonies, fountain water with a volume of almost three times the inner volume of a swimming pool in elementary schools and sand boil almost three times the capacity of a 4-ton truck appeared on the ground surface. Most of the fountain water did not appear turbid. It can be considered that the phenomenon was induced by liquefaction in the sandy soil layer (Nagase et al., 2006).

Photo 1 Location of sand boils in the residential area of Atagohama(provided by Ms. kayoko Hoshiko)

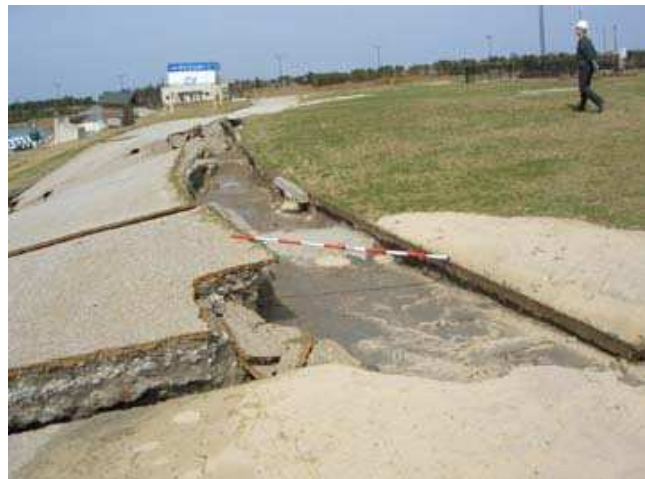
At the Uminonakamichi Seaside Park, flow failure occurred in an open space with a gently sloping ground toward a pond known as “Kamo-ike.” Photo 2 shows the state of the flow failure immediately after the earthquake, and Figure 3 indicates the locations at which a survey was carried out for measuring the ground displacement. Figure 4 shows the relationship between the ground displacement due to flow failure in the perpendicular direction of the waterline of the pond and its distance from the waterline of the pond. From the figure, it can be observed that the ground displacement reached a maximum of around 10 m, although the maximum displacement in the c-c line was around 1 m. It appears that a stone stairway that was constructed near the waterline had a restraining effect on the ground displacement. Further, a worker who manages tourist boats was interviewed regarding the flow phenomenon. It was clarified from this interview that the flow failure occurred almost immediately after the occurrence of liquefaction during the earthquake. The phenomenon of flow failure in this case is different from that during the 1964 Niigata Earthquake, where the flow failure supposedly occurred three minutes after the earthquake (Wakamatsu et al., 2004).

Photo 2 Flow failure of the ground at Uminonakamichi Seaside Park

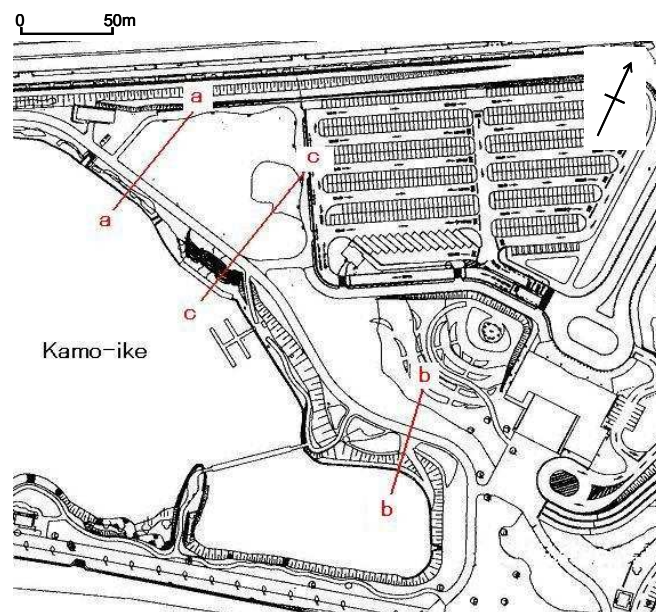
Figure 3 Locations where a survey was carried out to determine the ground displacement due to flow failure

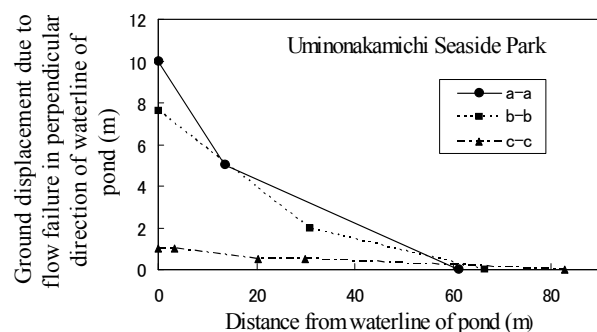
Figure 4 Relationship between ground displacement due to flow failure and distance from the waterline of the pond

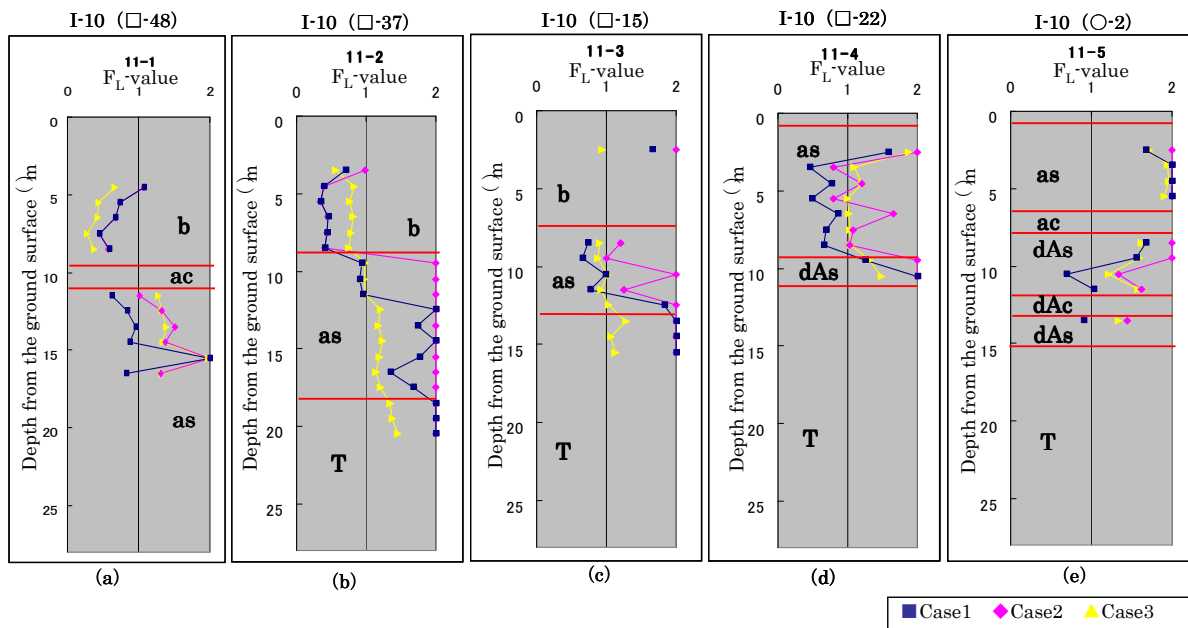
Figure 7 shows the results of the liquefaction analysis for Cases 1-3. The F_L -value for the reclaimed land is less than 1.0; this implies that liquefaction occurs in the reclaimed land in Cases 1-3, except in (c). However, in the alluvial soil layer, liquefaction apparently occurs for Case 1 in (a), (c), and (d), does not occur in (a) and (c), and its occurrence seems unlikely for Case 2 in (d). On the contrary, liquefaction does not occur in the alluvial soil layer in Case 3. It is evident that the result of the prediction of the occurrence of liquefaction depends on the manner in which the liquefaction strength is modified using the fine content ratio. Further for Cases 1 and 2, it may be considered that the effect of fine content on the liquefaction strength was not properly accounted for in the analysis.

Figure 7 Results of liquefaction analysis

During the earthquake, liquefaction occurred mainly in the reclaimed ground of the Hakata Bay area and hardly occurred in the alluvial ground, described above. Therefore, it is noteworthy that the occurrence of liquefaction was suitably predicted in Case 3. It can be considered that the effect of fine content on the liquefaction strength of alluvial ground in Fukuoka City was properly estimated in Case 3, although other predictions would be necessary in this regard to confirm the accuracy of the analysis.
