## ANALYSIS OF STAIRWELLS PERFORMANCE AND DAMAGE DURING WENCHUAN EARTHQUAKE

**ABSTRACT:** A large number of stairwells damage took place in various buildings during the 8.0 magnitude earthquake that struck northwestern Sichuan on May 12, 2008. For these special structural elements, a post-earthquake survey was carried out in Dujiangyan and different modes of failure of the stairwells were observed. Many structural deficiencies were highlighted by the earthquake damage. It is concluded that when buildings were mainly subjected to horizontal seismic forces in the transversal direction, the types of damage of stairwells included: 1) flexural damage in staircase treads, 2) shear damage at construction interface of staircase treads (initiating at the intersection between the treads and the risers), 3) shear failure in landing beams, and 4) crushing failure in the connections between the staircase treads and the landing beams. On the other hand, when the buildings were mainly subjected to horizontal seismic forces in the longitudinal direction, the type of damage of stairwells was mainly plastic hinging in the joints of the landing beams and columns or only in the columns.

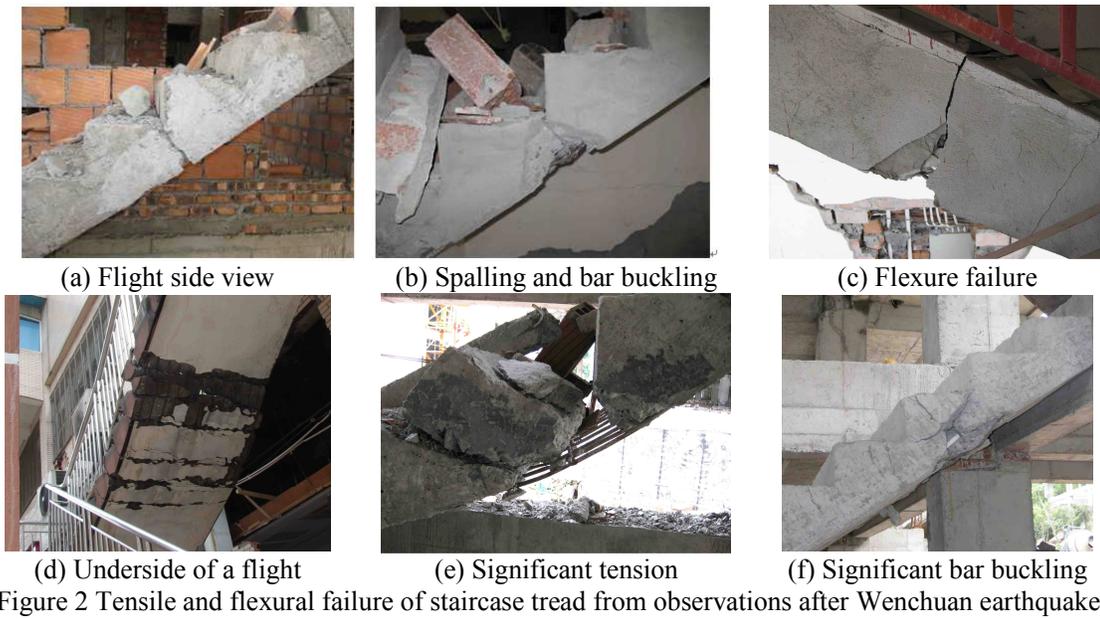
Figures 2 (a) to (f) show cracks occurred in the direction perpendicular to the staircase tread at middle of the staircase tread. According to the feature of damage, the cracks were caused by tension and flexure. Staircase treads were observed to experience shear damage on the construction interface initiating at the intersection between the treads and the risers where concrete was typically cast at different times, which are shown in

The damage exerted on the staircase treads is mostly caused by horizontal seismic forces in the transverse direction. The staircase treads worked together with the landing beam and platform to brace the stairwell. Under multiple cycles of tension and compression, damage occurred in the transverse direction of the stairwell. When the strength of concrete was low due to existence of construction interfaces, the two sides of the interface tended to displace relative to each other due to interface shear forces during the earthquake. In the absence of construction interfaces in the staircase treads, tensile and flexural damages were observed.

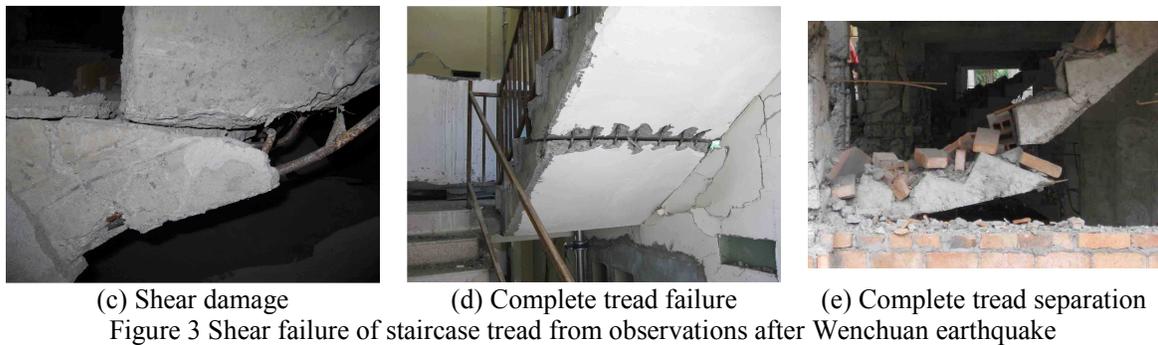
Figures 3 (a) to (c). One types of staircase tread damage is shown in Figure 3 (a), in which the staircase tread in the figures suffered lateral shear deformation in two perpendicular directions. The shear damage was due to insufficient shear strength in the construction interface.

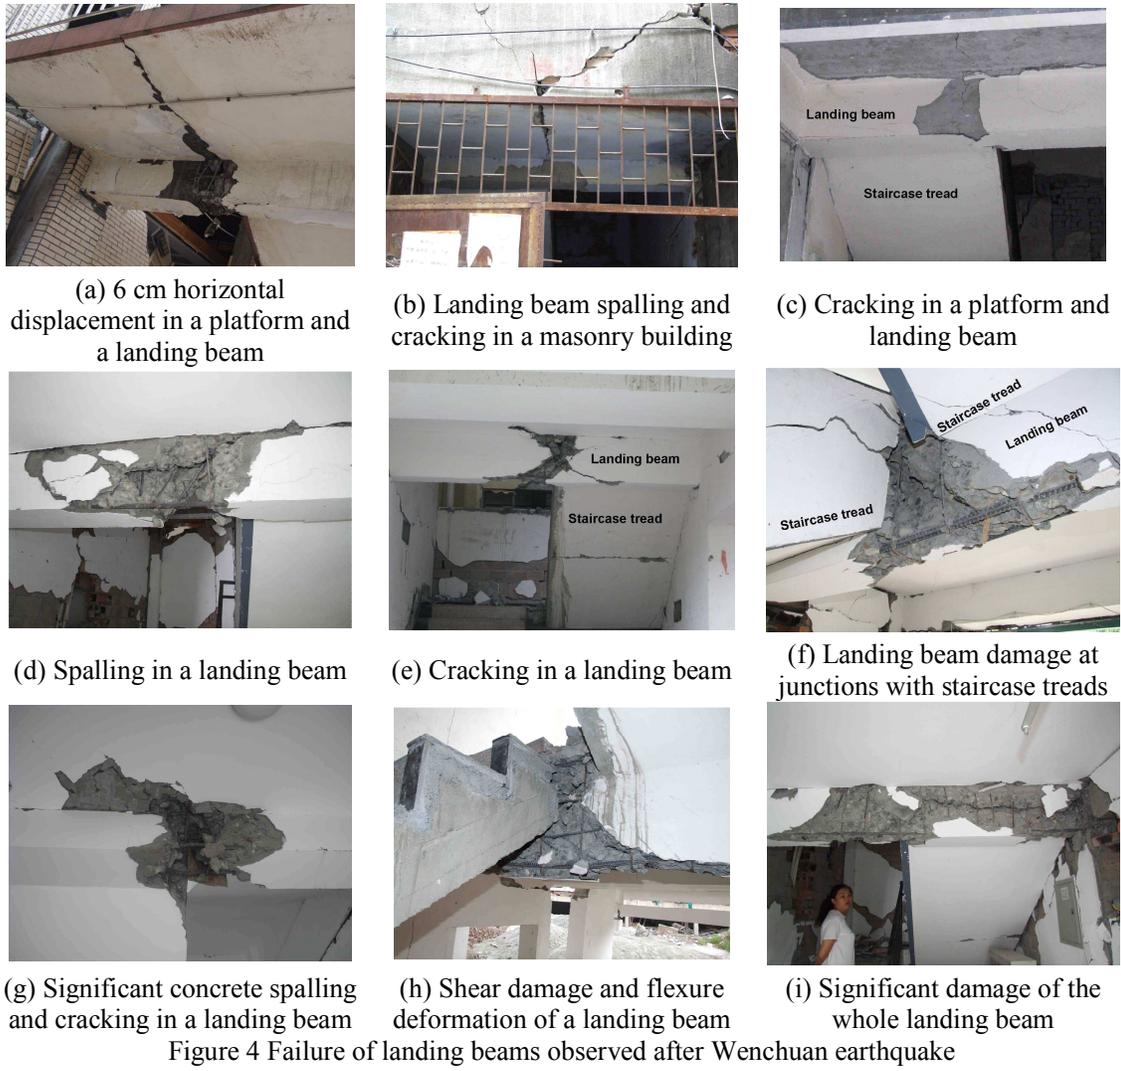
Landing beams failed in shear at their mid-span where the two flights meeting with the landing beam separate. Figure 4(a) shows a platform displaced in the horizontal direction about 6 cm during the earthquake where both the platform and the landing beam broke into two parts. Figure 4(b) shows views of a severely damaged stairwell in a masonry building which broke into two parts along the middle of the platform. One crack was observed in the platform and the landing beam in a mirror damage building in Figure 4(c). Figures 4(d) to (g) show various shear damages in the middle of the landing beams. This type of damage was widespread in the

epicenter region of the Wenchuan earthquake. Shear damage with flexural deformation is shown in Figure 4(h). Finally, Figure 4(i) shows a type of landing beam spread of damage for the whole beam length due to combination of stresses.

The damage in the landing beams was mostly caused by horizontal seismic forces in the transverse direction. During the earthquake, the beams were subjected to cyclic diagonal tension and compression from the staircase treads in two parts, as shown in Figure 5(a), where  $p_1$  is the compression coming from one staircase tread,  $p_2$  is the tension coming from the other staircase tread with  $p_{1x}$ ,  $p_{1y}$  and  $p_{2x}$ ,  $p_{2y}$  are the components of  $p_1$  and  $p_2$ , in the  $x$  and  $y$  directions, respectively, Figure 5(b). Accordingly, landing beam shear force in the  $x$  direction reached the maximum value at mid-span and possibly at the ends as well, Figure 5(c), causing the observed damages after Wenchuan earthquake. Since typically the mid-span sections are designed without or with very little shear reinforcement due to action of gravity load only, earthquake damage was mostly concentrated at mid-span. In other cases, as shown in Figures 6(a) to (c), landing beams experienced a mix of shear and bending damages near their two ends during Wenchuan earthquake.

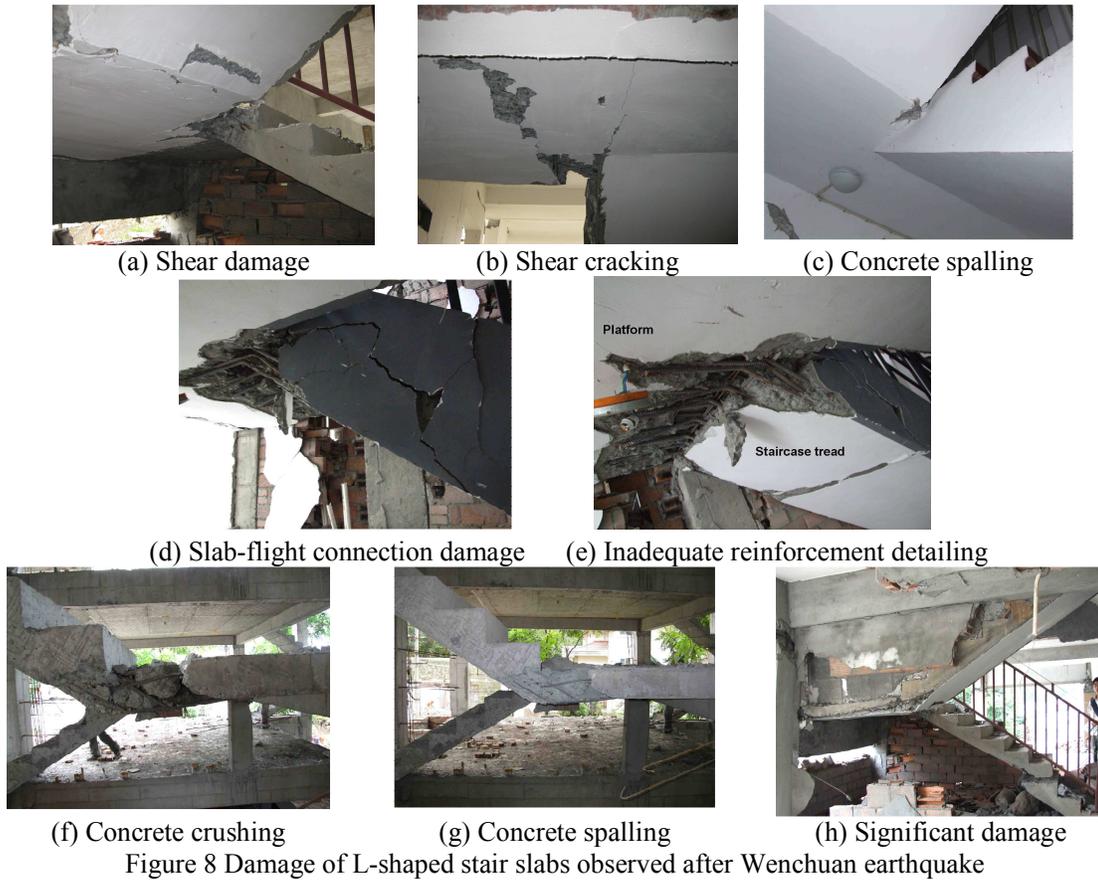
Figure 7 shows an L-shaped stair slab (according to the shape in the plan view) where, in the shown case, there is no landing beam. Figures 8(a) to (c) illustrate several cases of cracking in the stair slab where the two flights meeting with the slab in L-shaped stair. Crushed concrete (mainly at the connections between the landings and the stair flights) was observed after the Wenchuan earthquake in Figures 8(d) and (e). It is to be noted that Figures 8(d) and (e) demonstrate cases of inadequate embedment length of the flight longitudinal reinforcing bars into the landing slab. Figures 8(f) to (h) show crushing of concrete in the corner of L-shaped slabs caused by the reinforcing bars developed straight.

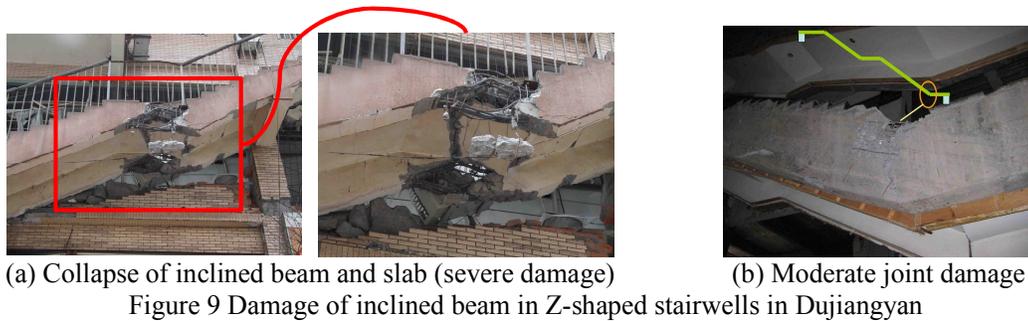
Having a landing in between two flights is required for large story heights characterizing the class of Z-shaped stairwell (according to the shape in the elevation view). Figure 9 illustrates two levels of damages (severe and moderate) to the inclined beams and slabs in Z-shaped stairwells observed after the Wenchuan earthquake. The damage was concentrated in the corner of the inclined beams due to tension and compression components produced by the earthquake loading.

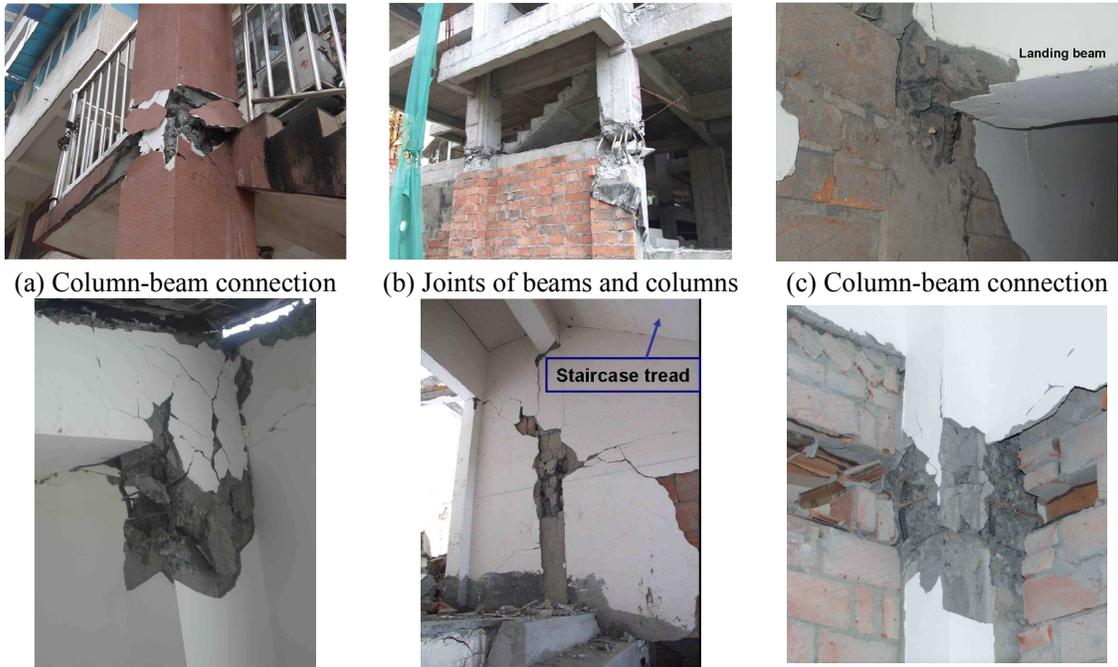
Figure 10 Damages in columns of main structure around stairwells in Dujiangyan

The plastic hinging in the columns which support the landing beams in Figure 10 were observed by the

reconnaissance team after the Wenchuan earthquake. In general, the columns around the stairwell were damaged more severely than columns in other parts of the building, especially in RC framed buildings. This is indicative of the large seismic lateral forces attracted to these columns by the stiffening effects of the stairwell. The damage of the main structure around the stairwell was caused by the horizontal seismic forces in the longitudinal direction caused by ground shaking component in that direction. The discontinuity in the floor slabs due to the existence of the stairwell reduces the overall stiffness in the longitudinal direction due to reduction of the diaphragm action. Therefore, damage takes place in the main structural elements as observed in the different cases shown in Figure 10.

(a) Column-beam connection

(b) Joints of beams and columns

(c) Column-beam connection

(e) Plastic hinging

(f) Column in infilled frame

(g) Plastic hinging in the middle
