STUDY ON BUILDING DAMAGES IN THE 512 WENCHUAN EARTHQUAKE IN CORRESPONDENCE WITH THE PROVISIONS OF THE SEISMIC DESIGN CODE GB50011 OF CHINA

Wang Yayong¹

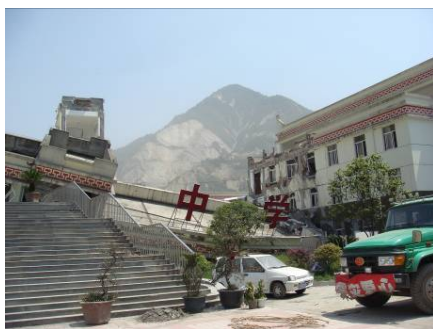
The multiple seismic defense lines are required for building structures by Chinese “Code for Seismic Design of Buildings GB50011-2001”(2001) that are significant for building safety against collapse on the major earthquake level corresponding to a return period of over 2000 year. On the major earthquake level, some structural members, for example for RC structures, braces, attached wind walls to columns of frame structures and coupling beams of shear walls, acting as the first defense line (or protective system) are allowed to be first damaged. In such case the earthquake energy is dissipated, the dynamic feature of the structure is changed and the earthquake action has been reduced therefore. The main structural members such as frame columns and shear walls which remain as the second defense line after the first defense line yielding, and therefore they protect the whole structure from collapse. For masonry structures, tie-columns and tie-beams which acting as restraint members to enhance the ductility of the masonry wall can be seen as the second defense line. Under major earthquake, masonry walls are allowed to be severely damaged but the structure can be escaped from collapse owing to the existing of the tie-columns and tie-beams. Figures 1 shows the collapse of a 3-story school building of RC frame structure with a typically spacious classroom of 7m×9m, but without any braces or attached wind walls to columns. This school is located in Yingxiu Town, the epicenter area where the seismic specified intensity is 7 (the corresponding PGA = 0.1g, according to the Chinese code), but the estimated intensity is as high as 11 (the corresponding PGA>1.0g). Under the action of the vertical earthquake component which may be larger than the horizontal ones, the frame columns were broken first and result in collapse of the whole building. In contrast, near by the above school building there is a 4-story office building of masonry structure, though they were severely damaged with a lot of cracks within walls, but did not collapse owing to the combination of RC tie-columns and tie-beams provided (see Fig. 2).

Fig. 1 Collapsed school building in
Yingxiu Town (7/11)*

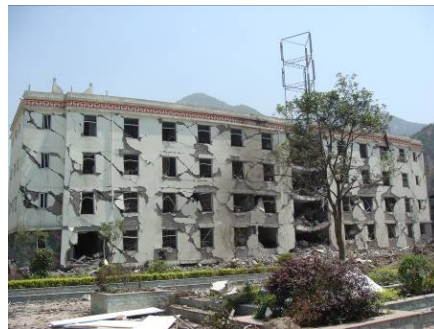
Fig. 2 Damaged office building in
Yingxiu Town (7/11)

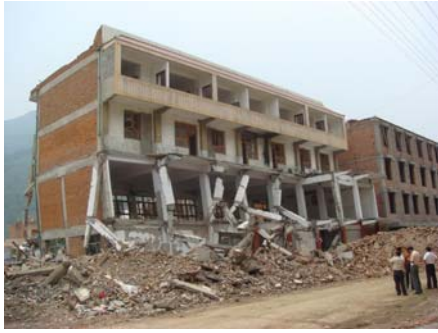
Figure 3 shows two 4-story buildings side by side of one RC frame structure and one masonry structure whose construction did not completed yet before the event, in Pingwu County with an estimated intensity 9, where the left building built of one span RC frame structure was severely damaged, but the right one of masonry structure remains safely because the brick walls are confined by tie-columns and tie-beams, leading to a significant increase in the integral rigidity and ductility of the building under large deformation. (see Fig. 4).

Fig. 3 Two buildings side by side in Pingwu County (7/9)

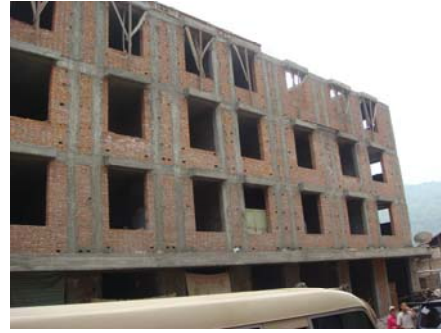
Fig. 4 Confined masonry building in the rear (7/9)

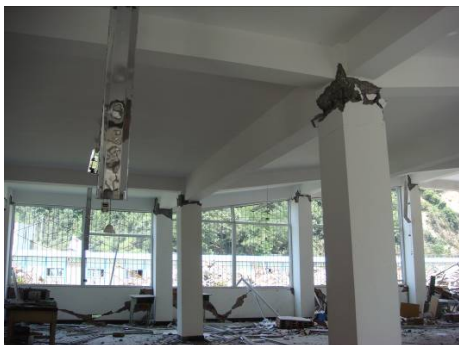
To consider the contribution of the floor slabs to the frame beam and other possible influence the factor η_c is generally assumed to be 1.5~2.0, as column is under a very complicated dual loading condition due to the couple of horizontal strong motions. In general, the section design of RC columns can be easily satisfied with the least amount of steel bars, particularly for low rise buildings as in the earthquake affected areas of this event. It can be obviously known that the practical design often results in a mechanism of “strong beam-weak column” as often observed in the damage of RC frame structures, and it reveals that the beam resistance or the assumed value of the factor η_c was significantly underestimated, if the Eq. (2) had been applied in the design. Figure 5 shows the plastic hinges of the frame columns of the west wind of the school. Figure 6 shows a plastic hinge at the top of a column of a residential building with 5-story upper masonry structures and a ground story of RC frame structure.

Fig. 5 Plastic hinges of the frame columns of Yingxiu School (7/11)

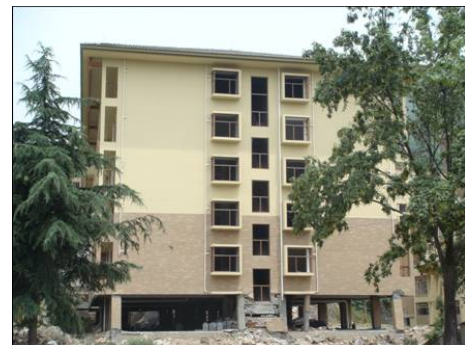
Fig. 6 Plastic hinges at top of columns of a residential building (7/9)

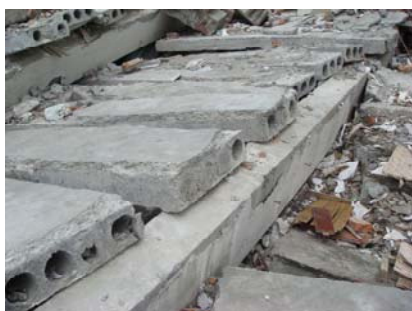
as required by Clause 3.5.5 of Chinese Code GB50011-2001. Unfortunately, some of masonry structures collapsed partly or entirely in the event due to the poor connection between the precast RC floor slabs and beam as shown in Figure 7. As masonry structures are often constructed of brittle material, the confined measures have been created and studied extensively after the 1976 Great Tangshan Earthquake in China. The combination of RC tie-column and tie-beam forms a restraining frame for masonry walls that significantly enhance the ductility and integration of the structure under large deformation. This specific type of confined structure has been widely used in earthquake-prone regions nation-wide. It is learned from past earthquakes that the three earthquake performance objectives can be reached for buildings which were designed and constructed strictly by following the requirement of detailing for tie-column and tie-beam issued in the current seismic code. Figure 8 shows a school building of confined masonry structures sustained a lot of inclined cracks in brick walls restrained within the boundary of tie-column and tie-beam, but survived. The precast RC multi-hole floor slab has been commonly used for school and residence buildings in China. The connection validity of precast RC structural members is very important to ensure the integration of the structure as required by Clause 3.5.5 of Chinese Code GB50011-2001. Unfortunately, some of masonry structures collapsed partly or entirely in the event due to the poor connection between the precast RC floor slabs and beam as shown in Figure 7. As masonry structures are often constructed of brittle material, the confined measures have been created and studied extensively after the 1976 Great Tangshan Earthquake in China. The combination of RC tie-column and tie-beam forms a restraining frame for masonry walls that significantly enhance the ductility and integration of the structure under large deformation. This specific type of confined structure has been widely used in earthquake-prone regions nation-wide. It is learned from past earthquakes that the three earthquake performance objectives can be reached for buildings which were designed and constructed strictly by following the requirement of detailing for tie-column and tie-beam issued in the current seismic code. Figure 8 shows a school building of confined masonry structures sustained a lot of inclined cracks in brick walls restrained within the boundary of tie-column and tie-beam, but survived from collapse on major earthquake intensity level.

Fig. 7 Fallen RC beam and precast floor slabs in Pingwu (7/9)

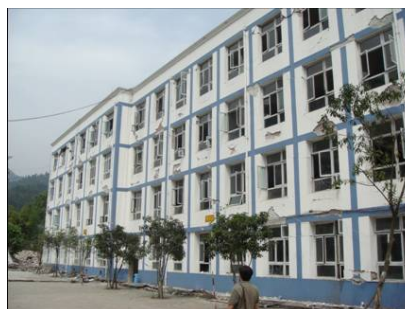
Fig. 8 Damaged school building of brick structure in Bailu (7/8)

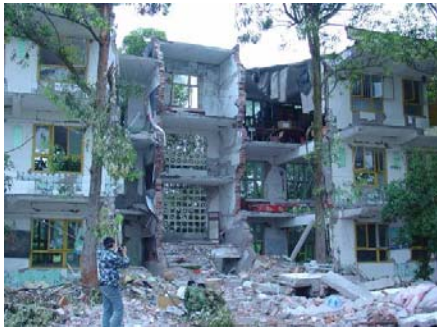
Fig. 9 Collapsed stair shaft of masonry school building in Mianzhu County (7/8~9)

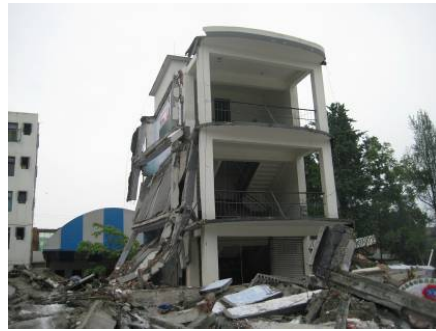
Fig. 10 Remained RC stair shaft of masonry school building in Dujiangyan County (7/8~9)

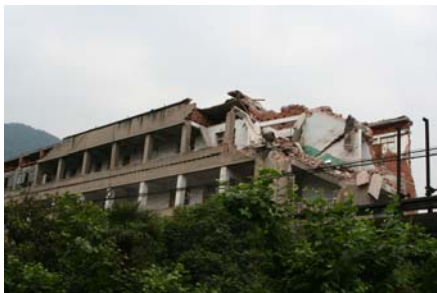
Fig. 11 Collapse of the stair shaft in the end of building plan (7/8)

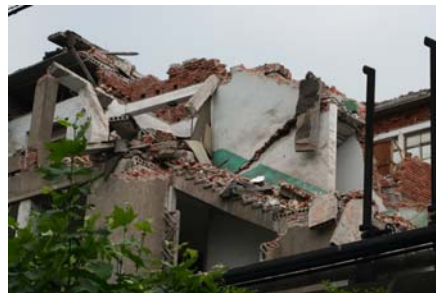
Fig. 12 The closely view of collapsed stair shaft (7/8)

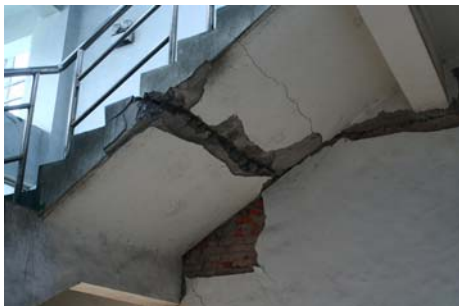
The stair shaft is the entrance and exit of buildings, and provides people the way to evacuate from incidents. The failure or collapse of stair shafts may kill or injure escapers, or block the exit way. The stair shaft of masonry structure may easily be damaged due to their relatively large mass, higher walls, steps between floor and stair platform, and rigidity of step beams etc. The Clause 7.3.1 of Code GB50011-2001 regulates that tie-columns be provided at corners of stair shaft and lift tube and at the joints of transverse and longitudinal walls on the step level. The Clause 7.3.8 requires that a valid connection be detailed between beams for steps and platform and so on; the tie-column be extended up to the top and be connected with the tie-beams of the stair shaft which protrudes beyond the roof. Figure 9 shows a collapsed stair shaft of a 3-story school building due to the wall breaking. Figure 10 shows a RC stair shaft remained with masonry structures besides collapsed. The Clause 7.1.7 Item 4 regulated that the stair shaft not be set in the end span or at the corner of building because the structural torsion may cause damages at these portions as shown in Figs. 11 and 12. The failure of steps was occurred because the structural partition was taken place at a position of the lower 1/3 length of the stair segment. Again, we can see the damaged step beam and the broken stair segment falling down in Figs. 13 and 14, respectively.

Fig. 13 Fractured stair beam at its lower 1/3 position (7/8~9)

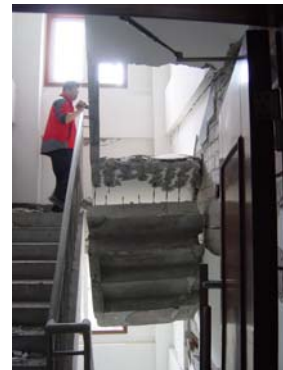
Fig. 14 Stair segment falling

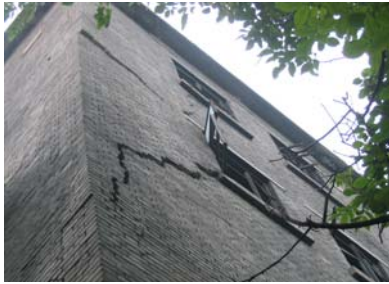
The earthquake actions in two horizontal directions may cause rotation of buildings as seen in Fig. 15, where the corner walls on the top of the masonry building rotated slightly. It means that the building sustained two-horizontal seismic actions at the corner. The earthquake forces transferred along the X and Y axes in the building plan so that its walls at the corner should keep connected straightly and tightly. In case of an opening or curve wall existing near or around the corner, structural failures shall certainly appear (see Figure 16).

Fig. 15 Rotation at upper corner of a masonry building

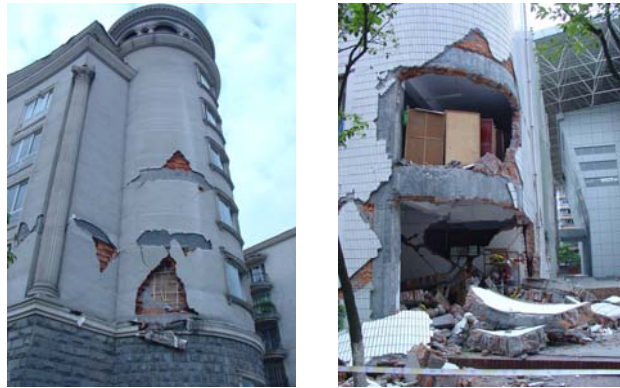
Fig. 16 Failure of walls at the corner of buildings (7/8)
