THE OVERVIEW OF SEISMIC DAMAGE AND THE ANALYSIS OF THE REASONS OF DIFFERENT STRUCTURES IN YINGXIU TOWN –THE HEAVY DISASTER AREAS OF WENCHUAN 8.0 EARTHQUAKE

SUN Bai-tao^{1,2} YAN Pei-lei²

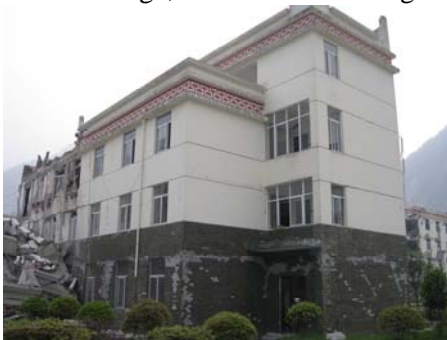
Fig2. the office building of the Yingxiu secondary school(Local 1)

The two frames building are used for the office, the bay is relatively smaller. In the earthquake, the main structure of the framework are basically undamaged; the back of the office building are serious damage by the collision with the complex building that collapsed; shear cracks appear in filling wall serious on each floor; parapet partial collapse; the prominent wall of the appearance partial collapse. The building belongs to the middle damage, local serious damage is caused by collision.

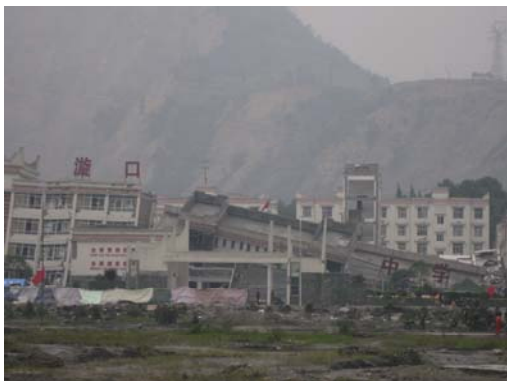
Fig5. the complex building of the Yingxiu secondary school (Global 1)

The two frames building is composed of two parts with a seismic joints in the middle. It is mainly use for classrooms. the bay is relatively larger. In Fig5, the right portion of the building is destroyed completely, the left portion of the building inclines to the right portion and serious deform, the disappearance of the first floor. On the second floor , the concrete peels off and the reinforced bar leaks out the top of the column ; The filling wall of second floor partially collapsed, lots of perforative and permeate oblique crack appear in window belly wall. A large number of external decoration fall. The building is already destroyed.

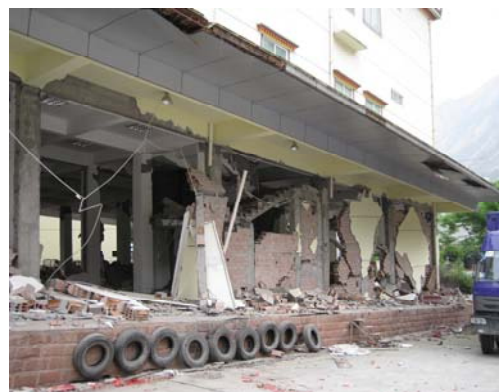
Fig8. the Aba tobacco company warehouse

The concrete is crashed, reinforced serious bend even broken or larger shift The filling wall of second floor partially collapse. The building has a severely damaged.

2) The Aba tobacco company warehouse is a standard designed and constructed building with level roof, the flat surface form is regular, stiffness scatters homogeneously, design and arrangement reasonable. Seismic fortification intensity is 8 degree; the seismic resistance exceeding locality at present fortifies intensity 1 degree. In Yingxiu town, multitudinous windows are the false window, the hole in the filling wall is less and the integrity of the wall is strong since considering local Qiang race customs and habits. According to the shearing force distribute by triangle principle, the ratio of shearing force and stiffness at the bottom of the uniform vertical rigidity building in heavy disaster areas is maximal, the bottom is cut off.

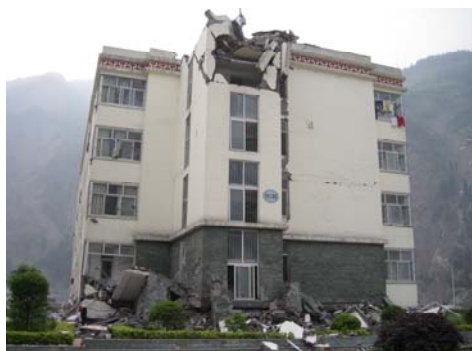
Fig10. the student dormitory of the Yingxiu secondary school

Lots of perforative oblique crack and crossed crack appear in window belly wall, spandrel wall; serious shear cracks appear in some bearing wall, partly collapse of the outstanding roof structure, the disappearance of the

first floor ,The building is already destroyed.

different, the material of the student dormitory is common sintered bricks, the material of the teachers residential building is shale bricks. Secondly, the structure column of the student dormitory are set up at the four corner of the exterior wall and the staircase. At the same time, the structure column of the teachers residential building are set up at the four corner of the exterior wall and the staircase, the junction of the exterior wall and unit cross wall, the junction of the gable and interior longitudinal wall, the junction of the interior wall and exterior wall, local wall pier in the interior wall. The number of the structure columns in the teachers' residential building is more than the number of the student dormitory. It is obvious that, if adopt different construction measure, the buildings designed by the same seismic fortification intensity are also different in behaviour in the same time of earthquake. Under equal condition, the more the structure column are set up, the better the ability that architectural entirety resisting to collapse was.

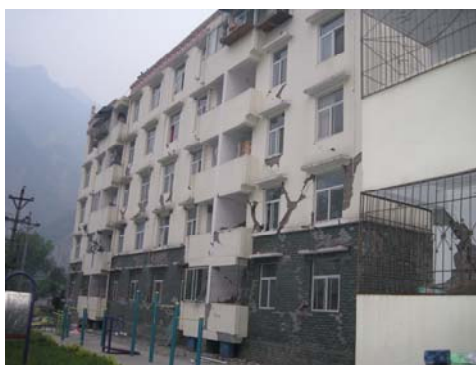
Fig12. the teachers residential building of the Yingxiu secondary school

Serious shear cracks appear in some bearing wall of the first floor and the second floor . lots of perforative oblique cracks and crossed cracks appear in window belly wall、 spandrel wall. The building has a severely damaged.

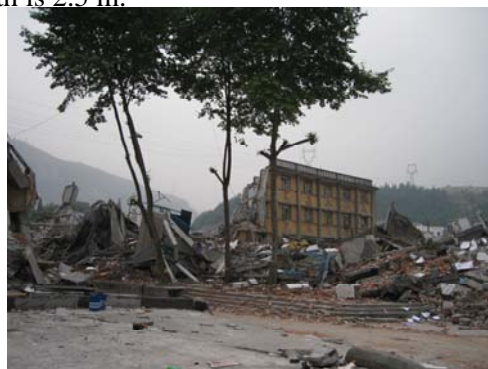
Fig13. the office building of the power station

Partly collapse; the concrete peels off and the reinforced bar leaks in structure column

2) The office building of the power station which did not taken preventive measures against earthquake was built in the 1980s. In the 1990s, the building was reinforced by the structure column and ring beam in exterior. The holistic seismic behavior of the office building of the power station is not as good as the building designed by the Code for Seismic Design of Buildings

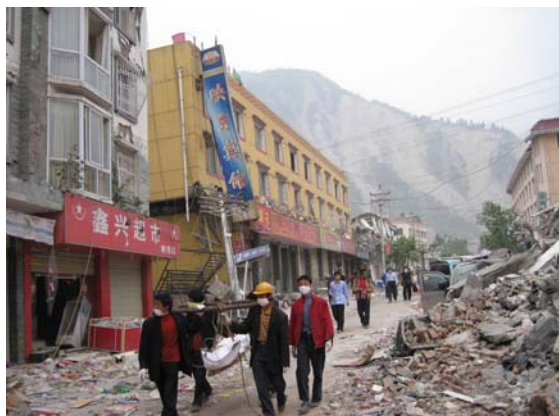
Fig14. the Yingxiu hotel (Global 1)

The disappearance of the second floor. Serious shear cracks appeared in the bottom layer. In Fig.9 and Fig.11, the Yuanyuanyuan tea house near the Yingxiu hotel is also bottom frame structure, and the second floor also disappear. It is very general.

As a bottom frame structure, the stiffness of the bottom layer is more than the second layer, the stiffness occurrence mutation at the second layer. the second floor is a weak story. In the heavy disaster areas, weak story was sheared break by huge horizontal earthquake action, the second floor also disappear. The credit cooperative with the poor quality of construction is not taken preventive measures against earthquake. In the heavy disaster areas, The credit cooperatives damaged by huge horizontal earthquake action. Whether or not to consider seismic fortification, the bottom frame structure does not have the reasonable stiffness transition in stiffness conversion layer, the performance of the bottom frame structure was poor in heavy disaster areas.

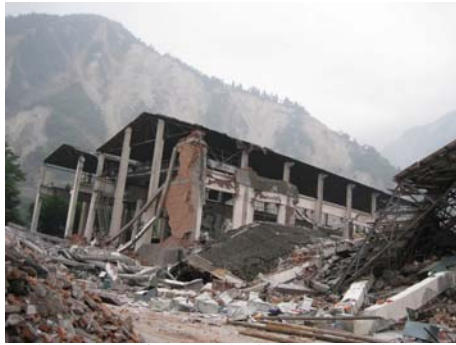
Fig20. the factory building (Global 1)

The main seismic damage are : the collapse of filling wall , the column inclined, top failure , integral decline

Compare with the factory building 1 and factory building 2, the two building are both standard designed , standard constructed with the same site conditions, section size and reinforcement of the load-bearing structure, material and thickness of the filling wall .In the earthquake, the factory building 1 is already destroyed, the factory building 2 still stand . The reason is that: the lateral stiffness of the single frame structure is poor the multi-frame frame structure, so it heavy damaged.
