RECONNAISSANCE REPORT OF THE 2008 SICHUAN EARTHQUAKE, DAMAGE SURVEY OF BUILDINGS AND RETROFIT OPTIONS

H.K. Miyamoto^{1,2}, and A.S. Gilani¹ and Akira Wada²

ABSTRACT :

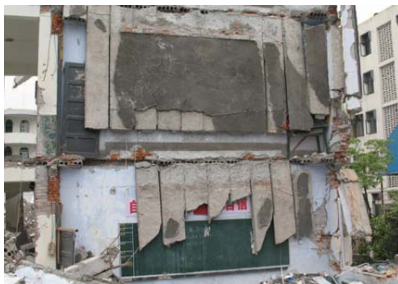
This three-story school is in Juyuan, a town in the county-level city of Dujiangyan. Juyuan has a population greater than 50,000 and is approximately 20 kilometers from the fault rupture. The school, constructed in 1986, housed 1000 students. More than 700 died when the building collapsed. Construction consisted of nonductile CIP-RC beams supported by URM walls, with precast concrete floor planks. Figure 5 shows the collapsed floor precast planks. Note that the planks pulled away from the walls, were hanging, and attached to the opposite walls. The collapsed URM walls and nonductile concrete beam is shown in Figure 6. A lab building adjacent to the collapsed school with similar construction did not collapse. This better performance was likely due to the orientation of its URM walls or better construction quality. Figure 7 shows the cracked walls.

Figure 5. Collapsed floor planks

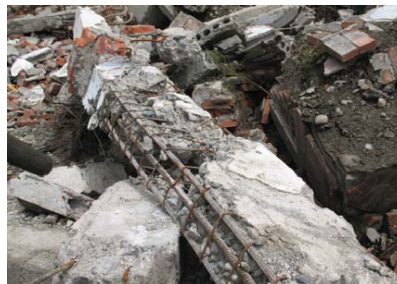
Figure 6. Collapse URM wall and concrete beam

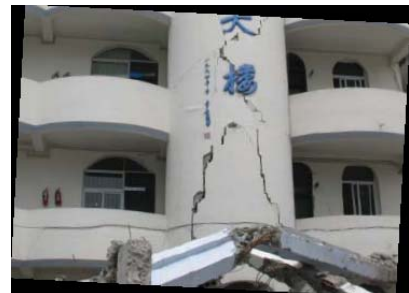
Figure 7. Shear cracks in masonry walls

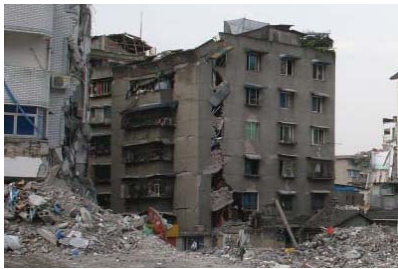
A wing at the Xingfu Hospital collapsed (Figure 12), resulting in 200 fatalities. This wing, constructed in 1996, had typical nonductile CIP-RC framing with URM walls and precast concrete floor planks. An adjacent wing, constructed in 2,000, performed better and sustained moderate structural damage, shear-wall cracks, and nonstructural damage, dropped ceiling panels (Figure 13).

Figure 12. Collapsed wing

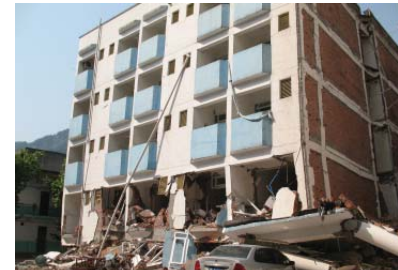
This five-story hospital was constructed in 1999. Construction consisted of nonductile CIP-RC framing and URM walls. The ground floor was designed as a parking garage. Hence, the URM bearing walls were terminated at the first floor, creating a bottom story with much smaller lateral stiffness. This soft story completely collapsed during the earthquake (Figure 14) and the upper floors dropped down one floor.

Figure 14. Soft story collapse

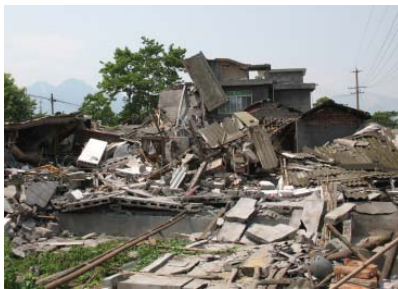
This small village of residential structures sustained severe damage and over 80% of the buildings collapsed (Figure 23). The structures were built of brick walls and wood-frame roofs with lightweight black roofing tiles.

Figure 23. Collapsed residential units

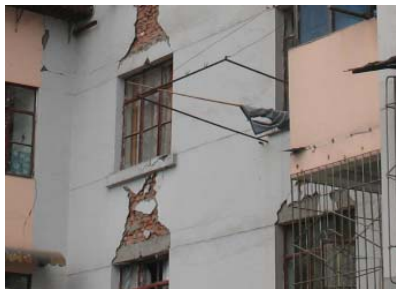
Several eight-story apartment buildings, constructed of URM bearing walls and concrete slabs, constitute a complex in the center of Hanwang township. Many diagonal shear cracks occurred in the walls between windows (Figure 24), but the buildings did not collapse due to the redundancy and lateral capacity provided by the network of interior walls.

Figure 24. Cracked URM walls

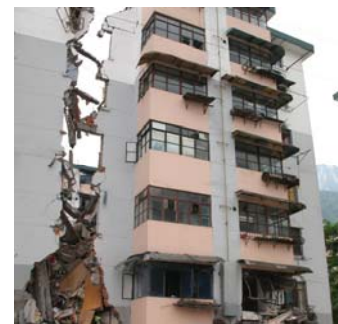
In this complex, a construction detail was used that called for connecting the adjacent residential units via a narrow corridor with a large number of windows. Hence, this portion of the complex, had little lateral stiffness or strength. The corridor URM walls for this complex failed, resulting in a portion of the building tilting and dropping by 3 m, and causing a vertical split in the corridor (Figure 25).

Figure 25. Vertical split and displaced apartment complex

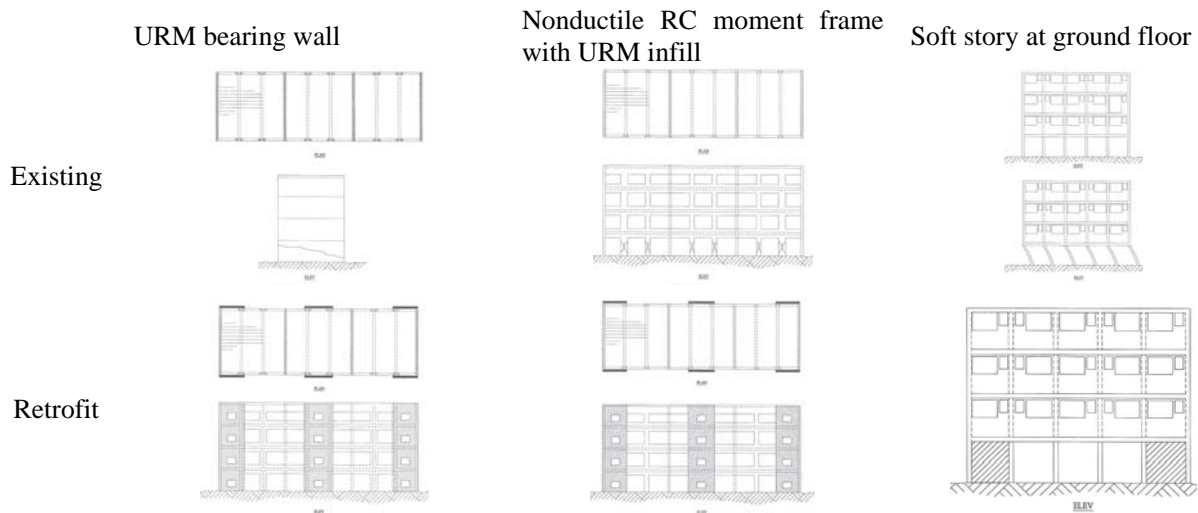
Figure 30. Proposed retrofit schematics

Nearly all the collapsed buildings had low strength, or stiffness, and ductility; little redundancy; questionable load path, and some undesirable seismic configuration (soft story, short columns, or irregularity). Cost-effective retrofit options are available to mitigate such deficiencies. Typical options are listed in Table 1 and schematically shown in Figure 30. Since schools, hospitals, and apartments can be classified as important buildings and high-density population areas, the presented options emphasize these buildings. While the basic ideas discussed here do not address substandard construction, retrofitting might have prevented the sudden and total collapse of many buildings and the subsequent loss of life. The retrofit options are intended to provide the basis life safety goal; that is to prevent collapse. Higher retrofit goals such as minimizing structural damage or immediate occupancy are also possible, albeit at a greater monetary cost.

Building Type	Deficiencies	Retrofit design
All	Lack of diaphragm action	Check strength and ductility of the RC ring beams. Reinforce and confine them as needed. Add ring beams at each floor if they are not present.
URM bearing wall	Lack of lateral capacity and ductility	Add full-height ductile, RC shear walls on the exterior of the building
		Apply engineered cementations concrete (ECC) to the exterior of the walls
		Place the structure atop of seismic isolators
Nonductile RC moment frame with URM infill	Inadequate joint capacity, lack of column confinement, captive columns	Add full height ductile RC shear walls on the exterior of the building
		Cut the connection between the partial height infill URM walls and concrete columns; Wrap columns using FRP; Add prestressing or confinement to joints to; Add shotcrete to the existing members
		Place the structure atop of seismic isolators
Soft story at ground floor	Lack of lateral stiffness and capacity at a floor	Add single-story ductile RC shear walls on the exterior of the building

Add single story steel braces on the exterior of the
		Add viscous or Visco-elastic dampers to the ground floor
