# Analysis of the Effect of Wenchuan Earthquake on Qiaoqi Dam

The Qiaoqi Dam on the Baoxing River is a rockfill dam with gravelly soil core. The dam height measures 125.5m and the overburden as the dam foundation is about 70 meters thick. The dam site was shocked intensely during 5.12 Wenchuan Earthquake at an epicentral distance of about 71 kilometers. The dam is well instrumented to monitor its working state. Through the contrastive analysis on the pre-earthquake and post-earthquake monitor data of the deformation, stress and strain, seepage flow and seepage pressure of the dam, the impact of the Wenchuan Earthquake on Qiaoqi Dam was obtained. The result showed that the dam remained a normal working state after the great earthquake. However, certain effects were displayed on the dam's deformation, seepage and stress and strain. Especially, some parts of the grouting curtain in the left abutment were damaged by the earthquake.

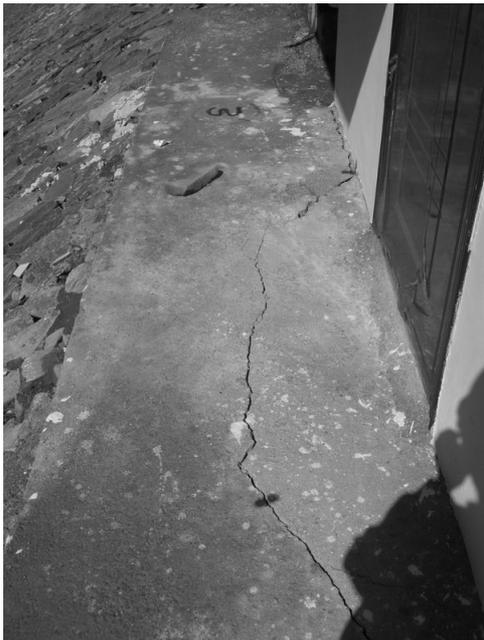
(a) dam crest

(1) Several cracks appeared on the downstream surface of the dam. The typical cracks resulting from the Wenchuan Earthquake are along the dam axis as follows: Beside the observation house on the dam crest in the left abutment, a 5.79 m long and 10 mm wide crack was shown in Figure 3 (a); another 2.23 m long and 7 mm wide crack was on the downstream steps in the biggest cross section, which is located in the position of 3/4 dam height shown in Figure 3 (b).

Figure 3 Cracks induced by Wenchuan Earthquake

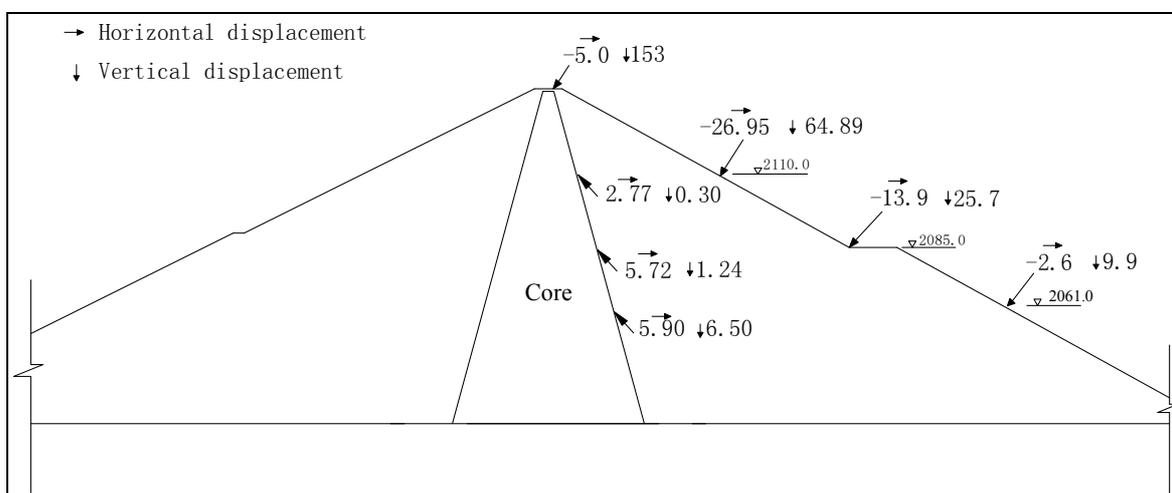
Through the post-seismic observation on the parapet wall and downstream surface in several cross sections, the maximal transverse seismic residual deformation of the dam surface was 26.95 mm ( the biggest cross section, 3/4 dam height), while the longitudinal maximum was 30.4 mm ( 3/4 dam cross section, 3/4 dam height). In the vertical direction, the maximal seismic residual deformation was 158 mm on the parapet wall in 3/4 dam cross section. The deformations of dam surface in the biggest cross section are shown in Table 1. From the deformation illustrated in Figure 4, seismic residual deformation increased from the dam toe to the dam crest. And the maximal seismic settlement was 153 mm on the parapet wall in the biggest cross section. It should be

Figure 4 Seismic residual deformations of dam surface and core (mm)

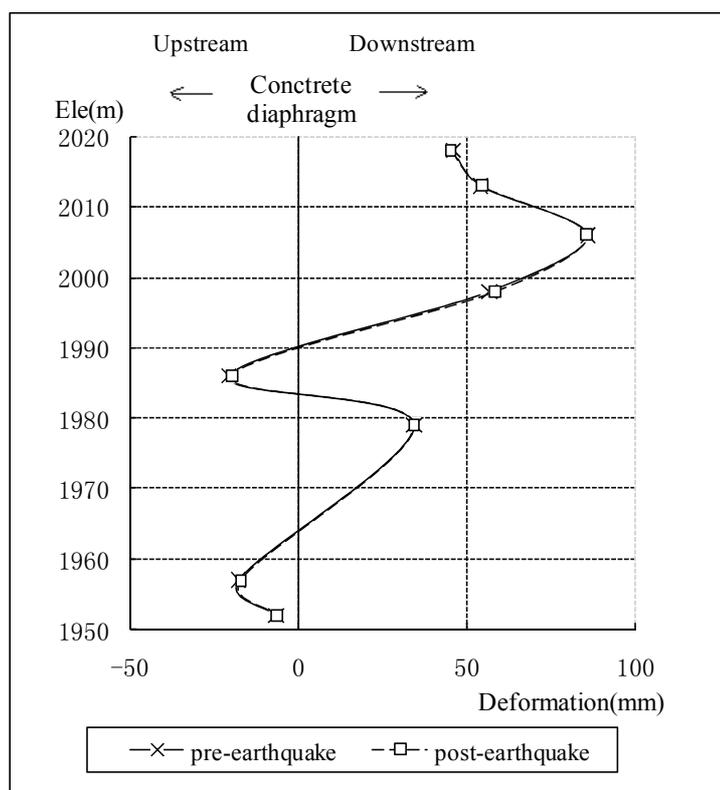
There were eight observation points on the underground diaphragm in the dam's biggest cross section. Table 3 lists the transverse displacements obtained by these points. The positive value means the displacement towards to the downstream while the negative one means the upstream deformation. Figure 5 demonstrates the distribution of the deformation along the elevation. From Figure 5, the diaphragm deformed towards to the downstream on the whole and the displacement of the upper part was larger than that of the lower part. The two

curves were almost coincident due to the small change of the diaphragm's displacements before and after the Wenchuan Earthquake. The maximum of the transverse seismic deformation was only 2.2 mm, which illustrated the tiny effect of the earthquake on the underground diaphragm.

Figure 5 Seismic residual deformations of the underground diaphragm

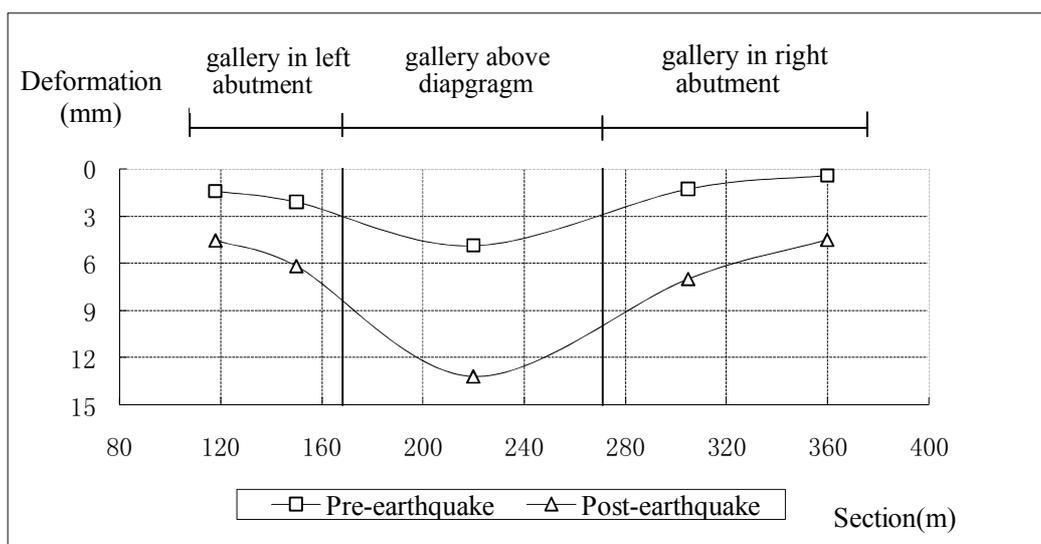
In the inspecting gallery and access tunnels in left and right abutments, nineteen settlement observation points were established. Because stiff joint was adopted at the connection of the underground diaphragm and its top gallery, the record values of the inspecting gallery could display the relative settlements of the underground diaphragm and the abutments. In the construction period, the settlements increased slowly and the middle of the gallery, which was above the concrete diaphragm, settled more than the parts in the abutments. The Figure 6 shows the pre-seismic and post-seismic settlements of the inspecting gallery. It was obvious that the gallery had been caused a seismic residual deformation and the maximal settlement, which was 13.20 mm, occurred in the middle of the gallery. The settlements and seismic residual deformation are listed in Table 4. These values showed that the earthquake had a certain effect on settlements of the inspecting gallery, but the effect was small.

Figure 6 Settlement of inspecting gallery

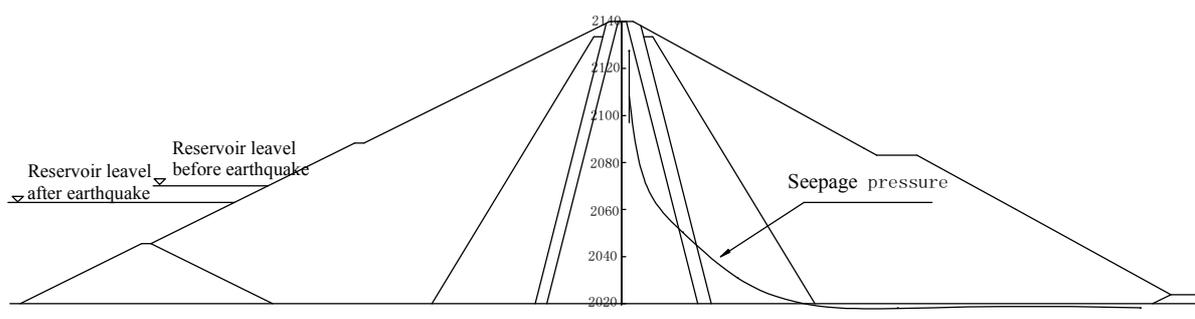
Based on the dam height and characters of the dam's seepage field, seepage pressure was inspected in the core, filter, transition and rockfill zones. Figure 7 shows the seepage pressure distribution of the dam downstream in the biggest cross section. Because of the small change of the seepage pressure before and after the Wenchuan Earthquake, the two curves were almost coincident. And the pressure fell down rapidly in the core. Table 6 lists the seepage pressure values in the biggest cross section. According to the table, only the record values of osmometers within the core changed little during the earthquake. Contrastively, there was still no seepage pressure in the filter, transition and rockfill foundation, which indicated the drainage system in downstream foundation performed very well. Overall, in the biggest cross section the maximal change of the seepage pressure was 0.8 m in the core. The little change demonstrated the little effect on the dam's seepage pressure of the earthquake.

Figure 7 Seepage water pressure distribution of max transverse cross section (m)
