RESTORATION OF AKASHI MUNICIPAL MUSEUM OF ASTRONOMY AND SCIENCE DAMAGED BY THE GREAT HANSHIN EARTHQUAKE IN 1995

Tomoaki AKIYAMA¹, Tsutomu ITAGAKI² And ISHIMARU ISHIMARU³

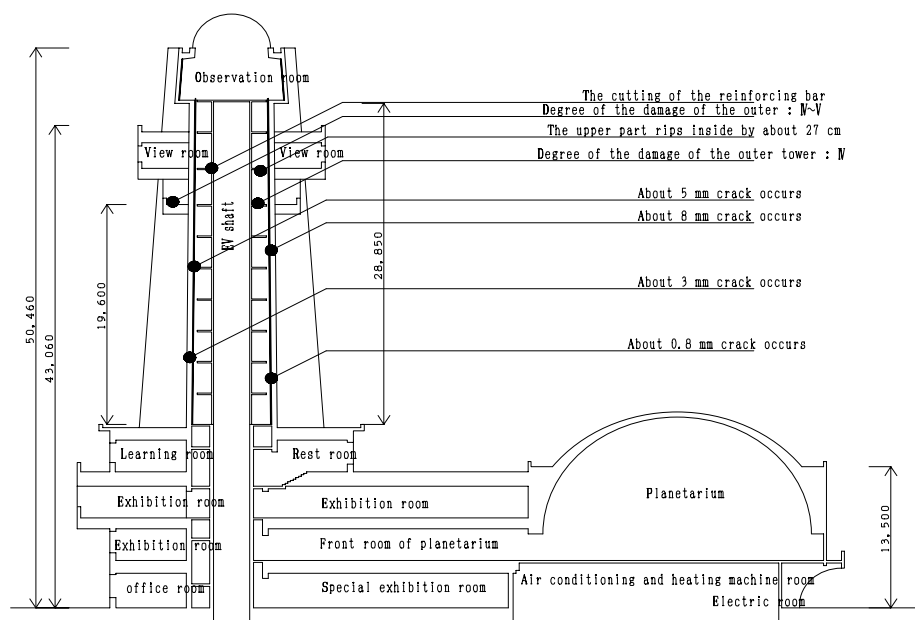
Fig.1 The main damage of the building

Damage situations affecting each section are shown in figure 1. An outline of the damage for each section of the building is as follows:

Damage to the tower is especially significant around the 13th and 14th stories. Particularly, around the 14th story of the inner tower, there was clearly visible structural damage. Thus, the upper part of the tower penetrated into its lower part at the north-east side by 27 cm approx. and inclined about 2.5 degrees (0.044 rad.) on the north-east side. In contrast, the tower was raised by 22 cm at the south-east side and thus the main reinforcement was ruptured in this part. This inclination was approximately 4.5 degrees (0.079 rad.). In the outer tower as well, the damage around the 13th story was mostly significant (damaged degree: 4-5). At the 8th to 12th stories, there was shear crack of 3.0-8.0 mm width occurring from the corners of the opening area. The 7th or lower stories of the outer tower experienced only minor damage. In addition, at around the 15th story, there was damage from a collision between the inner and outer towers.

Concerning the low storied section, there was shear and flexural crack (Maximum 2.0 mm width approx., all in the single direction) occurring on the wall of first story. This damage occurred because of the one sided soil pressure rather than vibration of the earthquake.

From a measurement of floor levels for one to three floors, it was clear that the building was wholly inclined to the south side by 1/389 – 1/1514. In addition, from the front yard being inclined to the south side and the damage situation affecting the low storied section, it is assumed that there was some soil movement or ground subsidence from north to south affecting the whole building site.

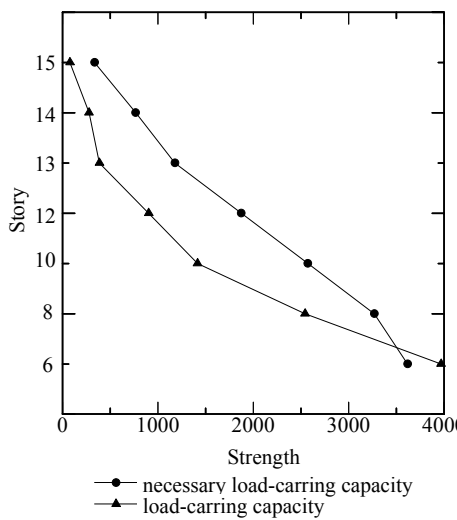
Fig 2 Relationship between load-carrying capacity and required capacity

the required flexural capacity at the 7th to 15th stories as shown in figure 2. At the 13th to 15th stories in which the damage was especially significant, prevalence flexural capacity was 25% - 35% of the required flexural capacity.

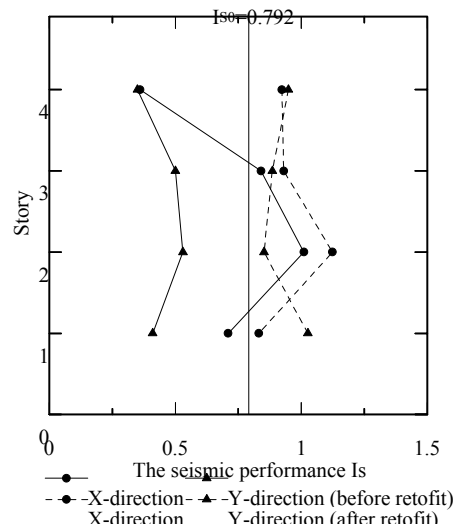
Fig 3 Is value before and after retrofitting of the lower stories

A seismic capacity (I_s : Structural Seismic Index) of the lower stories was calculated in compliance with a secondary diagnosis of an “Evaluation of Seismic Capacity For Existing Reinforced Concrete Building, Revised Version [4].” The Structural Seismic Judgement Index (I_{SO}) for determining seismic performance will be $I_{SO} = 0.792$ by considering the Standard Structural Seismic Judgement Index ($E_S=0.6$), Ground Index ($G=1.1$) and Usage Index ($U=1.2$). The result of calculation for I_s is shown in Fig.3. The value of I_s is within the range of $0.351 - 1.013$ for ridge direction (X) and within the range of $0.359 - 0.534$ for span direction (Y), and lower than the I_{SO} value in direction X for the 1st and 4th stories, and in direction Y for all stories.

Is value after reinforcement is 0.832 – 1.124 for ridge direction (X) and 0.852 – 1.026 for span direction Y which is approximately 1.11 – 2.64 times as large as it was before reinforcement (Fig.3). Moreover, earthquake resistance of the lower stories section is sufficiently secured since Is value after reinforcement is 1.05 – 1.42 as large as the Structural Seismic Index I_{SO} (= 0.792).

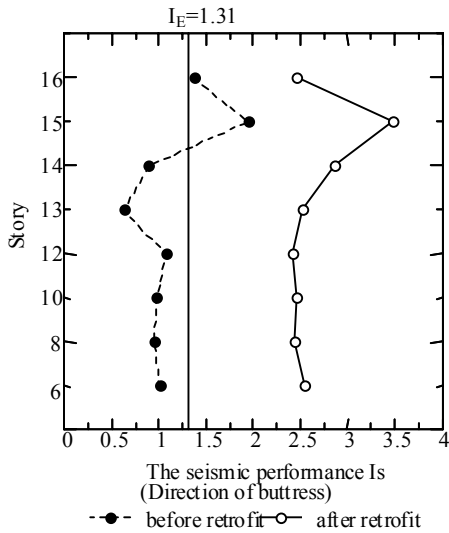
Fig 4 Is value before and after retrofitting (Outer tower buttress direction)

A seismic capacity (I_s : Structural Seismic Index) of the outer tower (6th and higher stories) was calculated in compliance with the “Overall Earthquake Resistant Design Code for Government Facilities, Earthquake-Proof Inspection/Workover Instruction of Government Facilities [2].” The Earthquake Index (I^*I_E) for determining seismic performance will be $I^*I_E = 1.31$ by considering the Standard Shear Force Coefficient ($C_0=1.0$), the Vibration Characteristic Coefficient ($R_t=0.99$), the Earthquake Index Correction Coefficient per Geography ($G=1.1$) and Important Coefficient ($I=1.2$). The calculation of the Structural Seismic Index was conducted by cross-section model listed in tables 2 and 3 for buttress direction and buttress 45 degrees direction [3]. As a result (refer to Fig.4 and 5), for buttress direction for the 6th – 14th stories and for buttress 45 degrees for all stories, the Structural Seismic Index, I_s were less than I^*I_E . Particularly, both for buttress and for buttress 45 degrees, the seismic capacity of the 13th and 14th stories were poor.

Is value after reinforcement is 2.41 – 3.47 for buttress direction and 1.56 – 2.25 for buttress 45-degree, which represents an increase of approximately 1.79 – 4.02 times as large as it was before reinforcement (Fig.4 and 5). Moreover, the outer tower’s seismicity is sufficiently secured since the Is value after reinforcement is 1.19 – 2.65 times as large as the Earthquake Index $I \times I_E$ (1.31).
