AUCKLAND HARBOUR BRIDGE SEISMIC RETROFIT

Michael J BEAMISH¹ and Ian J BILLINGS²

SUMMARY

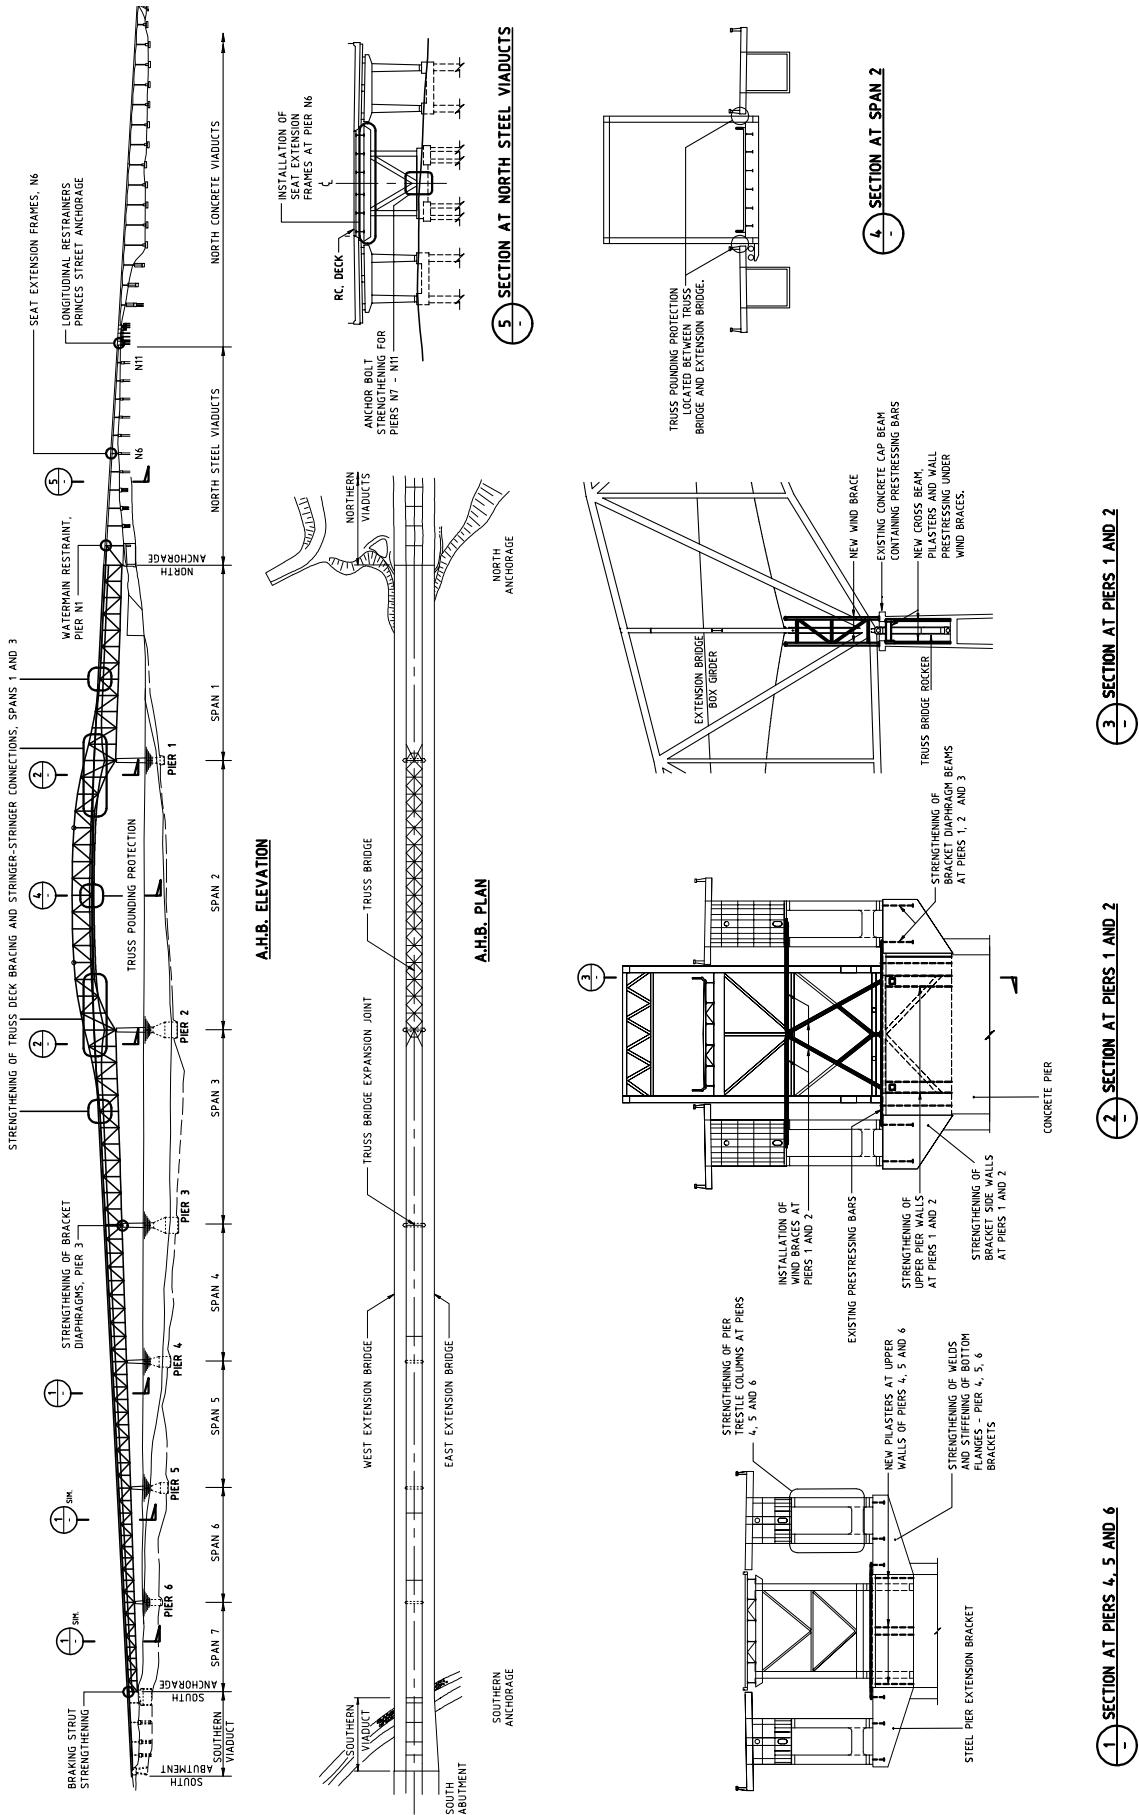
Figure 1 – Summary of Auckland Harbour Bridge Retrofits

The major vulnerabilities identified during the seismic assessment are summarised in Table 2 along with the corresponding retrofit solutions. The locations of the components to be retrofitted are shown by Figure 1. The assessment findings and retrofit solutions for the four key retrofit items are discussed in further detail below.

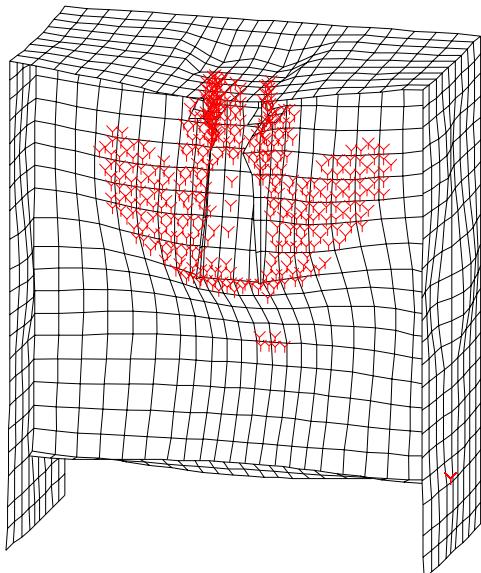
Figure 2 - Pier 1 & 2 Diaphragm Beam FEA

Evaluation of the diaphragm beams at piers 1 and 2 by hand calculation methods had indicated deficiencies in both bearing (crushing) resistance and in buckling resistance for seismic, gravity and wind loading. These calculations were later verified by inelastic post-buckling analysis using a detailed 3D FE model of the diaphragm beam (Fig. 2) which showed the collapse mechanism to be: a) yielding of the web and stiffeners under the load point creates a “pin”, b) overall buckling of the “unstiffened” web plate follows. Inspections of the diaphragm beams indicated minor deformations consistent with this predicted behaviour.

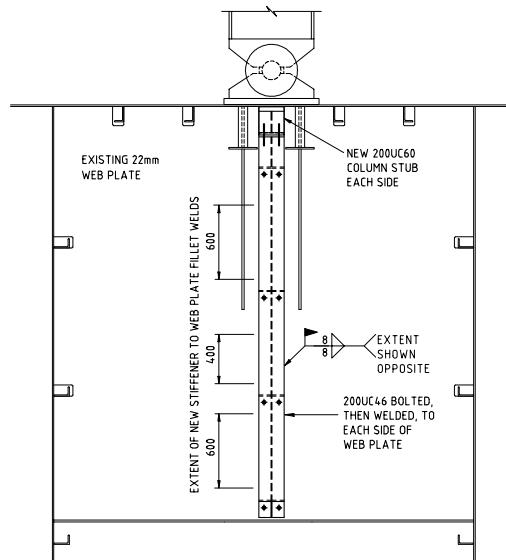
Figure 3 - Pier 1 & 2 Diaphragm Beam Retrofit

Several deficiencies were identified in the brackets supporting the Extension Bridges, as indicated in Table 2. Most are related to insufficient shear capacity in the fillet welds connecting the bracket side walls to the flanges and the diaphragm beams below the trestle columns. Other deficiencies were identified in the buckling resistance or yield strength of various plate elements including the diaphragm beams at piers 1, 2 and 3.

The pier 1 and 2 bracket diaphragm beams have been retrofitted by fitting pairs of 200UC stiffeners to the web plates (Fig. 3) in 3 stages: a) temporarily bolting in position to secure against buckling, b) welding to the web plates outside the likely tension field zone, then c) fitting stub columns to bear against the underside of the bracket top plate below the trestle columns. The Pier 3 diaphragm beams require the first stage only.

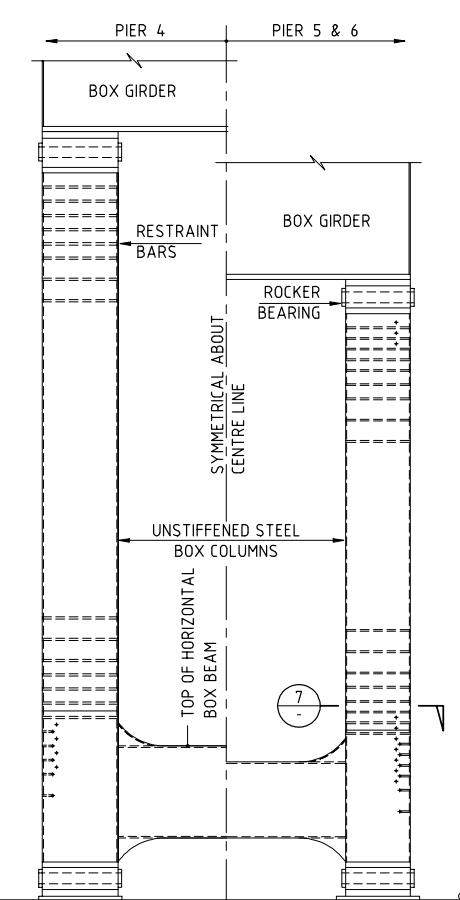
Figure 6 – Extension Trestle Column Retrofit

The Extension Bridge support trestles are steel box columns with a box beam above the lower rocker bearings. Plate slenderness ratios do not comply with modern seismic design standards and the web to flange plate welds are partial penetration butt welds. The butt welds connecting the upper rocker bearings to the underside of the box girders or the welds between the adjacent internal diaphragm and box girder flange plate do not have sufficient resistance to withstand MCE seismic actions.

At Piers 4, 5 and 6, local buckling of the column flange plates is expected at the MCE event loading. Although the assessed demand to capacity ratios were considered to be within acceptable limits [Astaneh, 1997], the partial penetration welds are considered to be at risk of “unzipping” following *any* local buckling deformation that causes joint “opening” forces. Furthermore, the occurrence of weld cracking adjacent to the inner edge of the upper rocker bearing can result in significant redistribution of load to one column, further increasing the risk of local buckling.

A variety of solutions were considered for addressing the local buckling and potential weld “unzipping” problems. Options such as weld repair and additional vertical welds to reinforcing plates were discarded due to potential problems with weld shrinkage stresses and long closures. The adopted solution is to connect the compression flange to the tension flange using restraint bars fitted through holes and welded to both flanges

(Figs. 6 and 7). The distribution of forces and moments in the trestles is such that the tension flanges of the columns will remain elastic (and thus able to support face loads) except at plastic hinge rotations well beyond the demands predicted using the maximum displacements from the dynamic analyses.

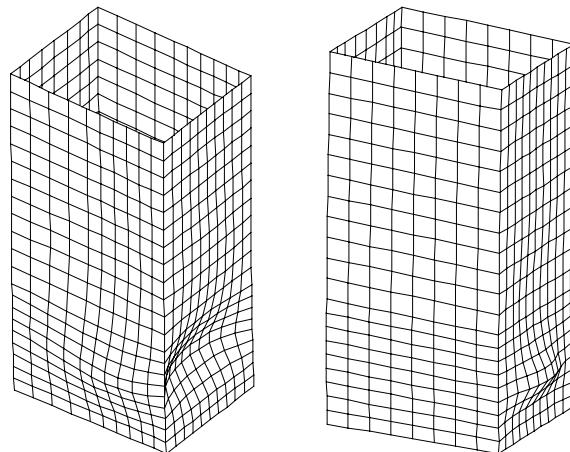
Figure 5 – Trestle Column FE Model, Before & After Adding Restraint Bars

The required spacings of the restraint bars were refined using inelastic post-buckling finite element models of the box columns (Fig. 5). These analyses indicated that local web buckling could occur in combination with local flange buckling, which would defeat the purpose of the flange restraint bars. To delay the onset of web buckling it was necessary to add more restraint bars between the web plates. For the lower portion of the trestle columns at the cross beam level, diagonal corner restraint bars are used instead of flange-to-flange bars.
