## WHY "REGULATIONS FOR STRUCTURES IN EARTHQUAKE ZONES" IN GERMANY?

By Professor Dr. Wilhelm Hiller\*

## DEVELOPMENT OF ASEISMIC CONSTRUCTION

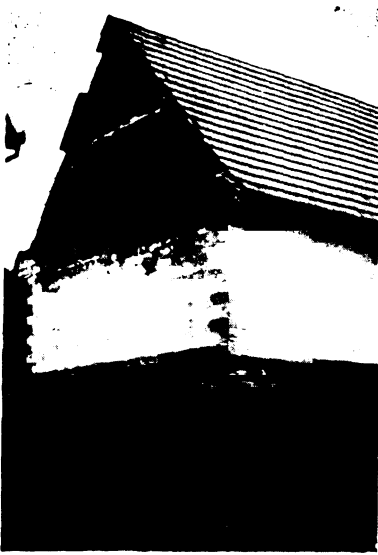
Figure 5  
The end wall of this barn was completely demolished. The wall was not anchored. Quake of May 28, 1943.

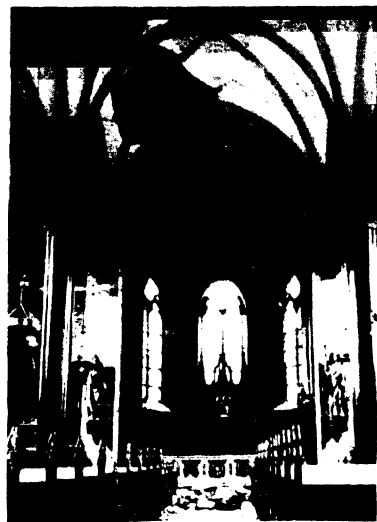
Due to the fall of masses from great heights onto lower buildings, secondary damages result whose magnitude frequently exceeds that of the original earthquake damage (churches in Kappel and Kanzach, factory building in Tailfingen, Figures 1 to 4). The gable walls of ordinary buildings are also endangered if they are not adequately anchored to the roof structure (house with barn in Onstmettingen, house in Billig, Figures 5 and 6). Portions of buildings which are built onto a larger building are subjected to greater stresses for their own time of oscillation greatly deviates from that of the main building mass causing intensified counter oscillations (corridor of the Bismark School in Tailfingen, Figure 7). In regions where earthquakes can be anticipated, buildings should be made simple and comprising one single unit. Light arch structures in churches which usually cannot withstand additional stresses should not be built in quake zones (Figure 8 - church in Overgarten).

Figure 8  
Large portions of the inner arch of this church building in Overgarten fell out during the quake of March 18, 1951. In addition, the seats of the church were badly damaged and the church remained closed for a long time.

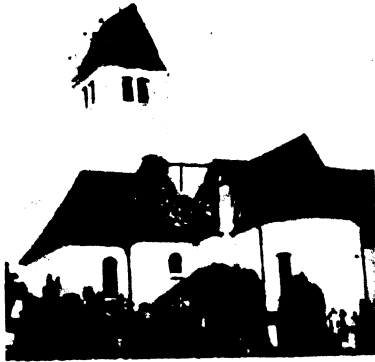
Figure 1  
During an earthquake on June 27, 1935, in Kappel Bei Buchau on Lake Feder, both end walls of a gabled-roofed church steeple were thrown out because they were not anchored. One of the walls fell onto the ground without causing any further damage, while the other fell onto the roof of the church, broke through it and through the ceiling and, thus, caused an appreciable secondary damage.

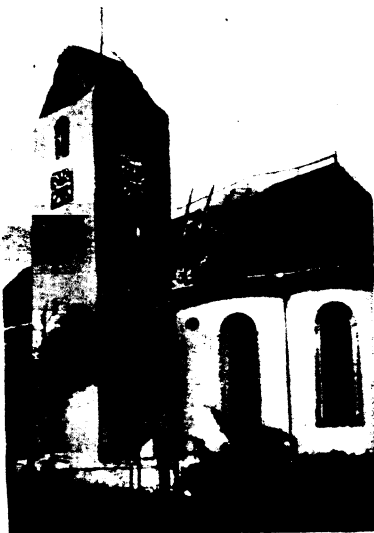
Figure 3  
Both gable walls of a peaked roof on a church steeple in Kessach fell out much like in the Kappel case. Quake of June 27, 1935.

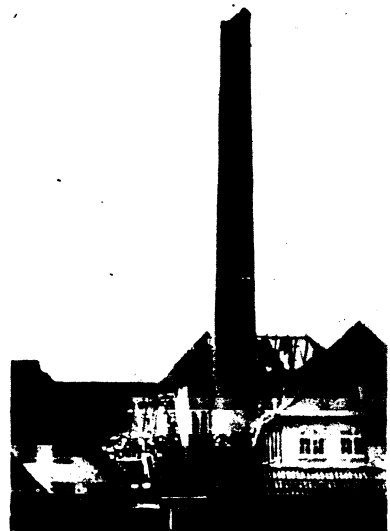
Figure 4  
Broken off top of factory smoke stack in Tailfingen during the quake of May 26, 1943. Appreciable secondary damage was caused to the factory building itself.
