## STRATEGIES FOR SEISMIC PREVENTION IN SCHOLAR'S BUILDINGS

## Strategies for Seismic Prevention In Scholar Buildings Bernardino Rivadavia School

Facade  
Strategies for Seismic Prevention In Scholar Buildings  
Bernardino Rivadavia School

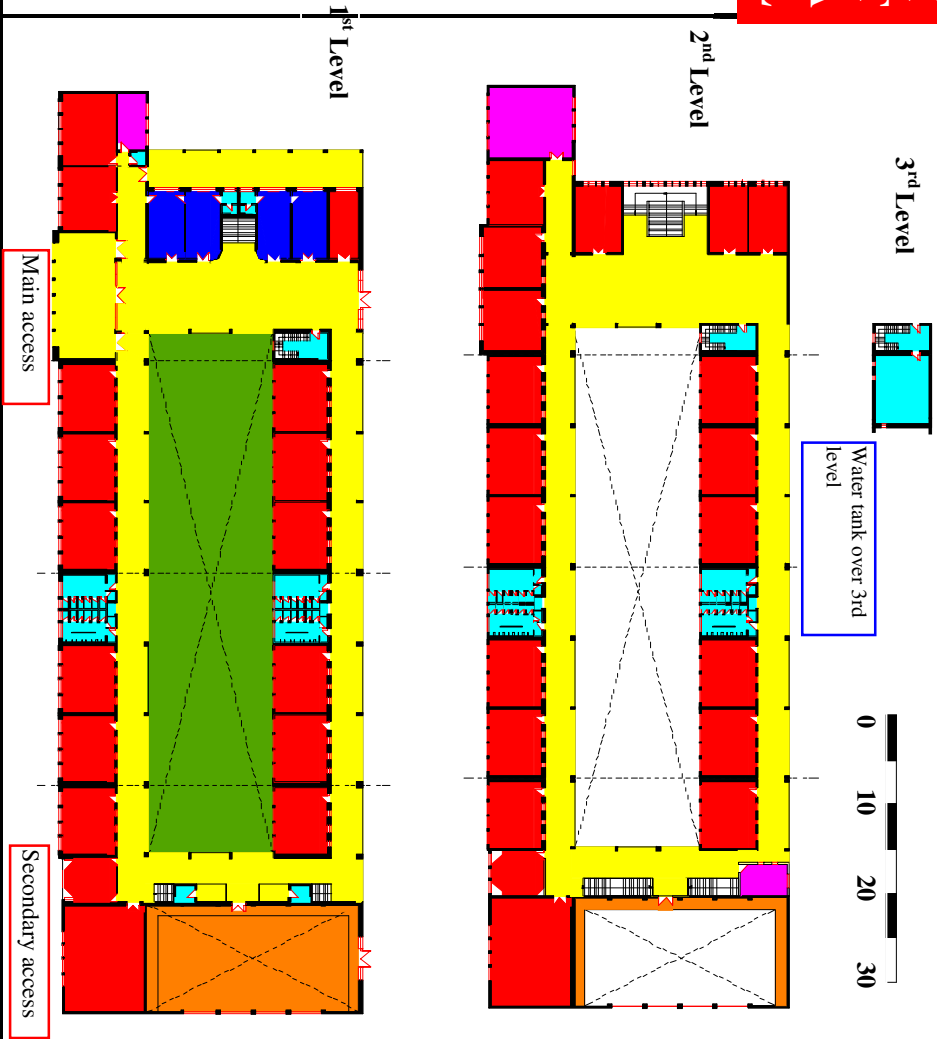
OBSERVATIONS  
A secondary hall was occupied as classroom in the first and second level.

VALUATION
Electric installation	Good Condition. There isn't security interrupter 0.5
Water and sewer installation	Good Condition 1
Gas installation	Outside installation without security valve. 0
Glasses dimensions	(2.8x1.5) m 0
Library and Video room equipment.	There isn't 1

Ceiling	Gypsum -	1
Classroom equipment	Fixed	1

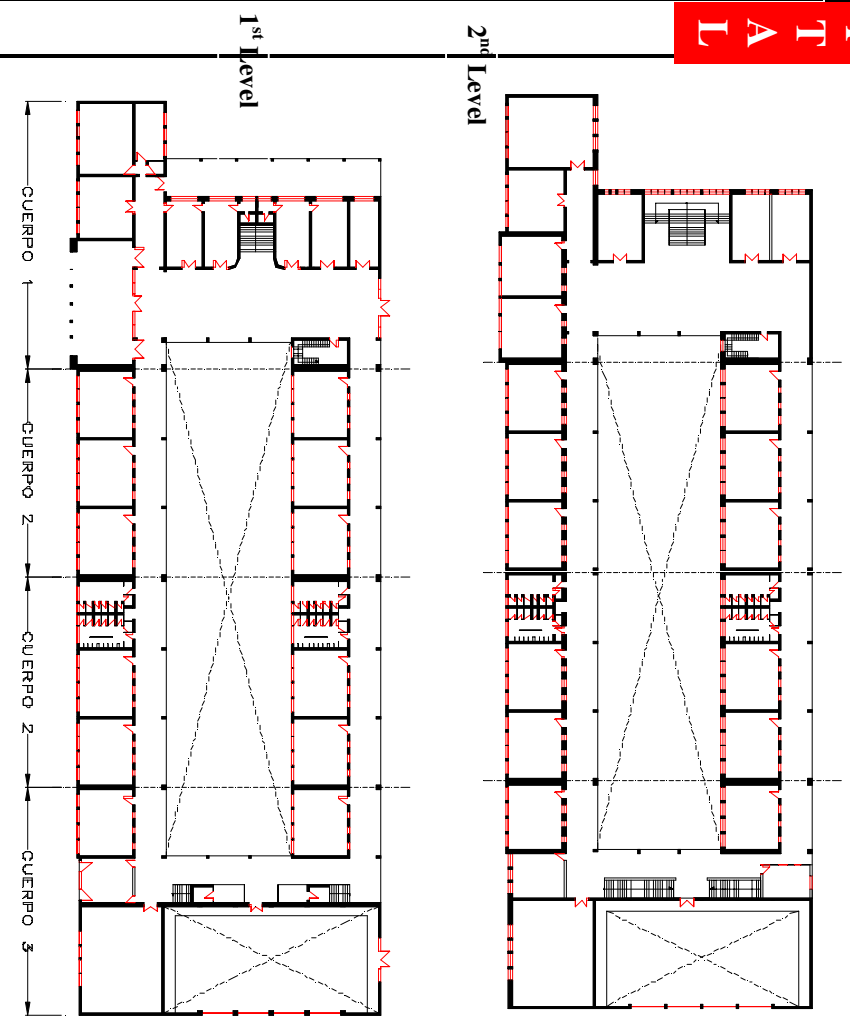
Building	Direc.	Level	File IN	File OUT	Coefic. K	Qualification
1	X	FIRST	RIV- C1X.DAT	RIV- C1X.RES	0.156	OK
		SECOND			0.299	OK
1	Y	FIRST	RIV- C1Y.DAT	RIV- C1Y.RES	0.159	OK
		SECOND			0.284	OK
2	X	FIRST	RIV- C2X.DAT	RIV- C2X.RES	0.200	OK
		SECOND			0.314	OK
2	Y	FIRST	RIV- C2Y.DAT	RIV- C2Y.RES	0.271	OK
		SECOND			0.426	OK
3	X	FIRST	RIV- C3X.DAT	RIV- C3X.RES	0.216	OK
		SECOND			0.311	OK
3	Y	FIRST	RIV- C3Y.DAT	RIV- C3Y.RES		OK
		SECOND				OK

**EVALUATION:** Method Of Standard Evaluation Of Seismic Capacity Of Reinforced Concrete Buildings (Low And Medium Height)  
**SATISFACTORY**
