ANALYSIS OF THE SEISMIC RESPONSE OF A DAMAGED MASONRY BELL TOWER

Giovanni BONGIOVANNI¹, Paolo CLEMENTE² And Giacomo BUFFARINI³

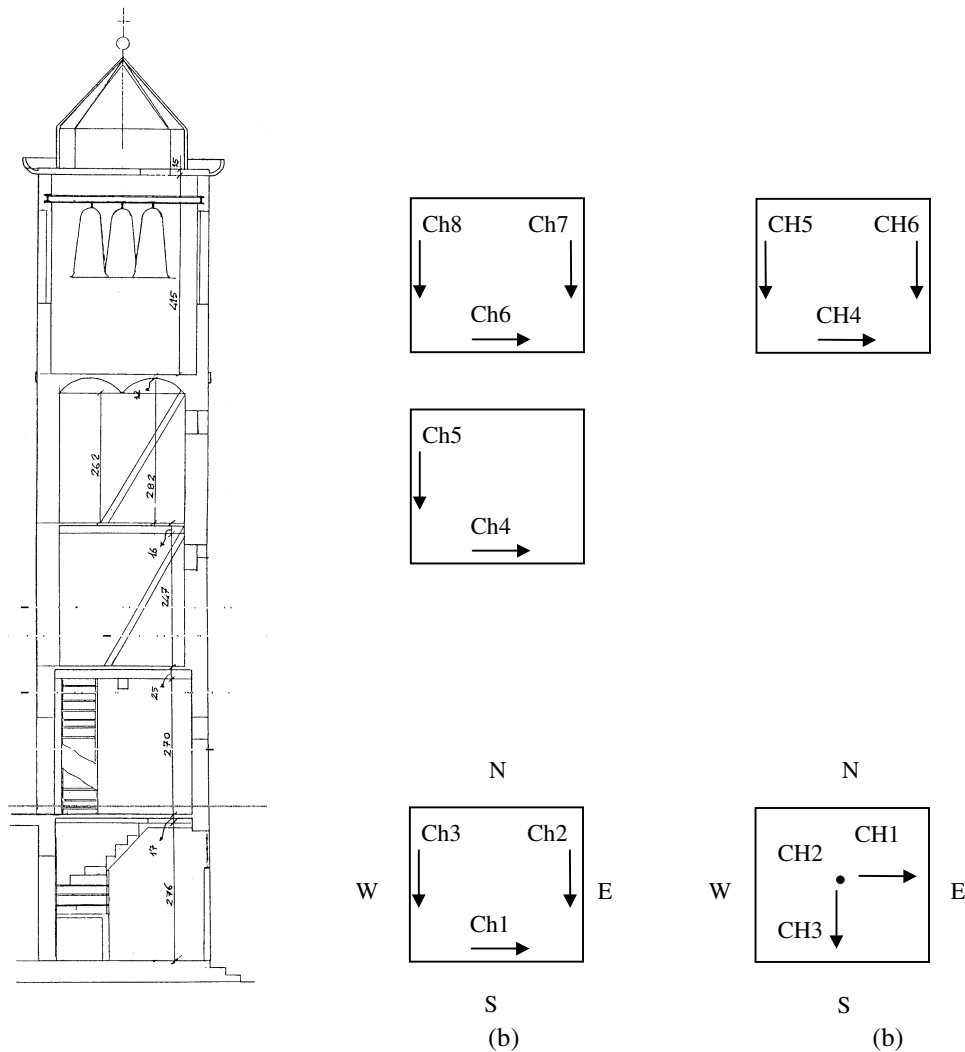
Figure 1: Velocimeter (a) and accelerometer (b) layouts
DESCRIPTION OF THE STRUCTURE

Several tests lasting 32 *sec* with a sampling rate of 0.004 *sec* were performed. The sensors were deployed in the configuration shown in Figure 1: Ch1, Ch2 and Ch3 were on the ground level; Ch4 and Ch5 were just under the cracks; Ch6, Ch7 and Ch8 were at the top.

The fixed instrumentation consisted of a triaxial accelerometric sensor located on the ground floor and three uniaxial horizontal accelerometric sensors at the top (Figure 1). Sixty-seven aftershocks were recorded in about two months. The events were classified on the basis of peak ground acceleration. The analysis in terms of energy content gave the same result.

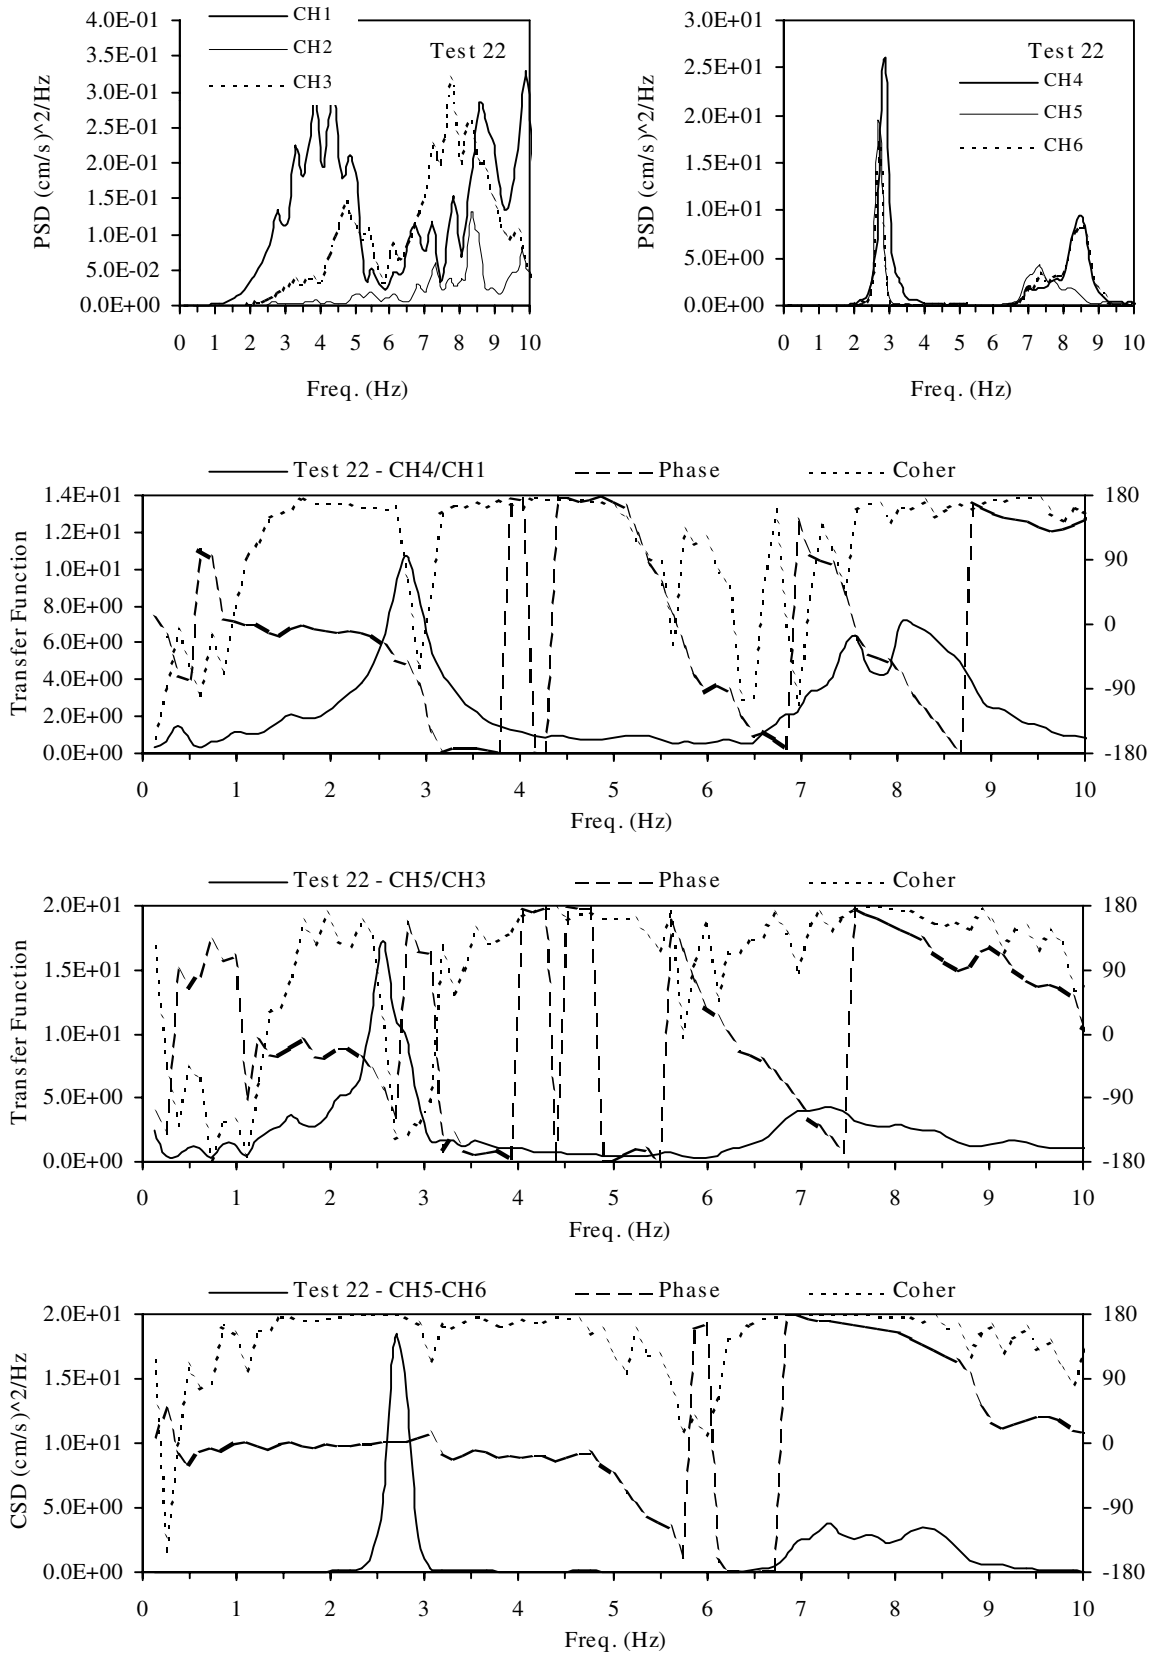
Figure 2: Spectra relative to Event No. 22

The records obtained under the lower energy earthquakes confirmed the results of the dynamic characterization. As an example the power spectral densities of records relative to a medium intensity earthquake, are shown in Figure 2. Peaks at the already mentioned resonance frequencies are evident. In more details the resonance frequency of 2.7 *Hz* is apparent for CH5 and CH6, while the resonance frequency of 2.9 *Hz* is present for CH4. The analysis of the phase factor pointed out that the signals at the top and the corresponding ones on the basement are 90 degrees out of phase at these frequencies. This occurrence allowed to consider the base records as the input and the top records as the response. The torsional resonant frequency of 6.9 *Hz* is also present.

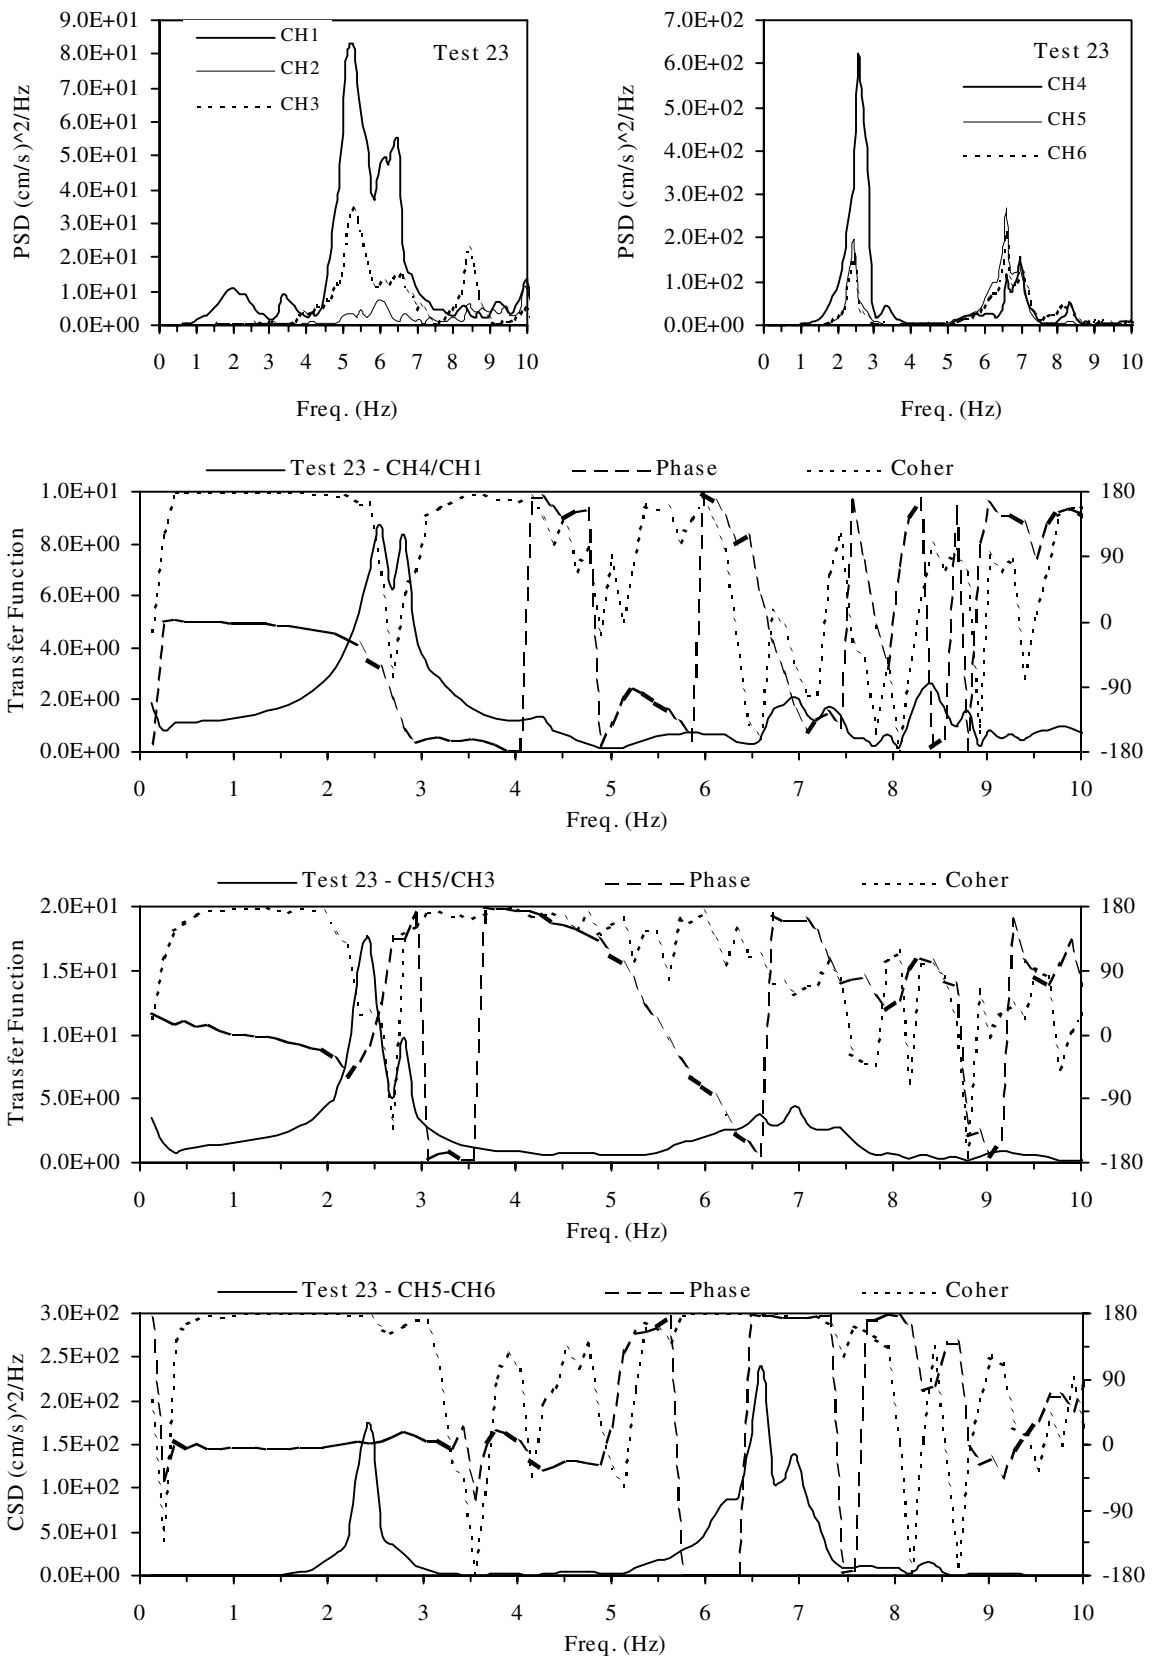
Figure 3: Spectra relative to Event No. 23

In Figure 3 the power spectral densities relative to event No. 23 are plotted. The different frequency content of the top records in comparison to the basement ones is evident. In fact, records at the basement contain, as obvious, the characteristics of the seismic motion.

The reduction of the resonant frequencies, with reference to the previous example, relative to event No. 22, is apparent. In fact the first frequency is equal to 2.43 *Hz* and is associated to a modal shape with prevalent displacements in the N-S direction. The second frequency is at 2.60 *Hz* and is relative to a modal shape with prevalent displacements in the W-E direction. It is also evident that, in this case, the energy in the W-E direction is much higher than the energy in the N-S direction. Just the opposite happened in the spectra relative to other events. This occurrence may be related to the different directivity of the various earthquakes [Clemente et al., 2000].

The transfer functions of event No. 23 are plotted in Fig. 3. The amplification of the motion at the resonance frequencies is evident.

The frequency at 6.6 *Hz* is apparent in the cross spectral density of records of sensors CH5 and CH6, which is also plotted in Figure 3. The signals being 180 degrees out of phase, this happens to be the torsional frequency of the tower.

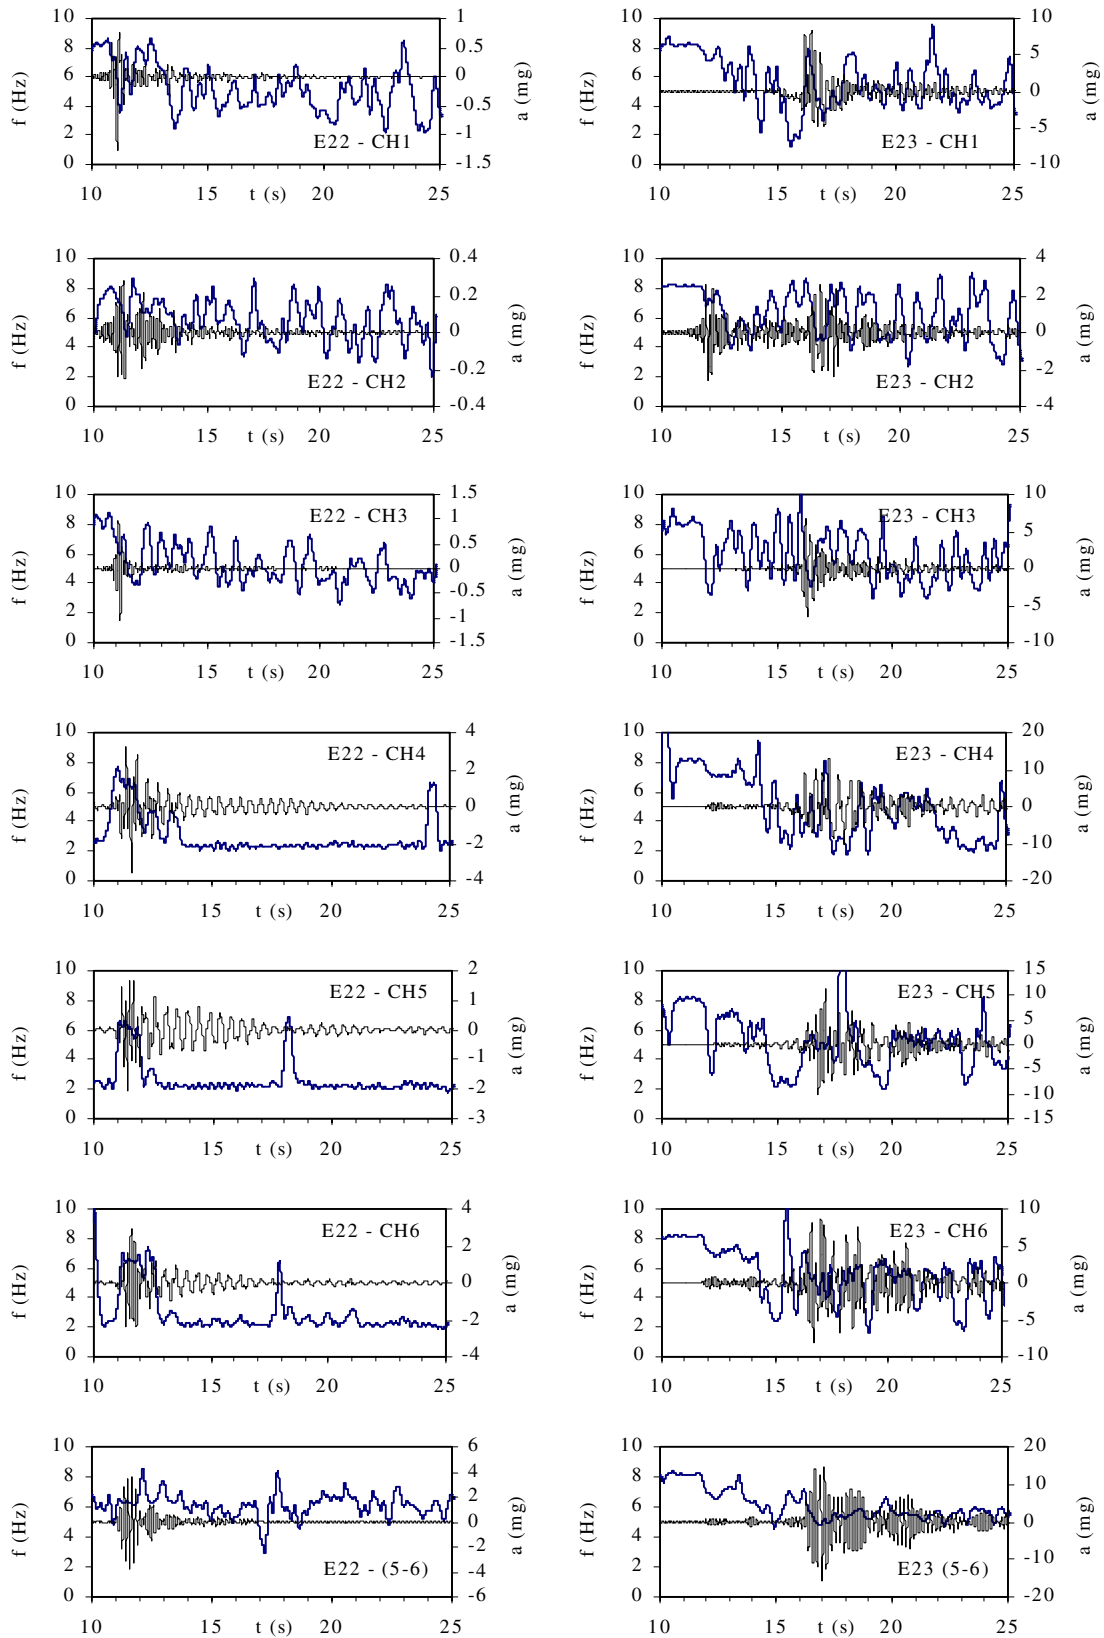
Figure 4: Time-histories and instantaneous frequencies

Torsional frequency, clearly seen from the analysis of difference between the time history of record CH5 and the time history of record CH6, is confirmed to have a value just below 7.0 Hz for the lower input energy cases, and which falls down to about 5.5 Hz for the higher input energy cases. These facts are illustrated in Figure 4, where the time histories and the relative instantaneous frequencies of event No. 22, characterized by a medium value of energy and event No. 23, which is one of the events with higher energy.

Looking at the evolution of the dynamic behavior of the structure, it is apparent, for the differences CH5-CH6 of both the events in Figure 4, that during the action of p-waves, i.e. with lower input energy, the torsional frequency is close to the value obtained from the dynamic characterization. Instead, during the strong phase, when also the effects of s-waves are present, this frequency lowers, more for the higher input energy record relative to event No. 23; after this phase the torsional frequency oscillates around the lower value according to the amplitude of the acceleration.

During the strong phase of event No. 22 it is apparent that the dominant frequency for the single channels, CH4, CH5 and CH6, is the torsional one. Lowering of bending frequencies with time, going from p-waves phase to the end of strong phase is clear only for CH4.

The analysis of records CH4, CH5, CH6 for event No. 23 (Figure 4), shows that the dominant frequency is always the torsional one, while the bending one is limited in time. Also in this case the lowering from p-waves phase to strong phase and further is apparent.
