DEVELOPMENT OF BUILDING DAMAGE CHART FOR POST DISASTER MANAGEMENT

Kei HORIE¹, Norio MAKI², Masayuki KOHIYAMA³, Hengjian LU⁴, Satoshi TANAKA⁵, Shin HASHITERA⁶ And Haruo HAYASHI⁷

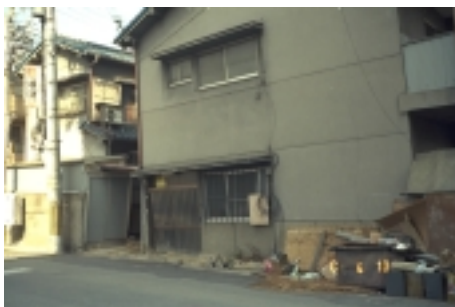
Photograph 1: Inclination damage (inclination angle: 2.0 degree)

Examples of the determined results for individual buildings are shown. The building shown in Photograph 1 was inclined by about 2 degrees. The TLRO survey gave a half collapse classification, the AIJ&CPIJ survey a slight damage classification. In the AIJ&CPIJ survey, the inclination could not be observed. The building shown in Photograph 2 was a steel structure which subsided about 500mm. The TLRO survey classified it as half collapsed, the AIJ&CPIJ survey, as not damaged. Although uniform subsidence of the building occurred due to liquefaction, the structure is not damaged or inclined. In such a case, the classification must be determined as half collapsed or as totally collapsed according to the amount of subsidence.

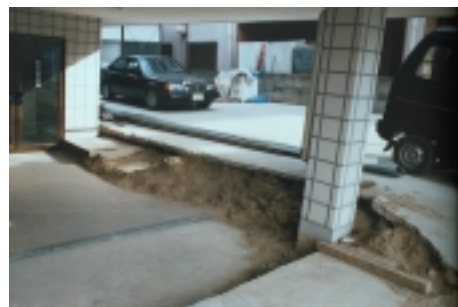
Even though the building damage pattern was mainly subsidence and inclination as shown in Photographs 1 and 2, structural damage such as total collapse or damage to walls and roofs also occurred. As a result of the AIJ&CPIJ survey, the proportions of totally collapsed buildings was 5.8% and that of half collapsed buildings was 5.2% in this area, excluding the unsurveyed buildings. As an example of building subsidence, there was a building have subsiding about 900mm in spite of it being a comparatively light wooden structure.

Photograph 2: Subsidence Damage (amount of subsidence: 500 mm)
