EVALUATION AND RETROFITTING OF BUILDINGS DAMAGED DUE TO JABALPUR (INDIA) EARTHQUAKE OF MAY 22ND 1997

P S PAJGADE¹, S S JAWADE², M P GAULKAR³ And S S KULKARNI⁴

SUMMARY

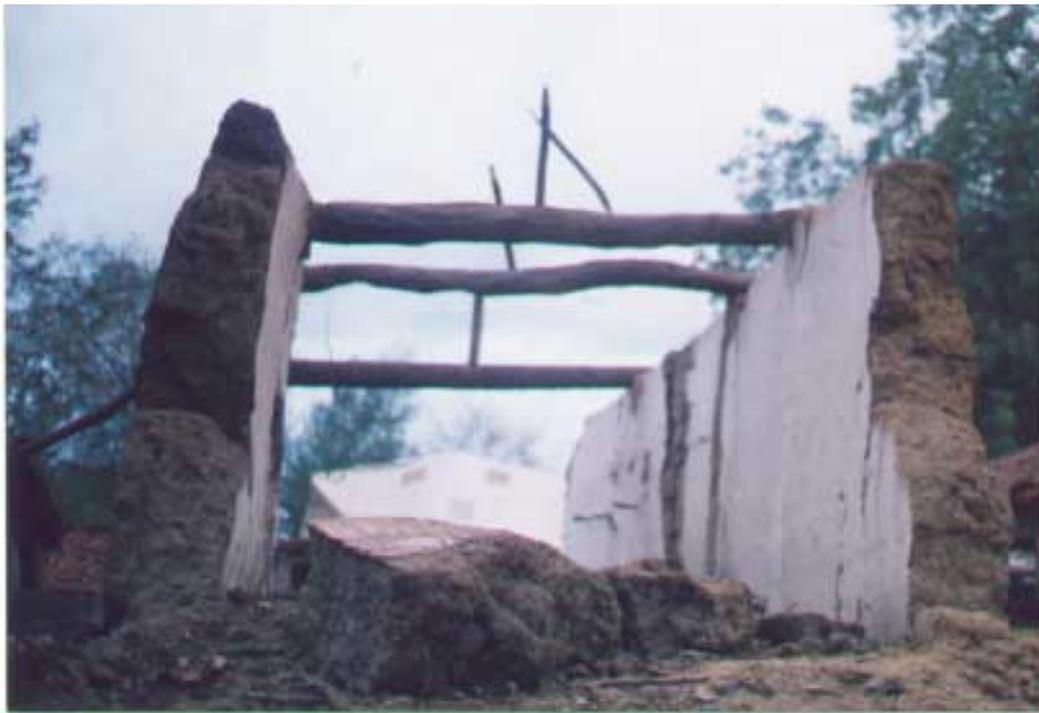
element, which will resist tension, such as collar beam or horizontal band. Photograph no1 shows a collapsed mud house. Collapse of mud houses in general was due to faulty construction practices such as,

1. High gable walls
2. Absence of tying elements (Beams /Rafters) at lintel level and below roof level.

Photograph No.1: -Collapse of gable wall & roof of rural building constructed with mud.

There are several mud buildings, which need to be strengthened. Strengthening of corner with the help of wooden member is essential to take tensile forces and for avoiding of separation of joint. This can be done to the existing buildings by providing external wooden band connecting the walls. This will prevent bulging out and collapse. Collar beam at roof level is essential in providing fixity to the rafters, which support the roofing

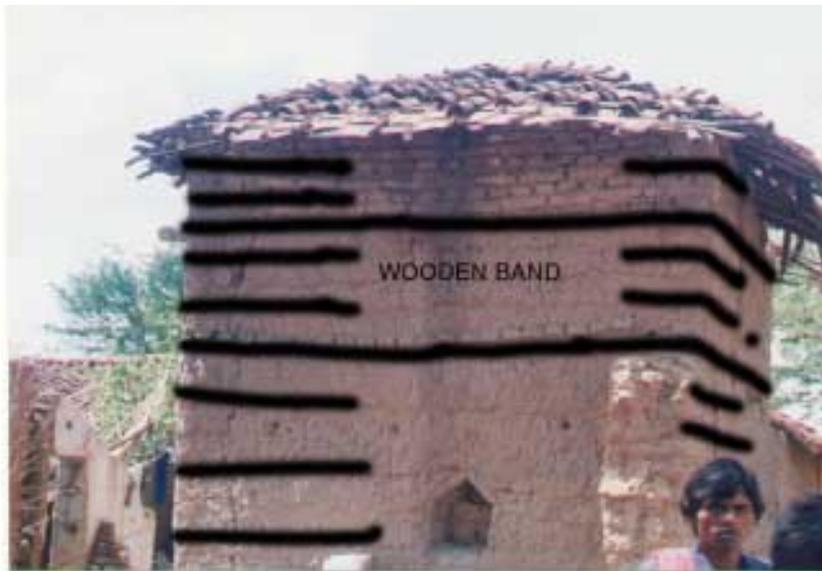
Photograph No.2: -Provision Of Wooden Band For Retrofitting Of Mud House.

system. (Photograph no 2 shows provisions of wooden bands.) Similar wooden bands must be provided from inside portion also. Proper preservative treatment must be given to the rafter to prevent its decay. Cracked portion must be filled with properly prepared mud mortar.

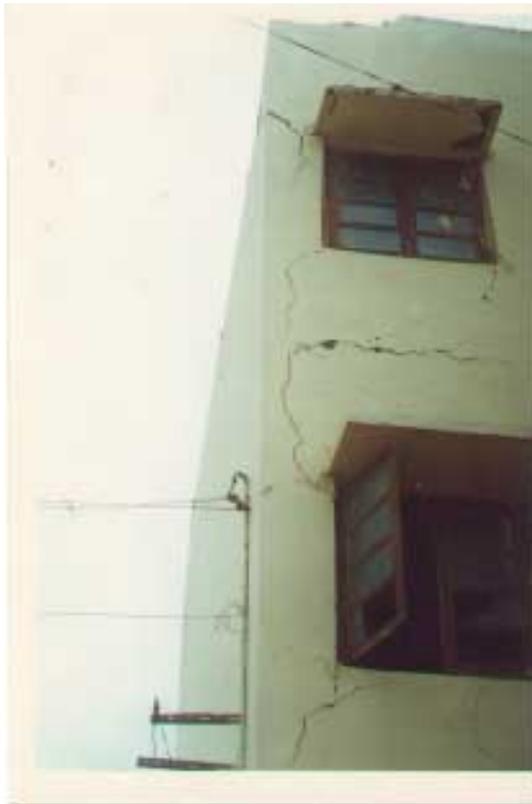
a) ACTUAL CONDITION

Cracks at lintel level and sill level

Due to placement of opening near corner and absence of continuous lintel band, several cracks were developed in the building.

For retrofitting of this types of buildings, provide 6 mm dia vertical bars at the corner. Fix strips of welded wiremesh of size 75x75mm, 2.5mm thick. Provide one layer of chicken mesh. Provide vertical splint and horizontal bandage at lintel level, windowsill level and at top level of parapet. Plaster this surface with rich cement mortar (1:3) or micro concrete. If it is possible, guniting is the best solution.

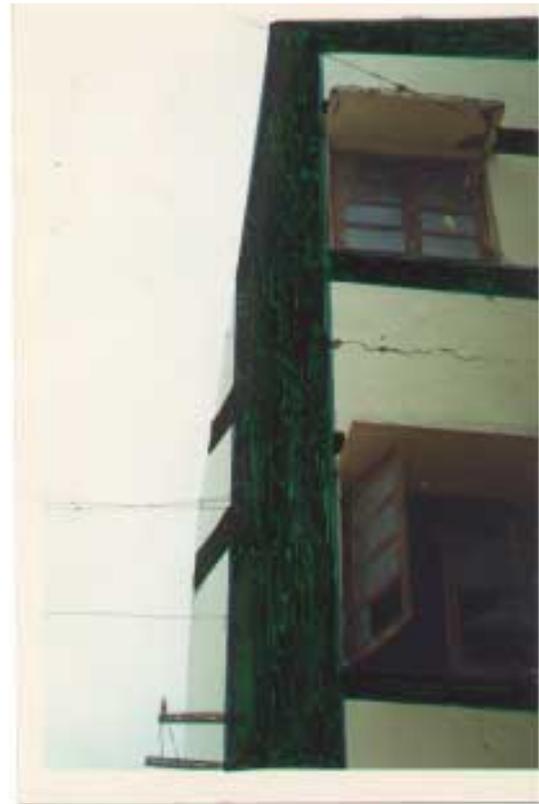
b) GREEN COLOUR SHOWS VERTICAL SPLINT AND HORIZONTAL BANDAGE

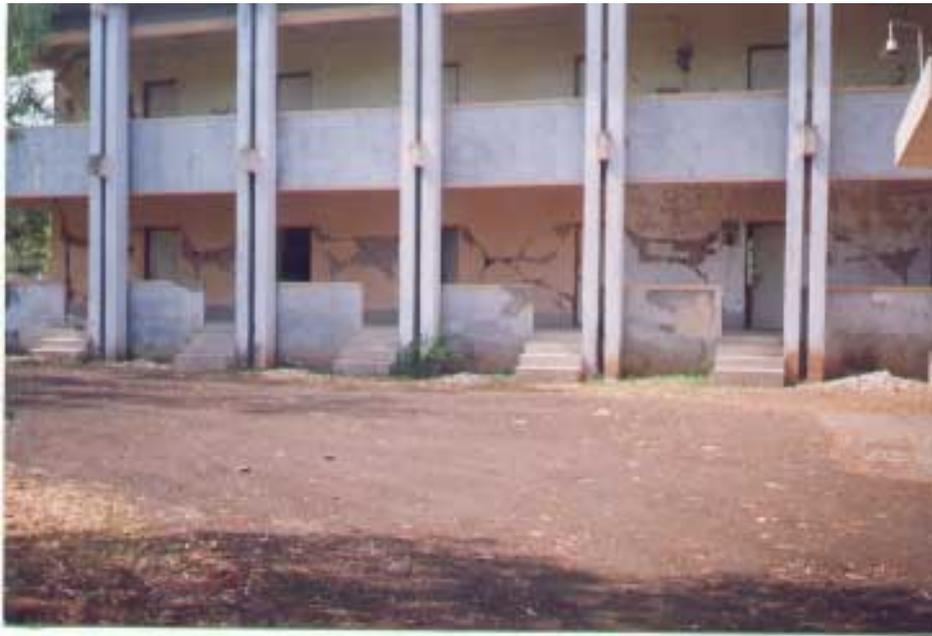
A very large size of cupboard reduced the area of load bearing. This resulted in reduction in strength of load bearing wall, so severe cracks were observed in the wall (Photograph no 4)

Photograph no. 4:- shows cracking of walls due to very large size of cupboard.

A very large size of cupboard reduced the strength of load bearing wall. So, this size of cupboard must be reduced by providing new load bearing brickwork or by providing concrete. Proper bond must be achieved between new and old work. Fix welded wire mesh and chicken mesh on cracked portion of wall. Plastering must be done with rich cement mortar on this surface.

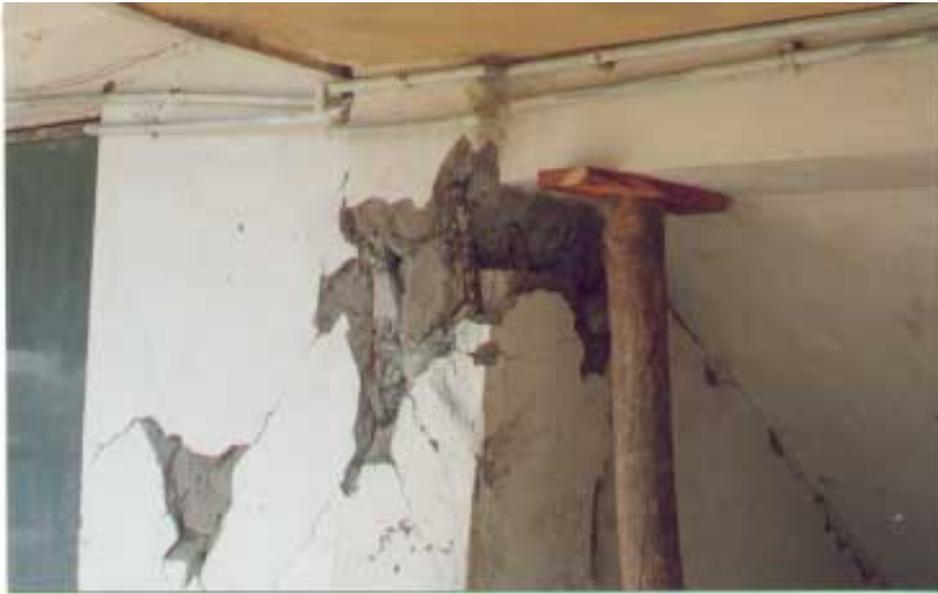
Columns supporting midlandings becomes short and stiff columns, which attracts large amount of earthquake forces. If these columns are not designed for the earthquake forces then, brittle failure of column is observed. Photograph no 5 shows such brittle failure of column used for supporting the staircase.

Photograph no.5:-brittle failure of short column supporting staircase midlanding.

Jacketting of column is required from foundation level so that strength of column is increased to required level. The column under repair must be relieved from the load by providing temporary supports to the superstructure. Crushed concrete must be removed. Size of column required will be evaluated on the basis of forces acting on the column after doing modal analysis. Vertical reinforcement and closely placed stirrups will be provided to have confinement effect.

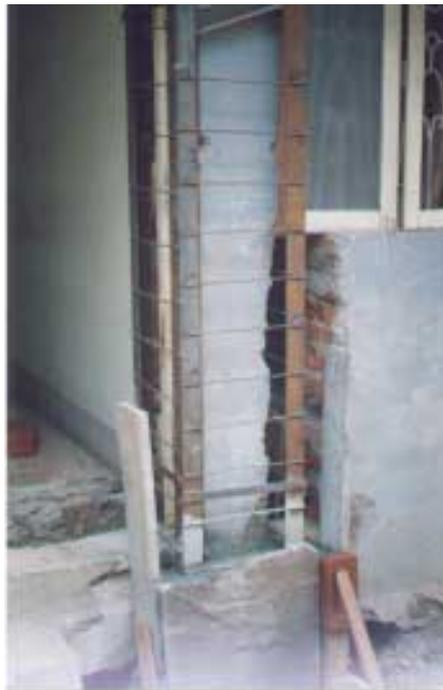
Photograph no.6:-retrofitting of column with the help of structural angles and concrete jacketing

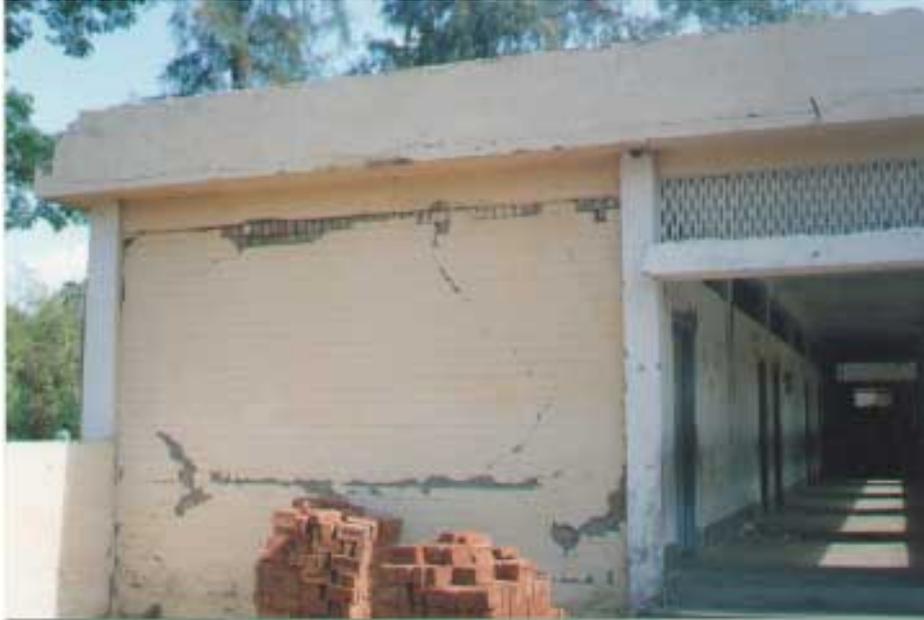
In case of very large and tall brick panel dimension, dummy columns must be provided, connecting upper and lower beams. This way unsupported length of panel can be reduced more effectively. Photograph no 7 shows separation of brick panel from frame.

Photograph no.7:- separation of wall panel from main frame

For retrofitting of this brick panel. Remove old plaster. Fix the strip of welded wire mesh and chicken mesh on the frame (i.e. on columns and beam) and on brick panel. These wiremeshes must be properly anchored to the frame and brick panel. This treatment must be done on both sides of wall. Plaster the surface with cement mortar (1:4).

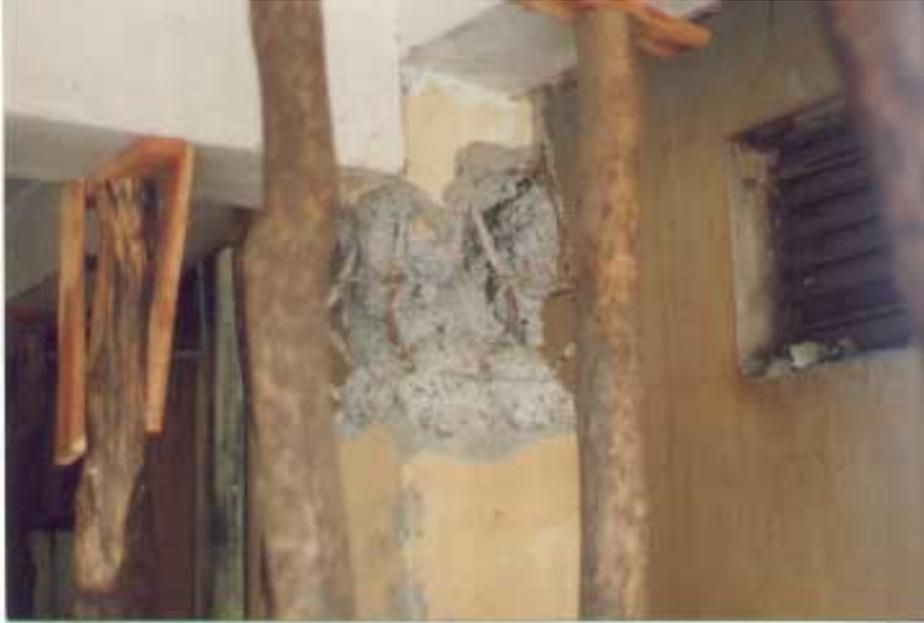
Photograph no.8:- brittle failure of column of a building with flexible first storey.

Damages to structures were observed mostly due to negligence on the part of designer and/or contractor. For building with flexible first storey (i.e. building on stilts. This type of arrangement is done for solving parking problem.) modal analysis is required. In frame structure with flexible first storey, first storey columns are subjected to large amounts of moments and shear forces. For retrofitting of these buildings detailed analysis of building is required. After analysis strengthening can be done by adopting following measures.

- 1) Strengthening of column by jacketting.
 - 2) Providing additional columns.
 - 3) Providing shear walls.
- Suitable ductility requirements must be satisfied.

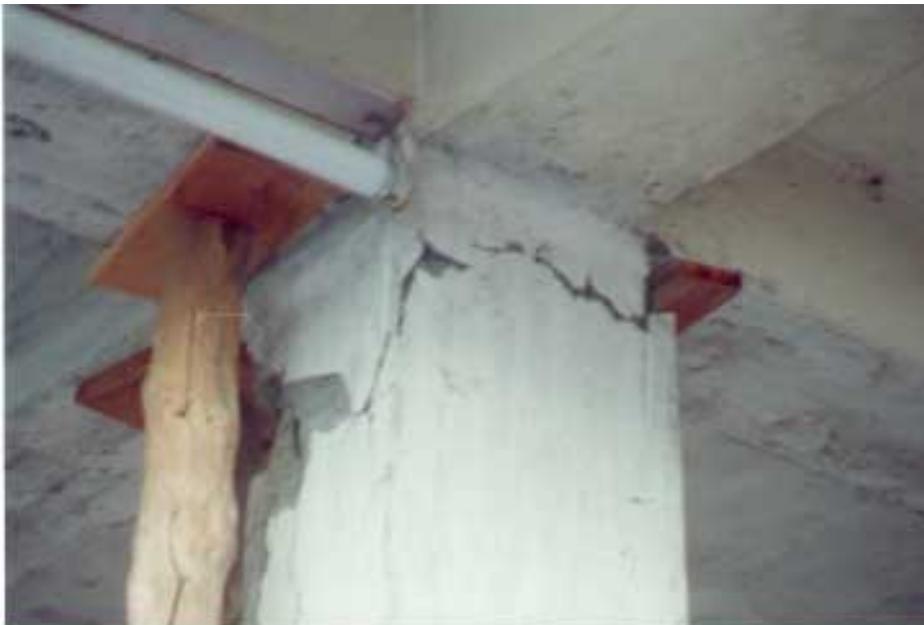
Photograph no.9:- severe cracks in column of a building with flexible first storey.
