DETAILED INVESTIGATION OF PILES DAMAGED BY HYOGOKEN NAMBU EARTHQUAKE

Kenichi HORIKOSHI¹, Akira TATEISHI² And Hiroyasu OHTSU³

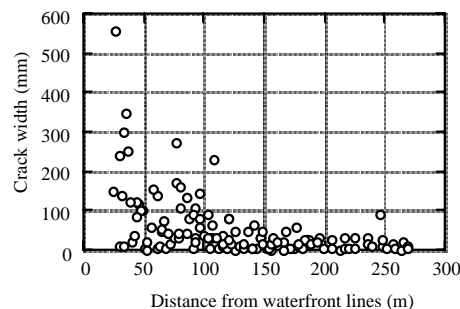
The reclaimed island where the site was located suffered from significant liquefaction during and after the Hyogoken Nambu earthquake. The authors investigated the distribution of crack width which surfaced on the ground with distance from the waterfront line, as shown in Figure 1. According to the figure, the crack width was large within a distance up to 150 m from the waterfront line. As the piles were at least 350 m from the quay walls it was therefore considered that the effects of the large quay wall displacements on the pile response at this site was small. Hamada et al.[1] reported that the soil at the site moved by about 1 m in the south-west direction based on analyses of aerial photographs before and after the earthquake.

Figure 1: Distribution of crack width observed at the island

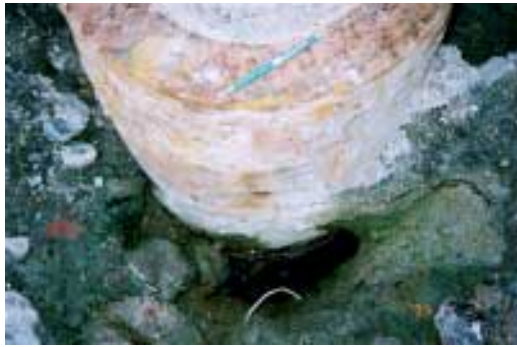
Figure 3 shows a close-up photograph of one of the pile tops. In the photograph, a small hole can be seen close to the pile surface which was thought to be the result of soil liquefaction. The ground at the investigated area settled by about 0.4 - 0.5 m due to the soil liquefaction. Figure 4 illustrates the settlement.

Figure 3: Hole found near pile surface

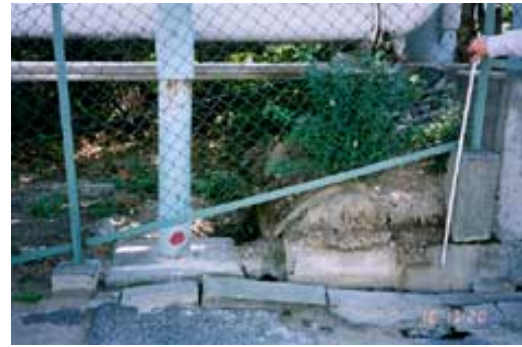
Figure 4: Settlement of the fence near the site

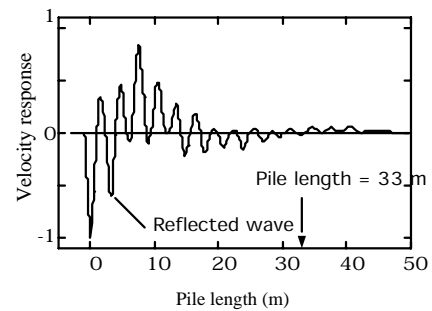
Figure 8(a) shows the result of the integrity test conducted on an undamaged pile which has the same components as the piles examined in this study. In the figure, the horizontal axis corresponds to the pile length, and the depth at which the incident waves are reflected is shown. According to the figure, a clear reflection can be seen at a depth of 24 m, which corresponds to the pile length. On the other hand, Figure 8(b) shows a typical response obtained from the piles at the investigation site. According to the figure, only a reflection from the relatively shallow depth of about 5 m can be obtained, and no reflection from a depth corresponding to the pile length, i.e. 33 m, can be seen. The results obtained from all the piles were essentially the same as shown in Figure 8(b). Therefore, based on the integrity tests it was considered that the majority of the piles at the site might have some damage similar to that depicted in Figure 8(b).

(b) Typical result obtained from the pile at the site
Figure 8: Results obtained from low strain integrity tests

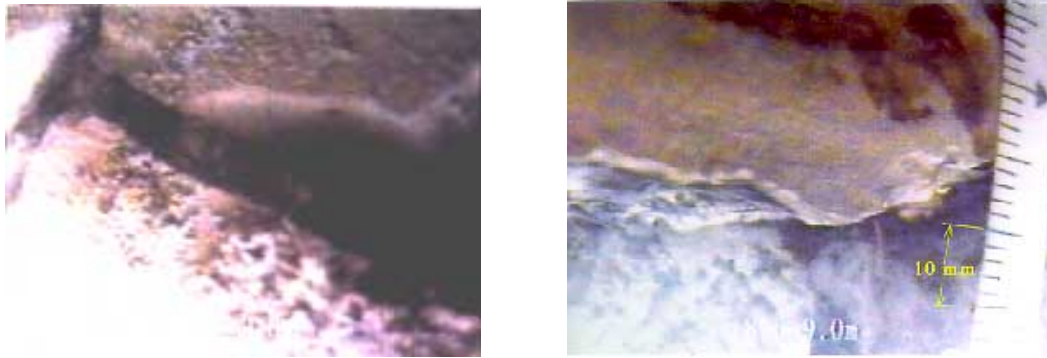
The photographs of major damage taken by the CCD camera are shown in Figure 9 for the piles No. 75 and No. 199. Although it was rather difficult to quantify the crack size accurately from these photographs, it was

(a) Pile No. 75, depth about 8 m (b) Pile No. 199, depth about 8.5-9.0m
Figure 9: Pile damage observed by a CCD camera from inside

possible to estimate the size by making comparisons with the size of the scale shown in the photograph. The actual width of the scale shown in the photograph was 10 mm.

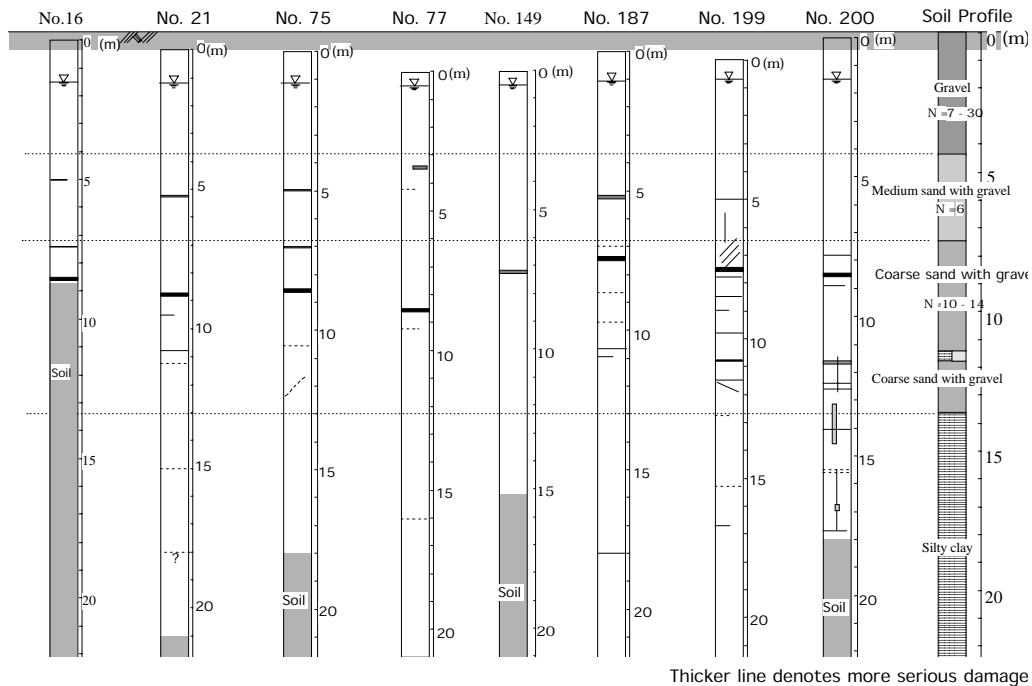
Figure 10 : Summary of pile damage obtained from inspection by CCD camera

Figure 10 summarizes the findings of this investigation. In the figure, the thickness of the lines represents the size of the crack and the thicker the line the larger the crack. According to the figure, it can be seen that the integrity tests only found the shallowest damage. Large cracks were found in all the investigated piles indicating the severity of damage caused by the Hyogoken Nambu earthquake. The color of the crack as indicated by the photographs taken by the CCD camera was light gray, indicating that the cracks were created just before the investigation, i.e. at the time of the earthquake. At times the inside diameter of the damaged point was sometimes too narrow for maneuvering the CCD camera. The depth of the largest crack in all of the 8 piles investigated using the CCD camera was about 7 - 8 m from the soil surface, slightly below the boundary between the reclaimed soil layers of coarse sand with gravel and the medium sand with gravel.

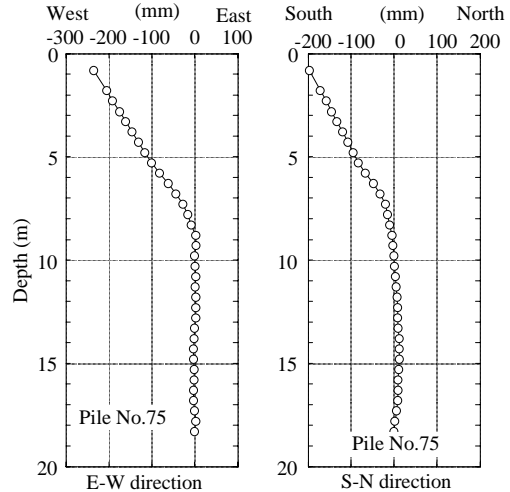
(a) Pile No. 75

The figures clearly show that the piles deflected at a depth about 8-10 m from the pile top. Although the deflection patterns are almost the same for the investigated piles, it was also seen that some piles (pile No. 199 & 200) deflected at two depths. The lower depth of the large deflection was about 12 m from the pile top as shown in Figure 12 (c).

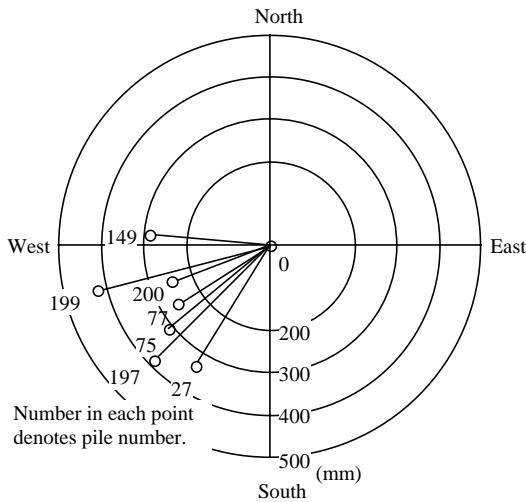
Figure 13: Displacement of each pile top estimated from results of inclinometer

Figure 13 summarizes the direction of the pile deflection. The figure shows that all the piles deflected towards the

southwest in the direction of the soil displacement as shown by Hamada et al [1]. The magnitude of the pile top displacement varied from 250 mm to 420 mm and was smaller than the amount shown by Hamada et al. It should, also, be noted that the major direction of the shaking in the Hyogoken Nambu earthquake was from the northwest to the southeast. The direction of the pile deflection was perpendicular to the direction of main shaking.
