EVALUATION AND RETROFITTING OF BUILDINGS DAMAGED DUE TO JABALPUR (INDIA) EARTHQUAKE OF MAY 22ND 1997

P S PAJGADE¹, S S JAWADE², M P GAULKAR³ And S S KULKARNI⁴

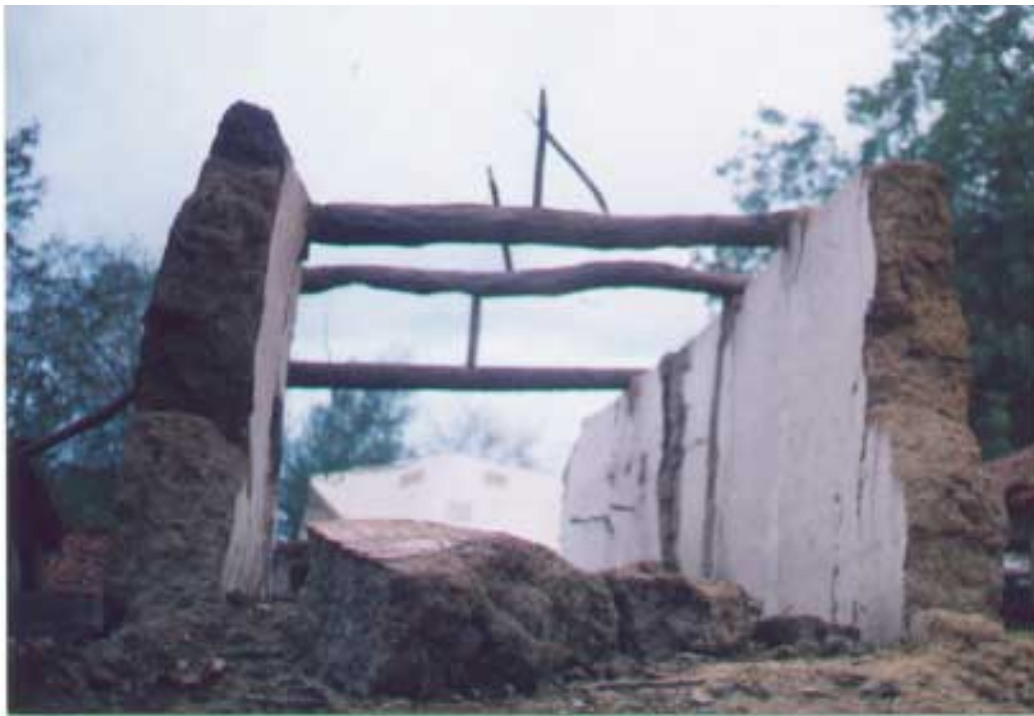
element, which will resist tension, such as collar beam or horizontal band. Photograph no1 shows a collapsed mud house. Collapse of mud houses in general was due to faulty construction practices such as,

1. High gable walls
2. Absence of tying elements (Beams /Rafters) at lintel level and below roof level.

Photograph No.1: -Collapse of gable wall & roof of rural building constructed with mud.

There are several mud buildings, which need to be strengthened. Strengthening of corner with the help of wooden member is essential to take tensile forces and for avoiding of separation of joint. This can be done to the existing buildings by providing external wooden band connecting the walls. This will prevent bulging out and collapse. Collar beam at roof level is essential in providing fixity to the rafters, which support the roofing

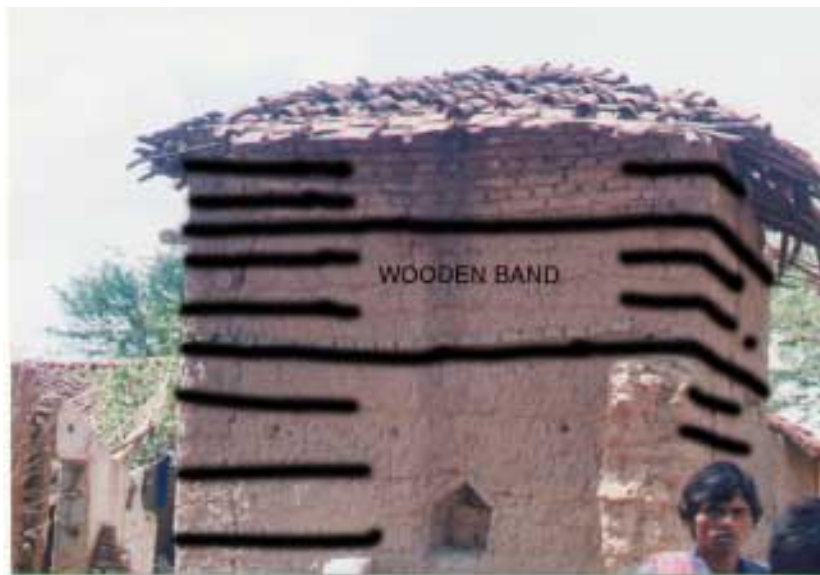
Photograph No.2: -Provision Of Wooden Band For Retrofitting Of Mud House.

system. (Photograph no 2 shows provisions of wooden bands.) Similar wooden bands must be provided from inside portion also. Proper preservative treatment must be given to the rafter to prevent its decay. Cracked portion must be filled with properly prepared mud mortar.

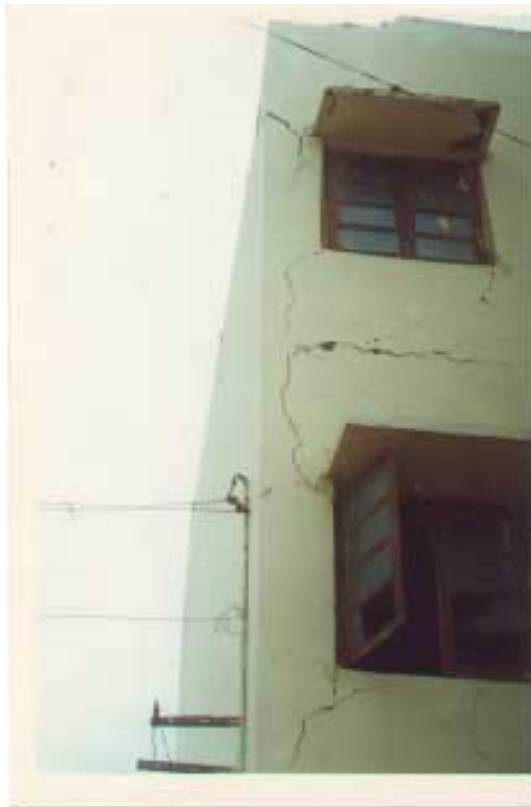
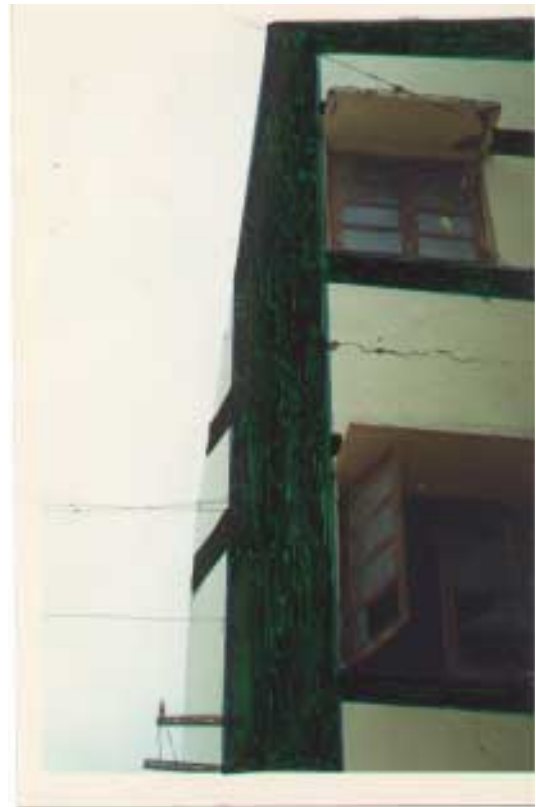
Photograph No.3: -Retrofitting System Suggested For Load Bearing Building.

a) ACTUAL CONDITION

b) GREEN COLOUR SHOWS VERTICAL SPLINT AND HORIZONTAL BANDAGE

Cracks at lintel level and sill level

Due to placement of opening near corner and absence of continuous lintel band, several cracks were developed in the building.

For retrofitting of this types of buildings, provide 6 mm dia vertical bars at the corner. Fix strips of welded wiremesh of size 75x75mm, 2.5mm thick. Provide one layer of chicken mesh. Provide vertical splint and horizontal bandage at lintel level, windowsill level and at top level of parapet. Plaster this surface with rich cement mortar (1:3) or micro concrete. If it is possible, guniting is the best solution.

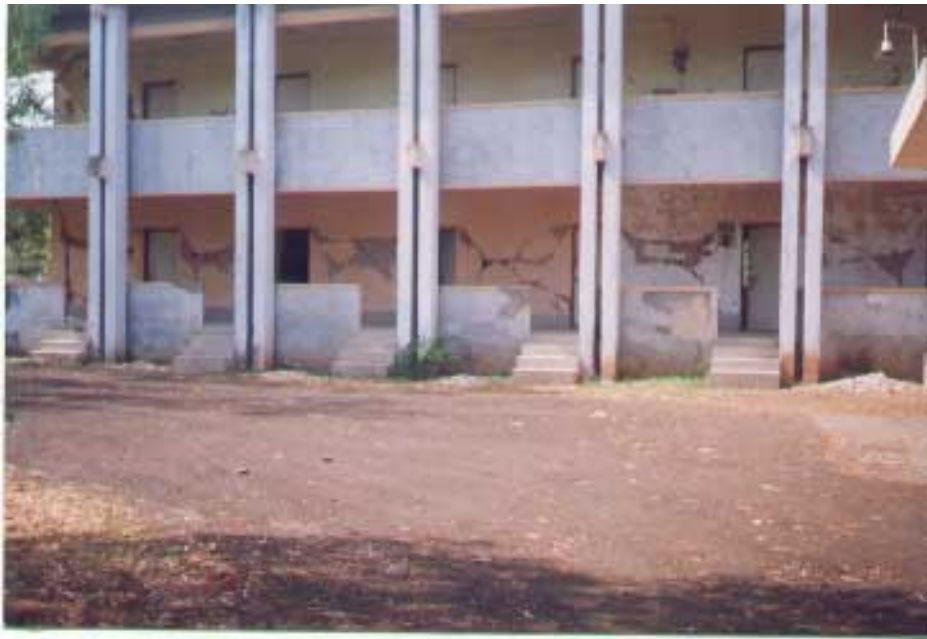
A very large size of cupboard reduced the area of load bearing. This resulted in reduction in strength of load bearing wall, so severe cracks were observed in the wall (Photograph no 4)

Photograph no. 4:- shows cracking of walls due to very large size of cupboard.

A very large size of cupboard reduced the strength of load bearing wall. So, this size of cupboard must be reduced by providing new load bearing brickwork or by providing concrete. Proper bond must be achieved between new and old work. Fix welded wire mesh and chicken mesh on cracked portion of wall. Plastering must be done with rich cement mortar on this surface.

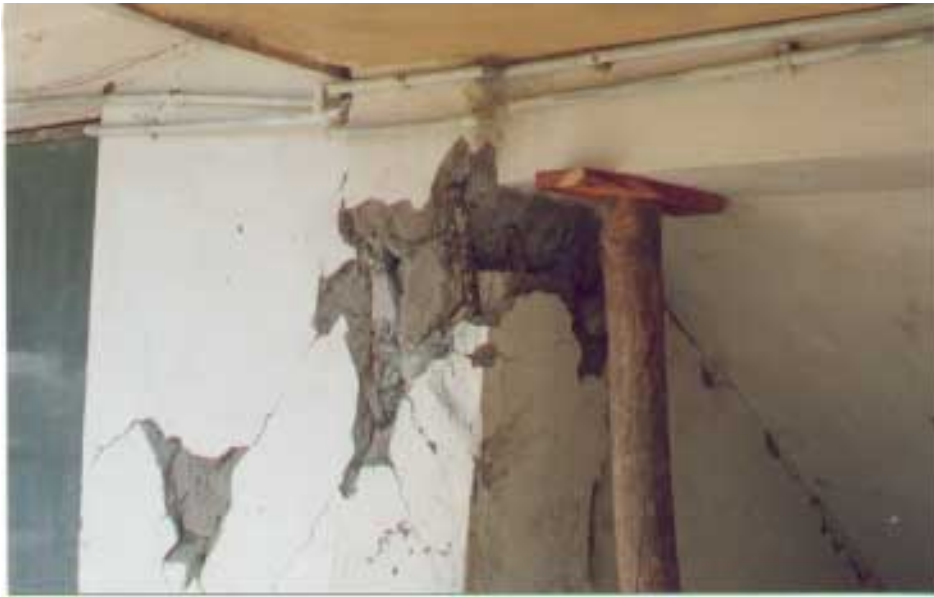
Columns supporting midlandings becomes short and stiff columns, which attracts large amount of earthquake forces. If these columns are not designed for the earthquake forces then, brittle failure of column is observed. Photograph no 5 shows such brittle failure of column used for supporting the staircase.

Photograph no.5:-brittle failure of short column supporting staircase midlanding.

Jacketting of column is required from foundation level so that strength of column is increased to required level. The column under repair must be relieved from the load by providing temporary supports to the superstructure. Crushed concrete must be removed. Size of column required will be evaluated on the basis of forces acting on the column after doing modal analysis. Vertical reinforcement and closely placed stirrups will be provided to have confinement effect.

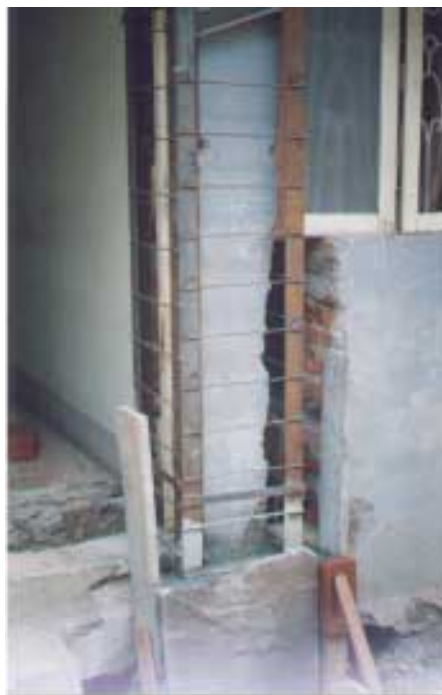
Photograph no.6:-retrofitting of column with the help of structural angles and concrete jacketing

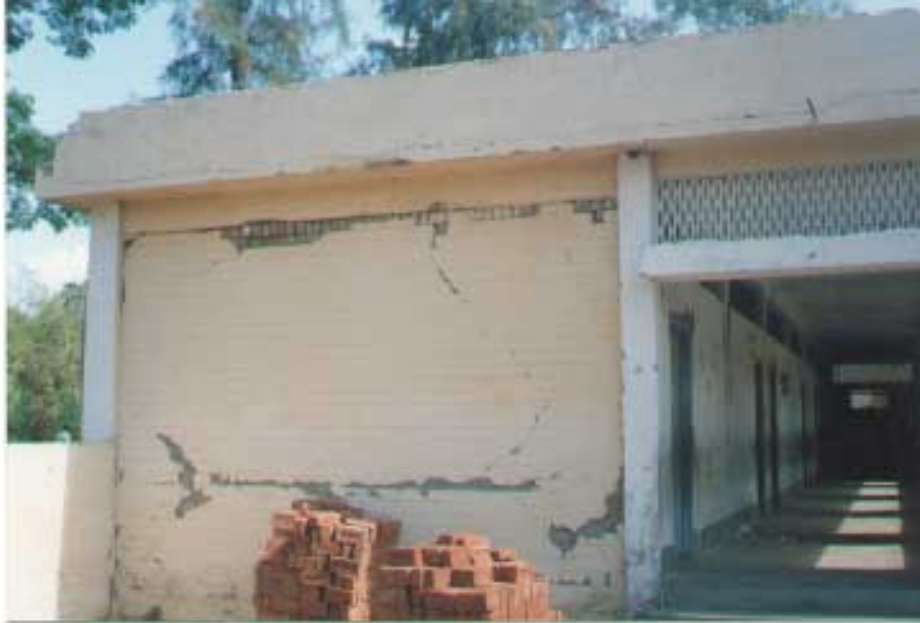
In case of very large and tall brick panel dimension, dummy columns must be provided, connecting upper and lower beams. This way unsupported length of panel can be reduced more effectively. Photograph no 7 shows separation of brick panel from frame.

Photograph no.7:- separation of wall panel from main frame

For retrofitting of this brick panel. Remove old plaster. Fix the strip of welded wire mesh and chicken mesh on the frame (i.e. on columns and beam) and on brick panel. These wiremeshes must be properly anchored to the frame and brick panel. This treatment must be done on both sides of wall. Plaster the surface with cement mortar (1:4).

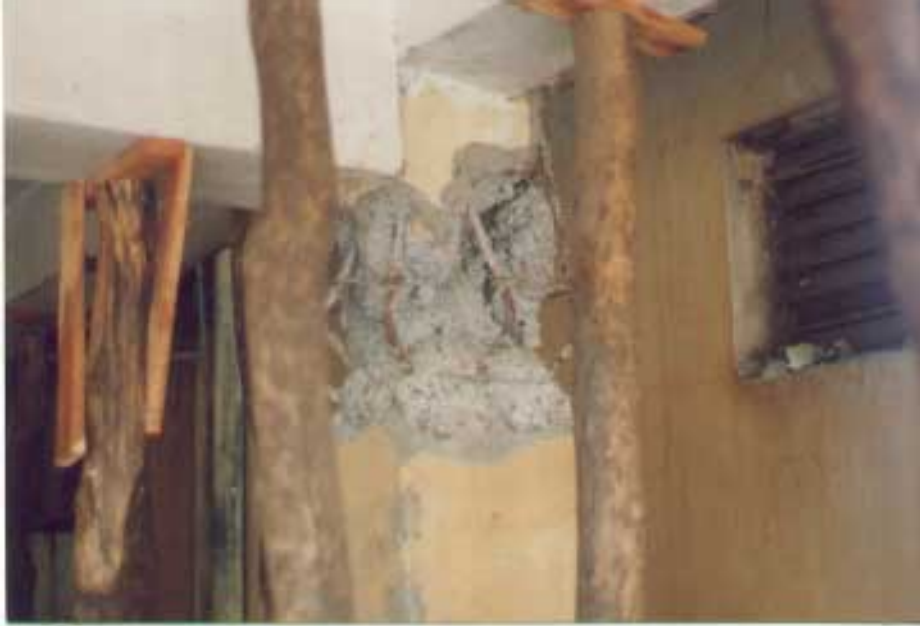
Photograph no.8:- brittle failure of column of a building with flexible first storey.

Damages to structures were observed mostly due to negligence on the part of designer and/or contractor. For building with flexible first storey (i.e. building on stilts. This type of arrangement is done for solving parking problem.) modal analysis is required. In frame structure with flexible first storey, first storey columns are subjected to large amounts of moments and shear forces. For retrofitting of these buildings detailed analysis of building is required. After analysis strengthening can be done by adopting following measures.

- 1) Strengthening of column by jacketting.
 - 2) Providing additional columns.
 - 3) Providing shear walls.
- Suitable ductility requirements must be satisfied.

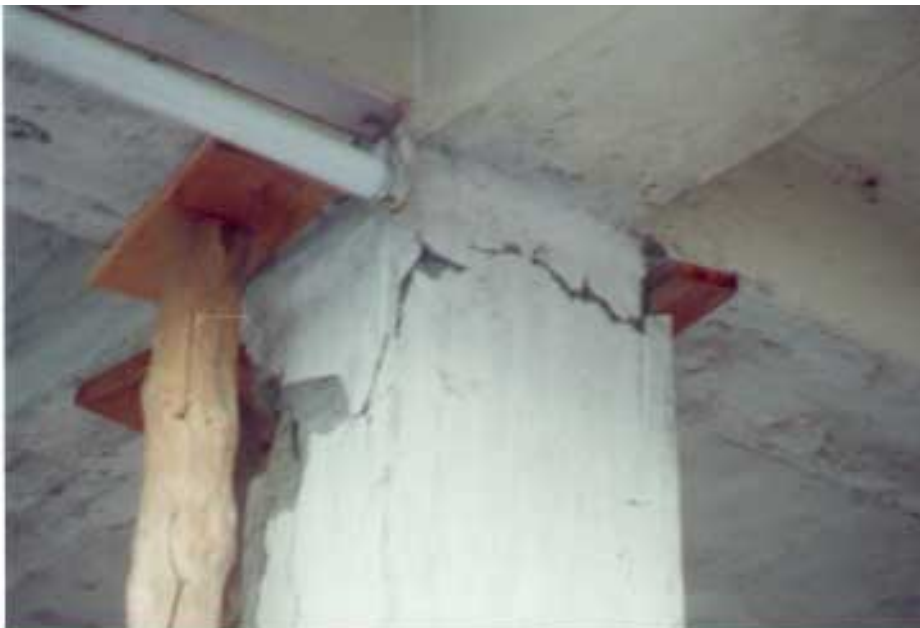
Photograph no.9:- severe cracks in column of a building with flexible first storey.
