BEHAVIOR OF THE MAIN WHARF IN SAN PEDRITO PORT IN MANZANILLO, MEXICO

E OVANDO-SHELLEY¹ And M P ROMO²

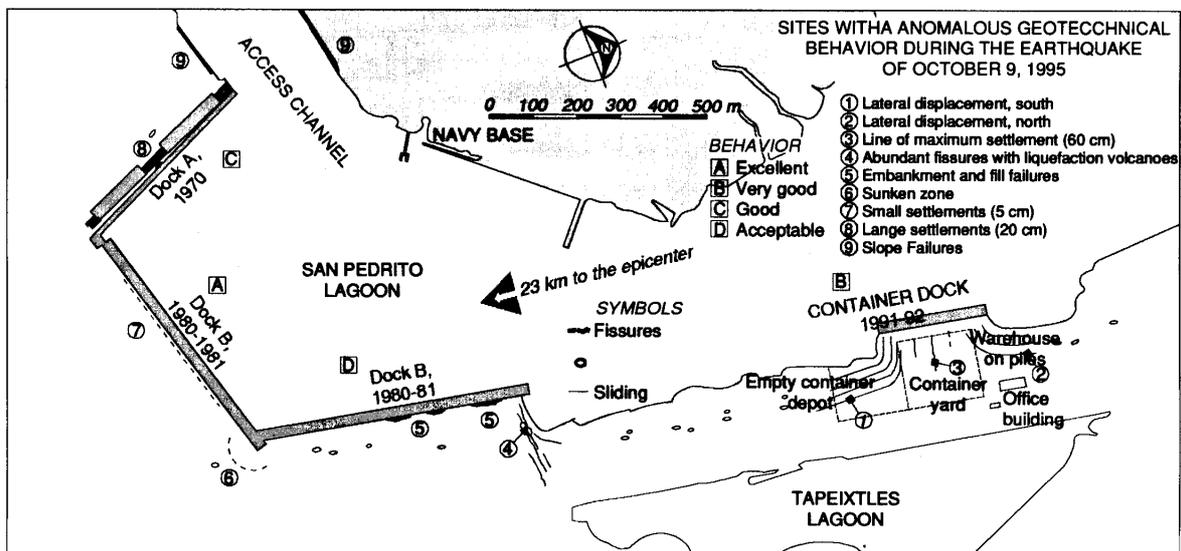
Many of the facilities in the San Pedrito harbor were built on reclaimed land, which liquefied extensively during the earthquake. Materials used for land reclamation were dredged from the neighboring lagoons and are deeper than in urban areas, typically their depth reaches 10 to 15 m. Settlements in yards produced the rupture of water supply and electricity lines; fissuring, cracking and dislocation of pavements were extensive; some buildings settled differentially and some others tilted, in many cases severely. Differential settlements in the yards of the Container Terminal exceeded 80 cm and lateral displacements in unconfined slopes were more than 2 m.

Fig 3. Damage and damage distribution in the San Pedrito Harbor

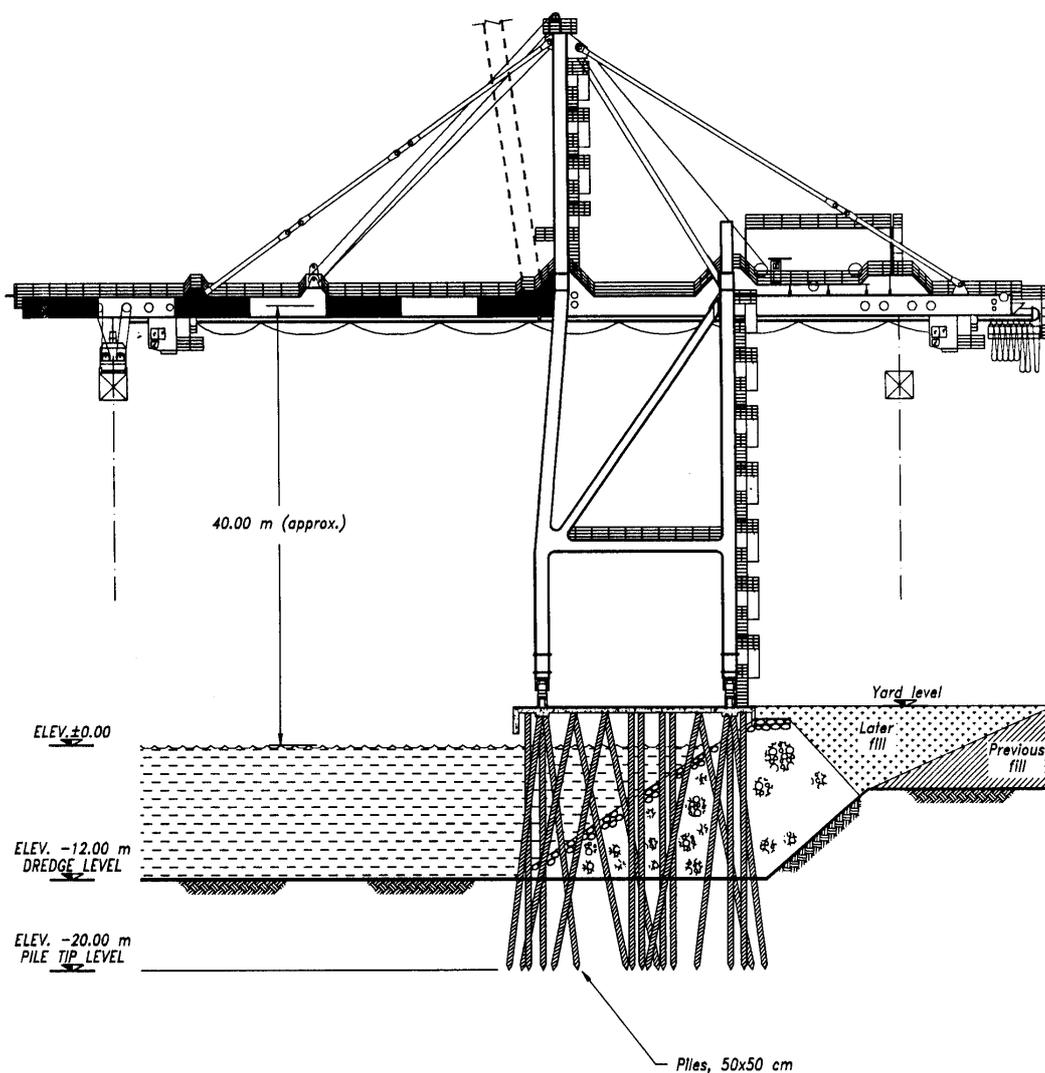
Fig 4. Cross section of the wharf in the Containers Terminal in San Pedrito

construction of the main one. The seaward toe of this embankment was aligned with the outer line of piles, as seen in fig 4. Silty sands dredged from the lagoon were placed behind the embankment with the hydraulic fill method. These materials now constitute the subsoil that underlies the Container Terminal yards.

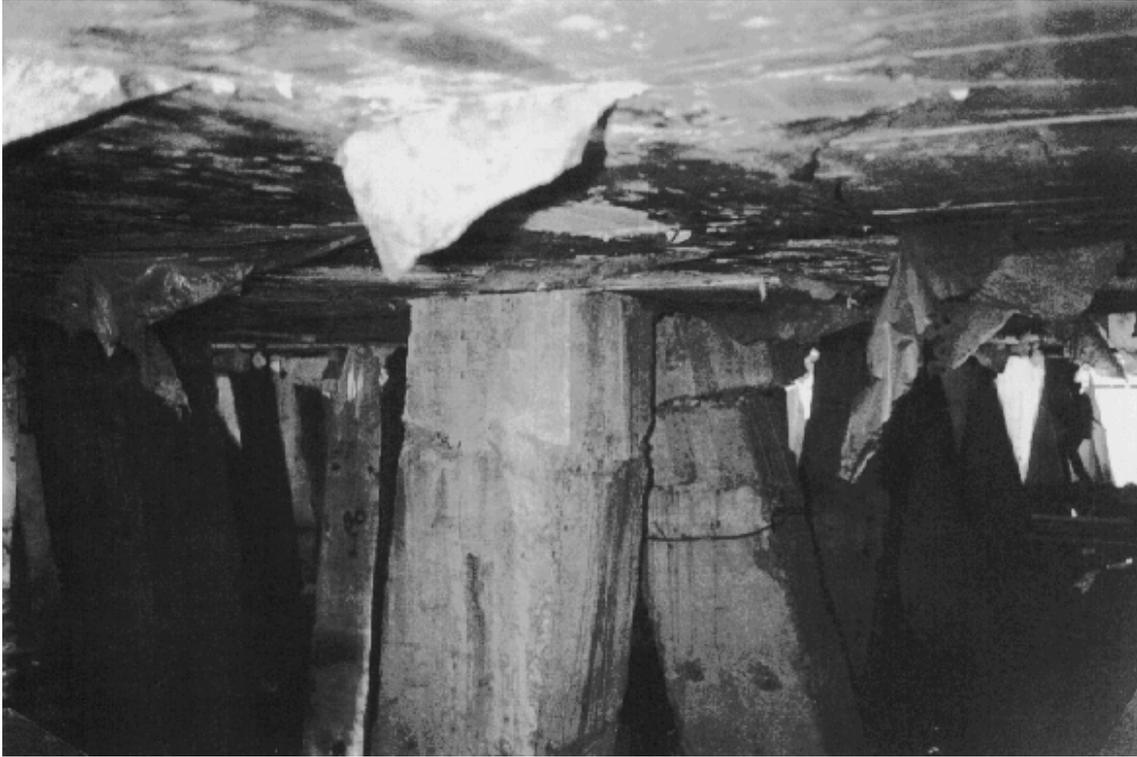
Most cracked piles were located in the landward side of the dock and had been provided with additions cast after the installation of the piles; 90 % of them were battered, with inclinations towards the seaward toe. Furthermore, the shearing patterns observed at their connection with the platform slab suggest that during the earthquake these piles were subjected to strong thrusts from the embankment as it displaced horizontally. Inadequate structural behaviour at the joints precluded the transmission of stress to the piles inclined towards the inland side of the dock. There were 29 piles damaged in this way, from a total of 1,170 piles, i.e. 2.5%. The authors concluded that these piles were either improperly driven, or moved during the construction of the embankment, or both. Hence their inadequate behaviour during the earthquake.

Damages were also observed in the slabs, at the connections with the battered piles. These resulted in the punching failure of the structural elements at these joints brought about by high shearing forces and bending moments produced by horizontal displacements. This mode of failure is also consistent with the hypothesis that the embankment settled and displaced horizontally during the earthquake. The number of failed joints was 53, 4.5% of their total number.

Despite the failures at the pile heads or at structural joints, the dock was not in danger of collapsing after the earthquake but its seismic resistance reduced substantially and its ability to survive future large earthquakes was judged to be doubtful. The observed damage pattern suggests that the embankment settled and displaced horizontally, hence large dynamic thrusts were exerted on the piles, probably influenced by the liquefaction of the loose granular fills retained by the embankment.

Fig 6. Earthquake induced damage to batter-piles in San Pedrito wharf

Rehabilitation of the dock after the earthquake required immediate action and an emergency plan to carry out the necessary work. The repair and retrofitting project was formulated on the basis of an elastic 3-D finite element analyses of the dock in which the seismic excitations were defined by means of the design spectrum discussed previously. A cross section of the model used in the analyses is shown in fig 5. Runs were made using a commercially available computer program. A critical aspect for modeling the behavior of the dock was the ability to simulate the interaction of the piles with the underlying soils and with the embankment. In view of the urgent need to start the rehabilitation of the Container Terminal, the interaction effects were simulated conservatively by means of horizontal subgrade reaction coefficients that were converted into equivalent spring constants. A detailed discussion of the results is provided by others (Rodríguez et al, 1996).
