## SEISMIC RESPONSE, EVALUATION, AND RECONSTRUCTION OF THE DVA SEPULVEDA CAMPUS FOLLOWING THE 1994 NORTHRIDGE, CALIFORNIA, EARTHQUAKE

Jeffrey R SOULAGES<sup>1</sup>, James O MALLEY<sup>2</sup> and Raymond S PUGLIESI<sup>3</sup>

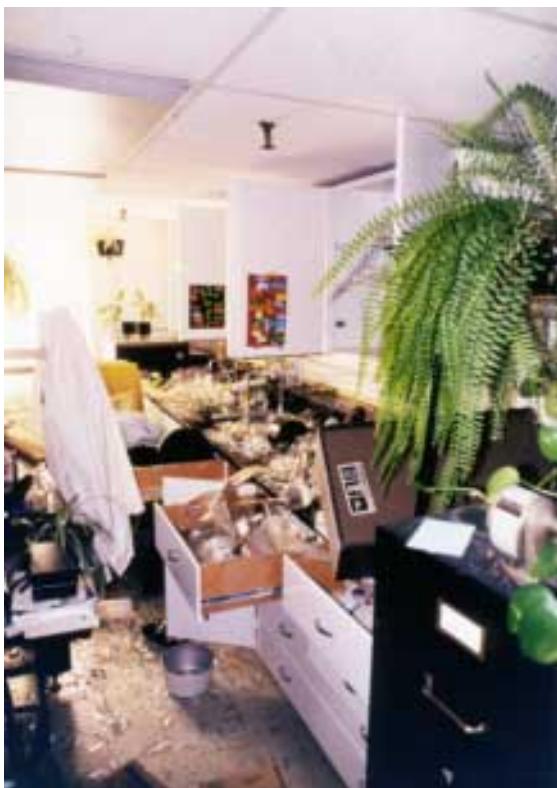
The buildings were yellow-tagged for a variety of reasons. Two were trailers that had fallen off their supports. Four were wood-framed residential structures that had lost their chimneys. Three had extensive cracking and damage to contents (see Figure 1). The last two, however, had more significant damage.

**Figure 1:** Left photo shows typical earthquake damage to contents in laboratory space.

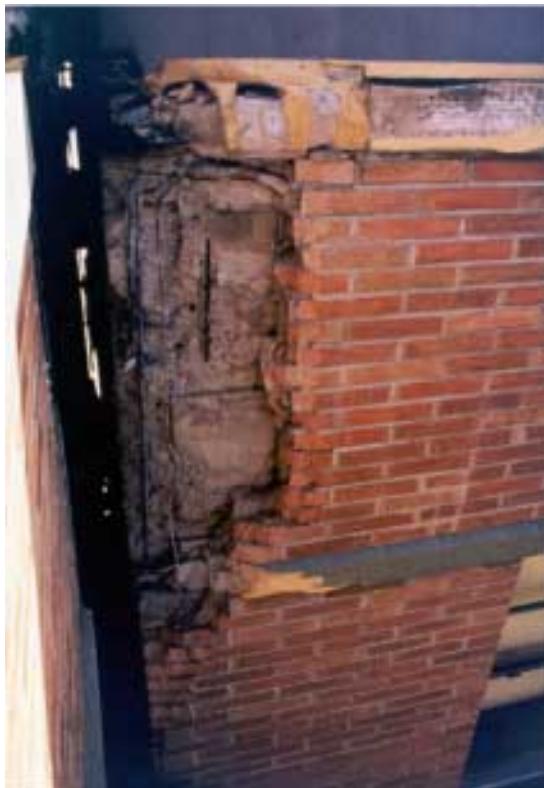
Building 3, the largest building at the medical center and the main hospital, suffered the most extensive and significant structural damage. It was a 6-story reinforced concrete shear wall structure with several wings separated by joints. Extensive cracking of the concrete shear walls and floor diaphragms, pounding damage between adjacent wings, and spalling of coupling beams over corridors were noted (see Figure 2). Most significantly, one of the building wings had rotated at the base away from the main building causing a permanent offset of over 8 inches at the roof.

**Figure 2:** Right photo shows spalling of brick veneer due to pounding between wings at Building 3.

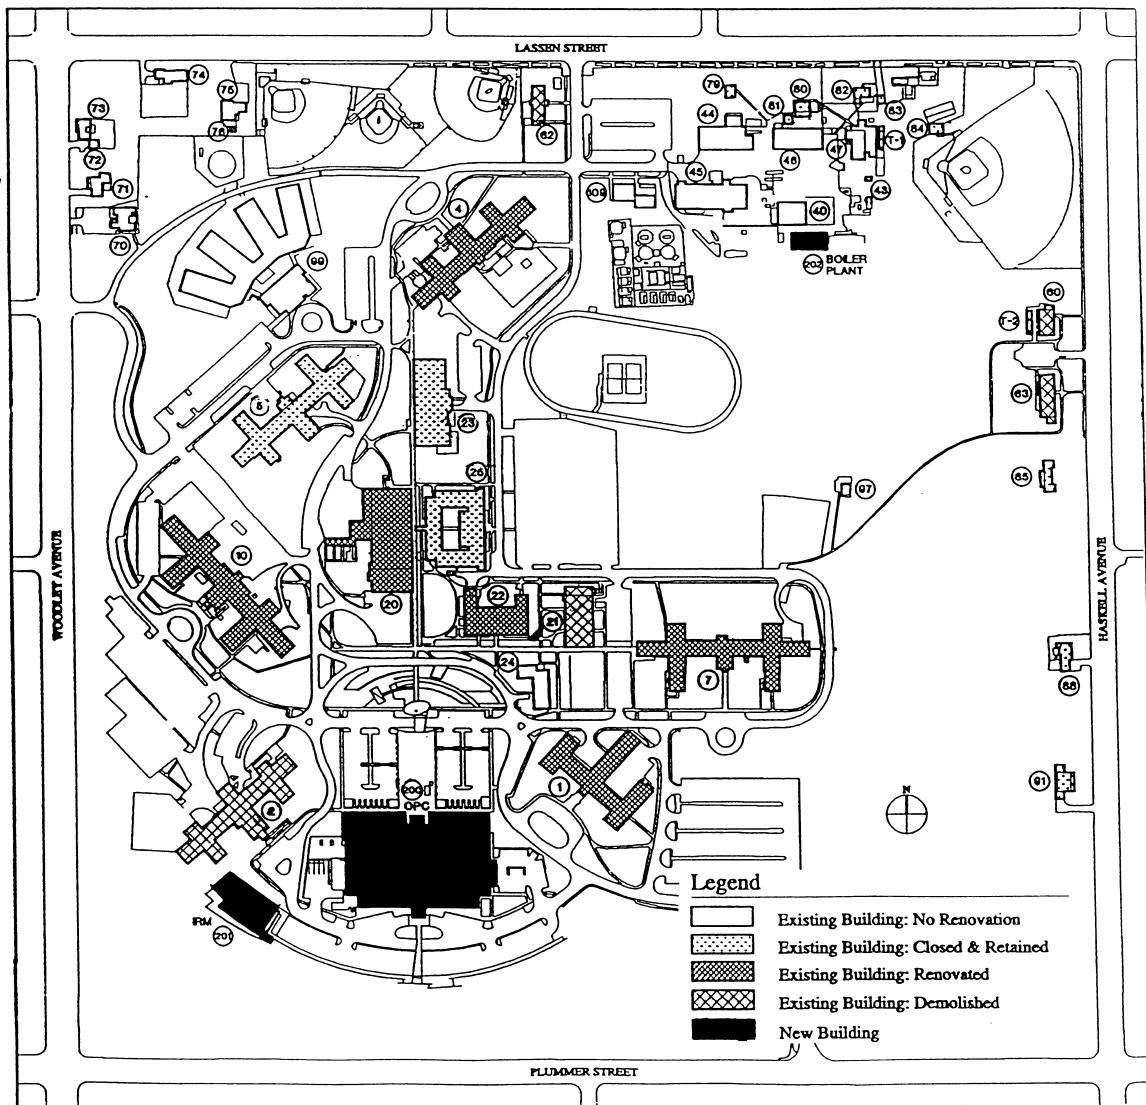
**Figure 3: Map of VA Sepulveda Campus with results of Damage Assessment Report.**

The complete team recommendations were made in five major categories in order to completely address all the work required for the future (see Figure 3):

- Buildings to be demolished and replaced
- Buildings to be upgraded in the short term (within 5 years)
- Buildings to be upgraded in the intermediate term (within 10 years)
- Buildings to become unoccupied and eventually demolished
- Buildings to remain as-is
