DISTINGUISHING BETWEEN EARTHQUAKE DAMAGE AND OTHER CONDITIONS

Kent K SASAKI¹ And Terrence F PARET²

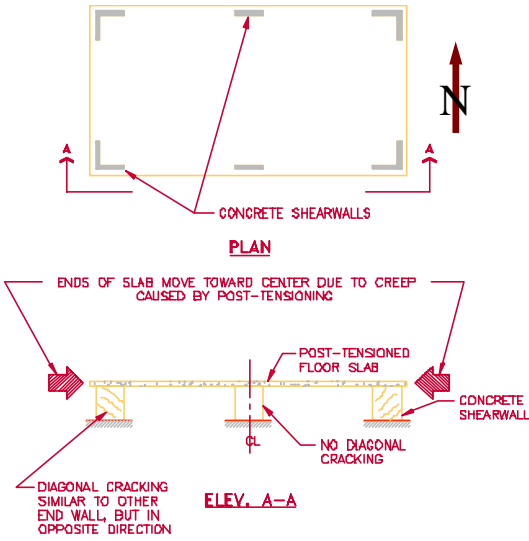
Figure 1

engineering mechanics. To return to a typical example of a post-tensioned structure from the 1960's, and setting aside the fact that cracking in the pattern shown (Figure 1) regularly occurs in similar structures in non-seismic regions, it is difficult indeed to conceive of how an earthquake could have caused these cracks. The pattern of diagonal cracks in the wall on the west end of the frame line is consistent with a horizontal force toward the east, while the pattern of diagonal cracks in the wall on the east end of the frame line is consistent with a horizontal force toward the west. The most rational explanation for each of these walls having cracked in a diagonally symmetric pattern is that they cracked in response to the post-tensioning induced shortening of the slab and prestressed "T". The absence of cracking in the wall near the centerline of the structure also attests to the absence of any relationship between the observed cracks and earthquake shaking. Only shortening of the slab could have left the end walls cracked as they have, and have left the center wall uncracked.

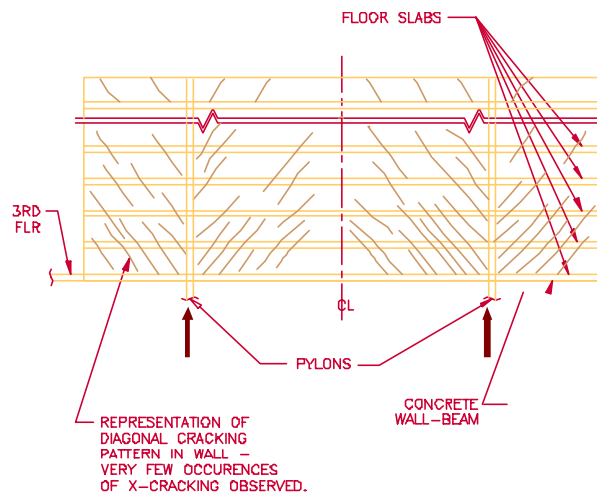
As another example of non-earthquake related splayed cracking in walls, Figure 2 describes a multi-story wall-beam supported vertically at approximately two quarter-points by reinforced concrete pylons and cantilevered beyond. The openings in the wall-beam, which are doorways, are not shown in the figure. The wall-beam also resists lateral forces above the third floor, but transfers them through the third floor diaphragm to other walls. The crack pattern observed after the Northridge earthquake --- splayed about each pylon and symmetric about the wall centerline --- is also shown in the figure. The original post-earthquake investigators --- seeing extensive diagonal cracking --- quickly concluded that extensive damage had been caused by the earthquake. The investigator then confirmed this finding via a response spectrum analysis (RSA) of a coarsely meshed finite element model, which showed that higher shear stresses generally occurred in the lower floors and nearest the pylons. However, the investigator failed to recognize among other things that a response spectrum analysis cannot predict crack orientation since RSA turns all stresses positive. Subsequent step-by-step static analysis involving both monotonic and superposition of opposite-direction monotonic loading demonstrated what is intuitively obvious --- the crack pattern observed is unrelated to horizontal loading. Instead, the pattern of diagonal cracks results from vertical forces due to gravity, concentration of gravity-induced stresses in the lower stories as a result of construction sequencing, and substantial upward redistribution of gravity-induced stresses as the wall in the lower stories cracked.

Figure 2: Elevation of Wall-Beam (not to scale)

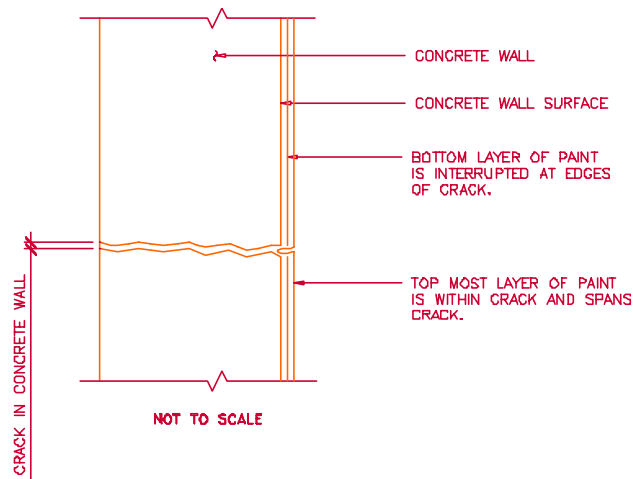
Figure 3: Wall Section - Paint within Crack

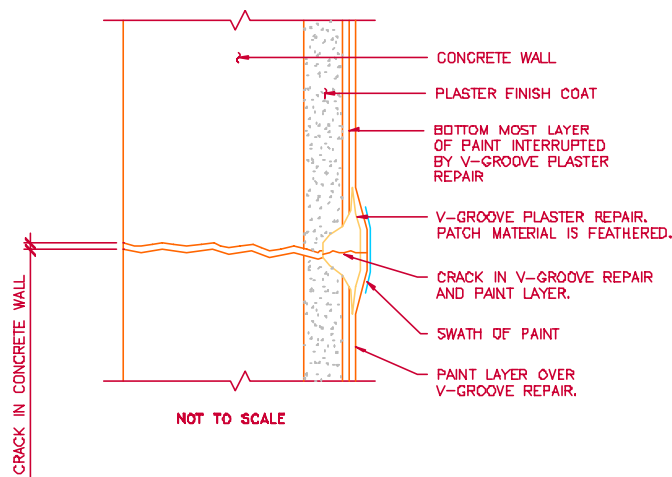
Figure 4: Wall Section - Multiple Cosmetic Repairs
