THE JANUARY 25, 1999, EARTHQUAKE IN THE COFFEE GROWING REGION OF COLOMBIA: ACCELEROGRAPHIC RECORDS, STRUCTURAL RESPONSE AND DAMAGE, AND CODE COMPLIANCE AND ENFORCEMENT

Luis E GARCÍA¹

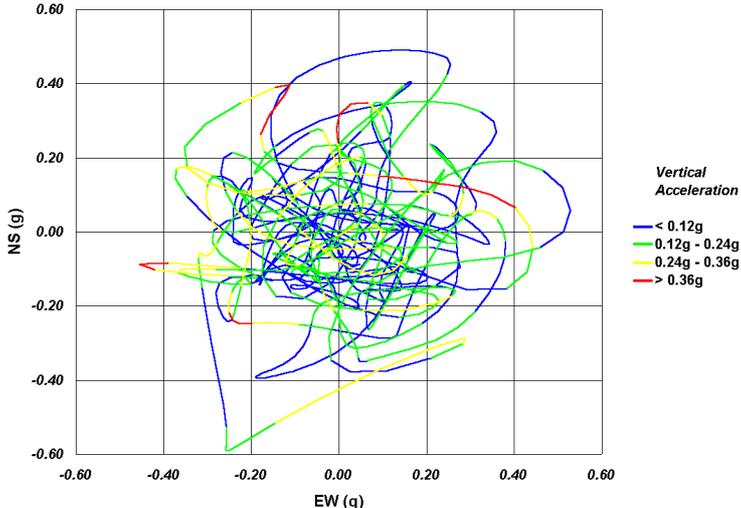
Figure 4 – Universidad del Quindío (Armenia) site accelerograph shown in plan view

The two horizontal components of the Universidad del Quindío accelerographic record are plotted together in Figure 4, with the corresponding vertical acceleration is described using a color code. It is possible to observe

that in some instances the two horizontal peaks occur simultaneously, and are accompanied by a very strong vertical acceleration. The acceleration response spectrum is shown in Figure 5. A high content of short period components can be observed. The EW component peaks at a vibration period of 0.25 seconds and the NS component at 0.56 seconds. The displacement response spectrum, shown in Figure 6, flattens at a period of approximately 1 second. The energy spectrum, Figure 7, shows characteristics periods of the order of 0.5 - 0.6 seconds for the horizontal components, and of 0.25 seconds for the vertical component. The Fourier spectrum, Figure 8, just confirms these observations.

The observed damage is consistent with age of construction, structural systems employed, and type of strong ground motion. The type of strong motion as depicted in Figure 4, with very strong accelerations in all three components, preclude any chance for unreinforced masonry to survive the earthquake. The short period waves containing the majority of the energy, accompanied by large vertical accelerations, is the worst combination for unreinforced masonry and low-height poorly constructed buildings. With 73% of the red tagged buildings being one and two-story buildings and 89.5% percent of the red and orange-tagged structures consisting of residential buildings: the unreinforced masonry is the culprit of most of the victims and observed damage. The sample of

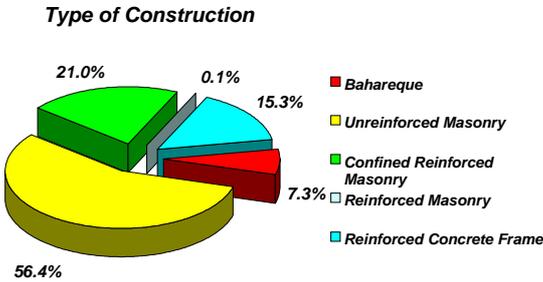
Figures 15, 16, and 17 show the distribution by type of construction, building use, and age of construction, for a 12,454 buildings sample in the center part of the city of Pereira. It is important to note that 56.4% of the buildings correspond to unreinforced masonry construction, and that 91.7% were dwellings. Only 11% of the buildings were built after the 1984 code was enacted.

Figure 15 – Type of construction for a 12,454 buildings sample in Pereira

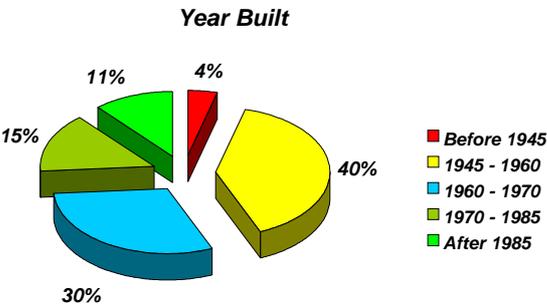
Figure 17 – Age of construction for a 12,454 buildings sample in Pereira

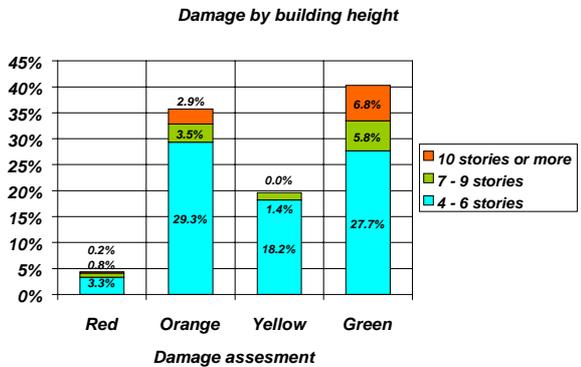
Figure 18 – Tagging of the 12,454 buildings by height for buildings 4 stories and taller

The results of the assessment of the buildings after the earthquake was performed using red tags for buildings either collapsed or with severe structural damage, orange tags for buildings with reparable structural damage or severe non-structural damage that required building evacuation while repair were performed, yellow tags for buildings with easily reparable damage that could be performed with the building occupied, and green tags for minor damage. Figure 18 shows the tagging results for the same building sample in Pereira.

buildings 4 or more stories of height confirms that better quality construction was employed: 40% of the sample was green tagged, less than 5% of the sample was red tagged, and red tagged buildings higher than 6 stories comprise only 1% of the sample. Having 55% of the buildings 4 stories and taller tagged orange and yellow just points toward the problems of employing brittle unreinforced masonry partitions and façades.
