SEISMIC BEHAVIOR AND DESIGN OF SMALL BUILDINGS IN CHILE

Joáquin Monge E. (I)

Synopsis.-

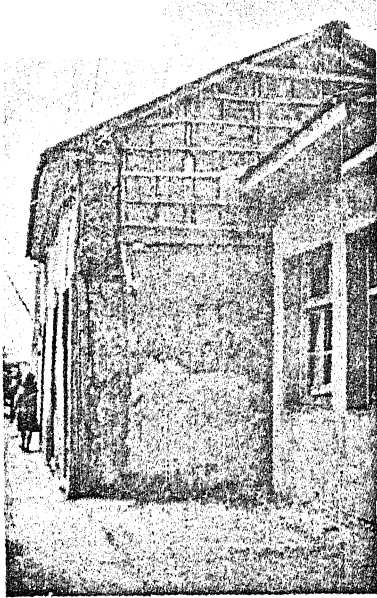
Even for weak earthquakes of intensity VI to VII, the upper parts of facade walls show horizontal cracks at the level of wooden lintels or ceilings leading in some cases to displacement over the lower part of the walls, Fig. 1. For higher degrees of intensity the upper parts of walls may tilt or fall down.

Fig. 1.- Serena, Sept. 26, 1967 Earthquake, MM VI-VIII. Adobe house.

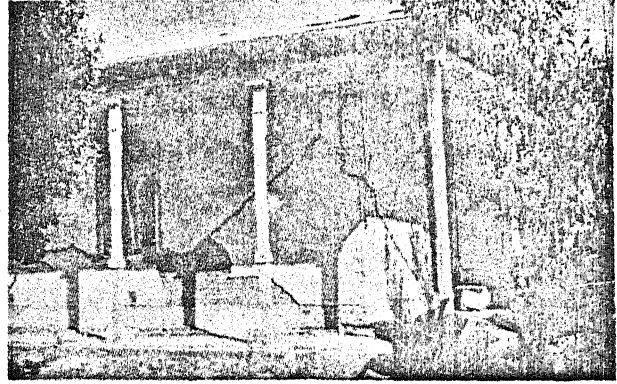
The weak connection between perpendicular walls resides only on the overlapping of adobes. With degree VI to VII, vertical cracks may appear, Fig. 2. With higher intensities these cracks are widened and each wall vibrates as a cantilever wall. In that condition, horizontal cracks appear, ordinarily near the base of the wall, causing the upper part to tilt or even fall down. In Fig. 2, the bottom of the walls is built of brick masonry and a horizontal crack appears just in the limit between bricks and adobes.

It is usual to find diagonal cracks that start from the corners of windows, upwards or downwards. This occurs mainly at the corners of houses and leads to a higher degree of damage for houses located at the corners of blocks. Fig. 2 shows this kind of damage.

Fig. 2.- La Ligua, March 28, 1965 Earthquake, MM VIII-IX. Old adobe hospital.

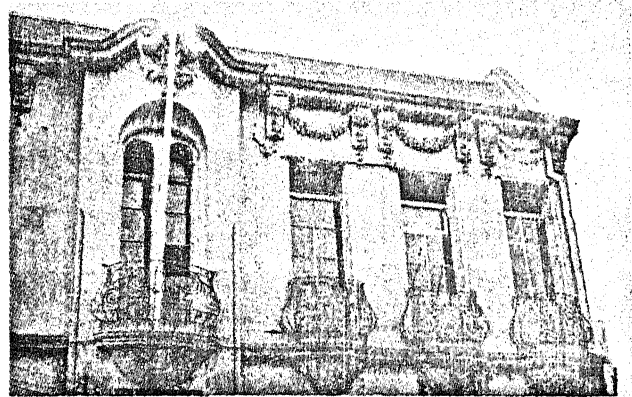
Most of buildings of this type are one-or two-story buildings. They behave slightly better than adobe, graph 4, but they are still very dangerous for degrees of intensity VIII or higher. It was prohibited by the 1940 building code after the 1939 Chillán earthquake. They have usually wooden floors and roofs, but in some cases there is a reinforced concrete slab at the floor of the second story. Figure 3 shows damage on a two-story building in Concepción, after the 1960 earthquake. Horizontal cracks appear at various levels, specially at the level of lintels. The upper parts of walls may be displaced, tilted or collapsed for degree VIII or higher. Diagonal cracks starting from the corners of windows are also common.

Fig. 3.- Concepción, May 21, 1960 Earthquake, MM VIII. Two-story unreinforced masonry building.

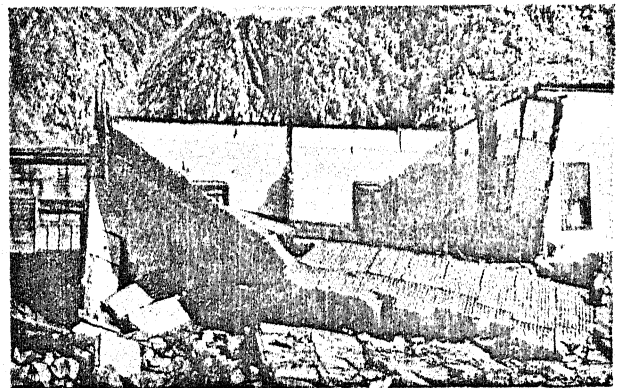
close enough. Other weak point of these buildings is the connection between perpendicular walls. They are made by overlapping the horizontal wooden members and by nailing them together. In figure 4, the failure of connections between walls led to a complete destruction.

Fig. 4.- Tocopilla, Dec. 20, 1967 Earthquake, MM VII-VIII. Wooden framed house with heavy fill.

Wooden frames should be improved by strengthening some connections. Nailed connections of diagonal members, joints of perpendicular partitions and anchor of frames to foundations are weak points of these structures. Bolted joints with steel plates could prevent most of actual damage. Brick or concrete block masonry, with reinforced concrete columns and tie beams, could be strengthened by a good detail of bars and by a good inspection at the site.

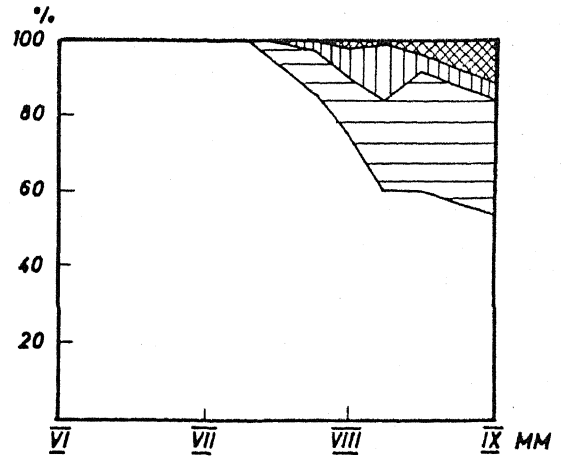
Graph 1- BRICK MASONRY, REINFORCED

Buildings of this type are considered earthquake-resistant and designed for a seismic coefficient 0.10 to 0.12. Graph 1 shows the statistical behavior.

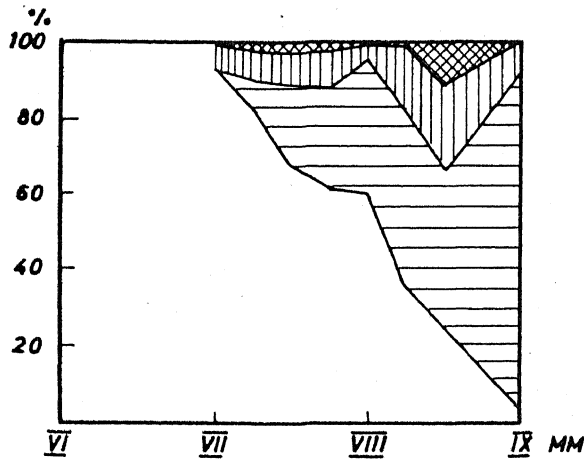
Graph 2- WOODEN FRAME WITHOUT FILL

The behavior of this type of construction is effective against strong earthquakes, as shown in graph 2. It presents, however, some weak points. One of these is the insufficient connection between perpendicular partitions, leading in exceptional cases to failures similar to that shown in figure 4. Other one is the weathering of the wooden piles, when used. Lack of appropriate maintenance is also an important factor of damage. Generally speaking, the frames show the kind of damage described in the former paragraph but in a minor degree.

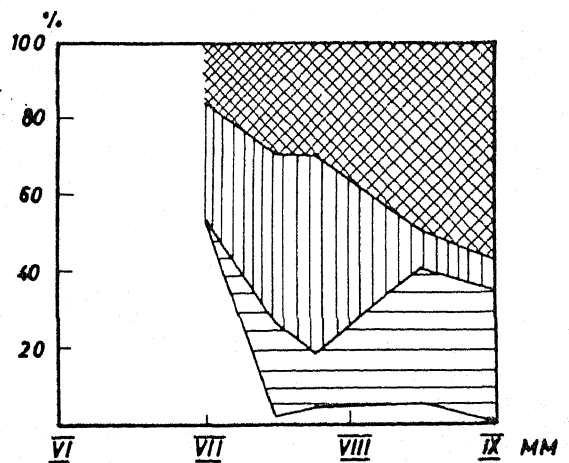
Graph 5- ADOBE

The behavior of adobe buildings during earthquakes is very poor, as shown in graph 5. After the disastrous 1939 Chillán earthquake, where most of the deaths were caused by the destruction of adobe houses, the committee in charge of the building code (4) considered their prohibition. However, it was the prevailing opinion at that time that no other cheap material was available for families of low resources and adobe construction was allowed with a limit of 3 meters in height for adobe houses.

Adobe buildings should be prohibited, because their poor seismic behavior is a menace to life and property. The present economical conditions are different from those prevailing in 1940. Adobe construction is no longer cheap, because the cost of labor in agricultural zones is now close to the cost of labor in industries. Other construction types, such as wooden frames, have an advantage from economical considerations and their behavior during earthquakes is uncomparably superior.
