REPAIRS ON POWER HOUSE AND BOILER SUPPORT STRUCTURE DAMAGED BY
1965 EARTHQUAKE. VENTANAS 115 MW STEAM ELECTRIC STATION (CHILE)

By: Santiago Arias (I), Víctor Arze (II) and Jaime Bauzá (III).

**VENTANAS STEAM ELECTRIC STATION
SEISMIC ANALYSIS**

1965 Earthquake Damage

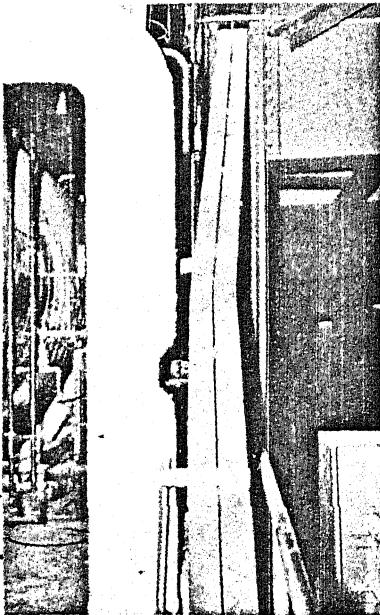
Photograph No 3 Buckled diagonal in the Power House. The

At the Power House, nearly 50% of the diagonals located above operating floor level were damaged, by buckling in the minimum flexural rigidity plane. An aspect of this can be seen in Photograph NQ 3.

As the bracing system is damaged, experimental period values are higher than those corresponding to the undamaged structure. Under these circumstances, the structure's real condition had to be considered in the theoretical calculations to have a realistic comparison.

This was obtained by varying the damaged diagonals' degree of effectivity, acting on their area participation coefficients. It was determined that the damaged bracing system's effectivity degree is 25% of the original value, percentage for which the experimental and theoretical periods were comparable.

The dynamic study showed that in the probable seismic loading scheme the ultimate loads of certain diagonals were exceeded, there being a close correlation between these results and the building's damages.

oscillations damaged the thermal insula-
 tion lagging on an adjacent pipe.

In any case, the Power House will be provided with an additional bracing in the central bay of the larger side's perimetral bents, as they do not have an adequate antiseismic structural design due to their great length with bracing in the end bays only.

It was determined that the strengthened bracing systems should resist the loads represented in the shear diagrams with a minimum safety factor of 1.75, referred to their ultimate loads.

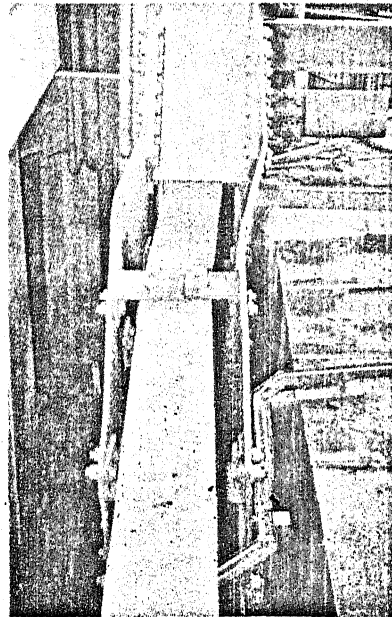
Photograph No 4 Boiler Structure diagonal connection at

On the Boiler Structure damages were localized in the diagonals' connection system, with 3 main joints failing due to lateral displacements. In addition, 30% of the friction-type bolts slipped and went into bearing when their slip resistance was exceeded. Photographs NQ 4 and NQ 5 show 2 main joint damages.

The diagonal connecting joints' lateral stability was also analyzed, considering them as elastic supports with properties defined by the concurring elements' characteristics. The maximum diagonal axial loadings compatible with the connections' lateral resistances were calculated, finding insufficient transverse support capacity precisely in the damaged joints.

The bracing connection study showed that their load transfer capacity is lower than the connected members'. This situation is critical for the north and south bents' joints at elevations 131' - 11" and 75' - 5", which have a low lateral stiffness permitting their transverse displacement, due to the axial load shear component, reducing the connected diagonals' capacity. The dynamic loading scheme shows that these joints exceed their ultimate load, and furthermore, certain bolts surpass their slip-resistance, confirming the boiler's damages.

elevation 75'-5". The girder's lateral
 deformation and bent gusset can be seen.

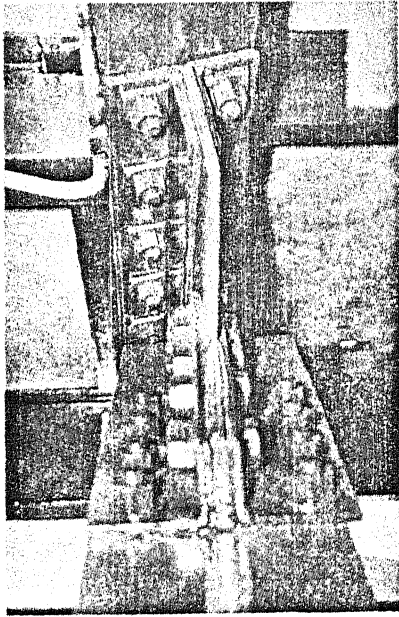
Photograph No 5

Boiler Structure connection detail at elevation 131' - 11". Notice torsion of top girder flange and bent gusset.

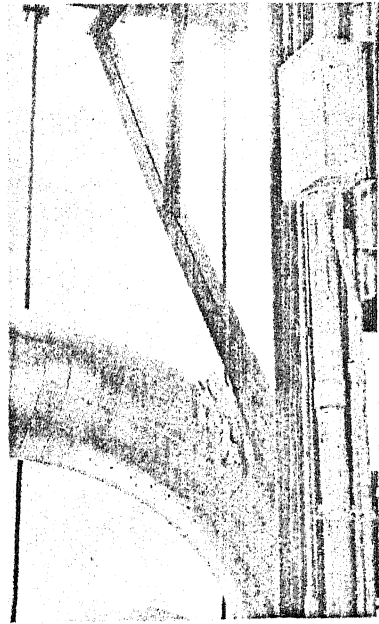
Photograph No 6

Piping, supported by pipe hangers to allow thermal expansion, oscillated violently, banging against adjacent members because they did not have special seismic action control devices, there being only restraints for maximum displacements. These impacts damaged the lagging without affecting the pipes themselves. Photograph NQ 6 shows typical damage.

Damage on Main Steam Pipe lagging at elevation 163' - 9" due to banging against knee brace.
