SEISMIC FAILURE AND REPAIR OF AN ELEVATED WATER TANK

Elías Arze (I)

Bueras Water Tank, a structure 41.6 m. in height with 4000 m³ capacity, located at Valdivia, Chile, suffered spectacular damages during the earthquakes of May, 1960.

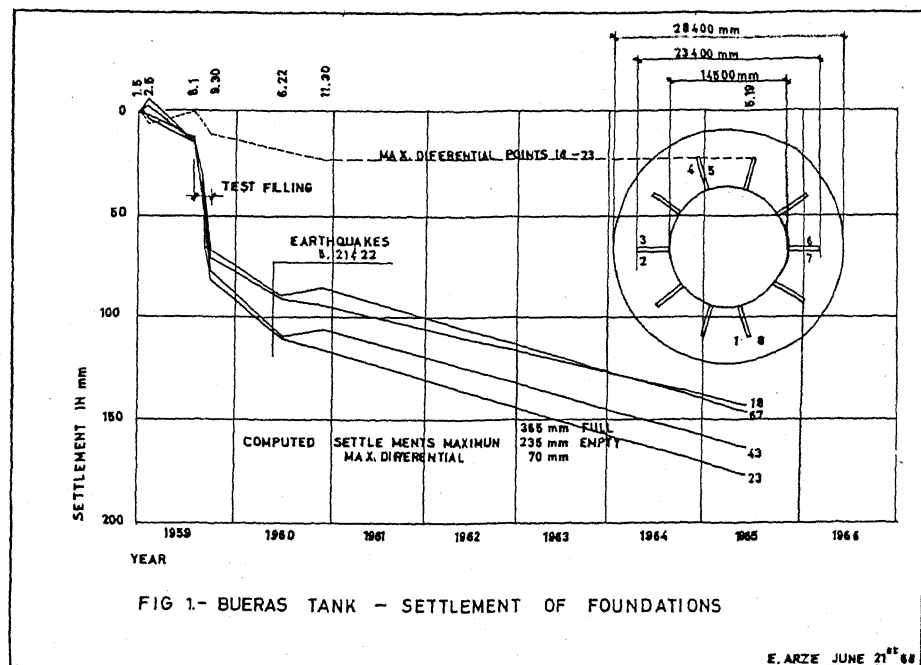
Settlements were measured on eight points distributed around the base, during a seven-year period, from October 31st, 1958, to May 5th, 1965. Figure 1 shows the location of control points and the time settlement curves. It can be seen that the tank sank to a maximum of 17.9 cm. in 1965, but that differential settlement remained constant at 2.35 cm., during the last five years of control. It is also noted that approximately 1/3 of the settlement took place during the 34 days the tank was filled with water in 1959. The 1960 earthquakes did not apparently influence the rate of movement, except for minor irregularities probably due to variations at the reference points. At the time of the last control, the phenomenon was still in progress, at a rate of 10 mm. per year.

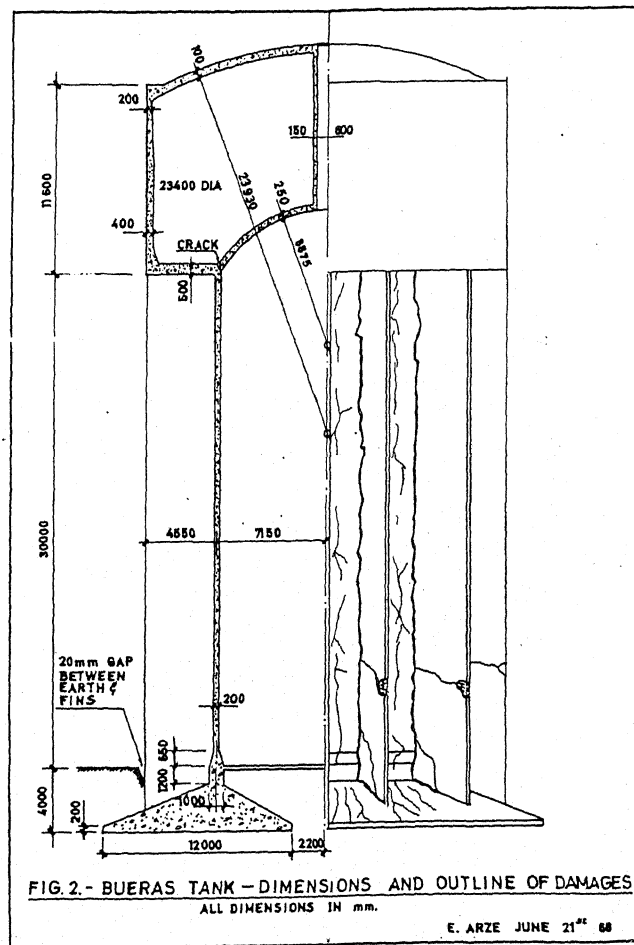
Damages suffered by the tank's structure are shown in Figures 2 and 3 and are described below:

- a.- Small cracks inside the upper tank.
- b.- A large number of vertical, horizontal and diagonal big cracks in the tower mantle and fins, that go through the wall thickness and leave the reinforcing bare.
- c.- A large number of horizontal cracks in the radial fins, at approximately 5 m. from the ground, coinciding with a construction joint and a zone of heavy splicing of vertical reinforcing.
- d.- Vertical cracks separating the fins from the mantle.
- e.- Deep diagonal cracks at the lower part of the fins and separation between them and the foundations, with severed steel bars and appreciable offset; and

Radial cracks on the footing's upper face.

Computations to determine the ultimate strength of the structure and its main components were then made, on the basis of standard theory and the strength of materials controlled during construction. The following main conclusions were reached (see Fig. 2):

- a.- The foundations did not have adequate capacity for negative bending moments due to vertical loads.
- b.- The weakest sections of the tank were the vertical joints between the fins and the mantle. Their ultimate bending moment capacity is reached with horizontal acceleration between 0.03 g. and 0.05 g.; and
- c.- Should the structure maintain its integrity, ultimate capacity of the full tower section would be reached with seismic accelerations of 0.44 g. for the empty tank and 0.15 g. for the full tank.

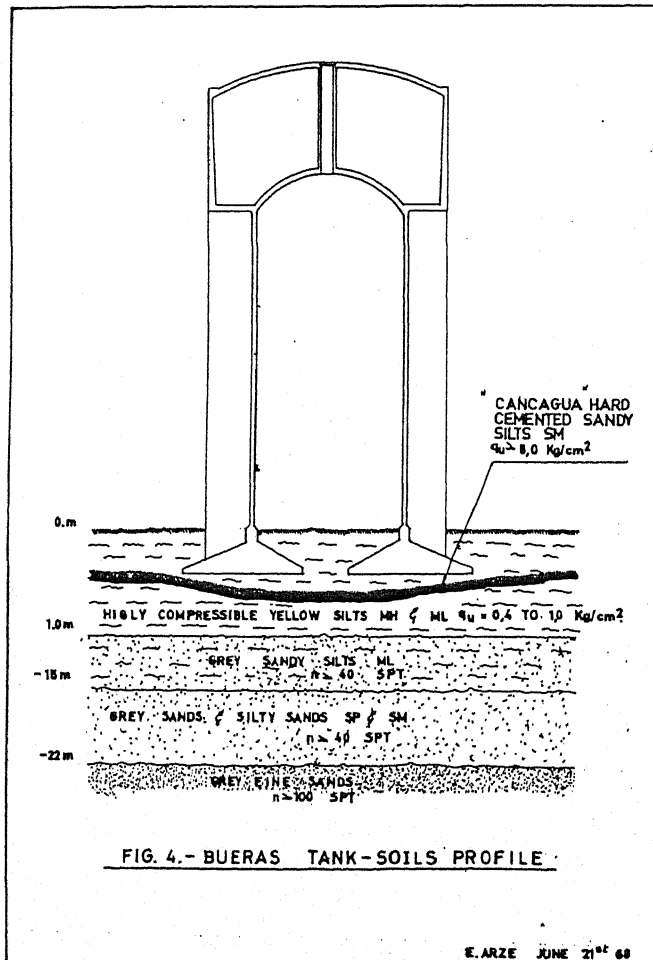
Figure 4 shows a typical soil profile under the tank; three different layers are clearly discernible:

- a.- Elevation 0 to -10 m.:
Highly compressible yellow silts, classification MH and ML with some organic matter. Low to medium consistency, high void ratio and sand content below 10%. Interposed in this stratum, immediately below the footing, there is a hard layer of cemented sandy silt of 0.8 m. average thickness, classification SM, of very good bearing capacity, locally known as "Cancagua".
- b.- Elevation -10 to -15 m.:
Hard grey sandy silts of low compressibility, classification ML, sand contents from 12% to 45%; and
- c.- Elevation -15 to -22m.:
Grey fine dense sands and silty sands, SP and SM.
