Observation of Damages of Industrial Firms in Niigata Earthquake

The authors report the damages of plants and factories in Niigata Earthquake 1964. They refer to the important design consideration which were obtained through their observation.

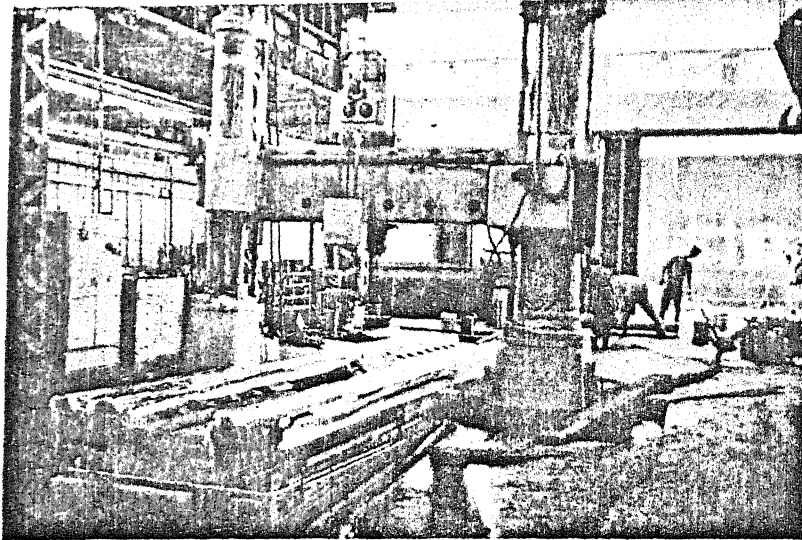
Two types of damages were observed. One was caused by an irregular subsidence, and another by water and mud floodings. A jig borer, machine weight 77 ₪ and total weight 270 ₪, supported by 42 frictional piles, tilted in 1.9° to the river. The reason had been considered as the irregular settlement caused by an irregular distribution of its weight (photo 1). Supporting capabilities of the piles may not be equal at the both ends, because the soil condition of the river side is worse. The tendency of subsidence of the soil was also the same. Planers also tilted like the jig borer.

PHOTO 1. JIG BORER, SETTLED TO THE RIVER SIDE.
AN EXAMPLE OF DAMAGES OF LARGE SIZE MACHINE TOOLS.
ITS TABLE WAS REMOVED.

Liners were inserted under machines, and the gaps were filled with mortar. At first the replacement of the foundation was considered, but there has been no report.

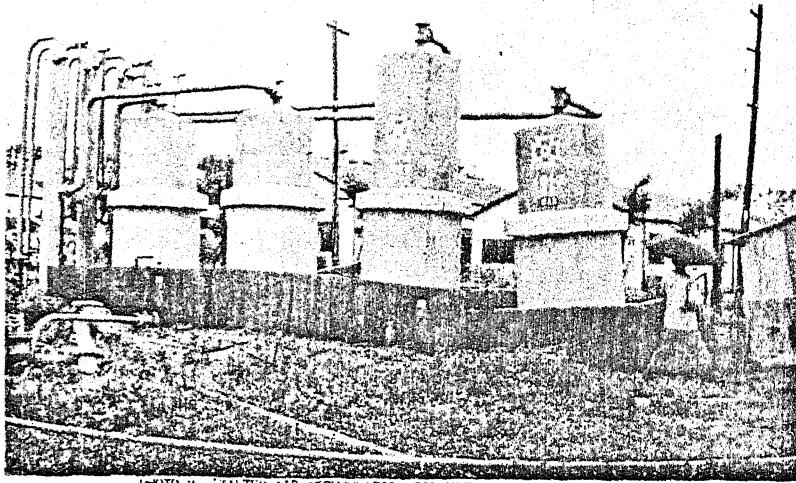
Their centres of gravity are so high that they were not keeping upright, when the soil at their feet was liquified (photo 2). The heavier ones are supported by piles usually, so they could escape from the subsidence effect. The lighter ones were sometimes pulled by the other heavier structures through pipings. The way of repairing was to insert liners between its bottom and foundation and to fill mortar in the gap. But some of them are left to be inclined, and others were dismembered. The reactors, some types of which were sensitive to their leveling, were carefully checked.

PHOTO 2. TILTED AIR ACCUMULATORS FOR NATURAL GAS WELL.

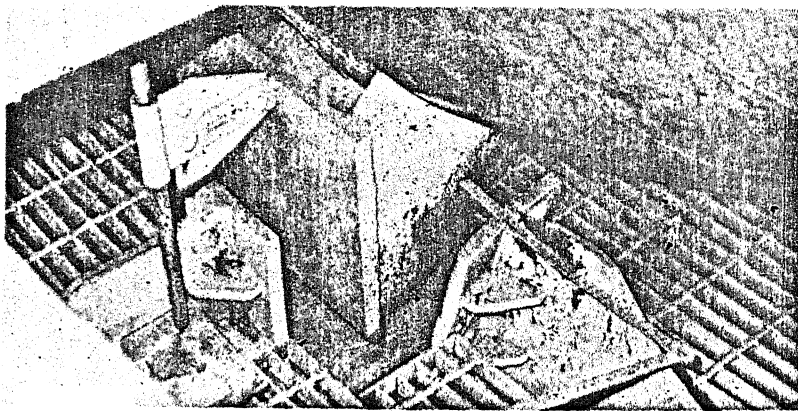
An boiler drum hung by rods swung and hit the stopper strongly (photo 3). The gap between its stopper and drum is 90 mm. The

natural frequency of this hung drum might be 0.25 c/s, but the authors can not tell exactly, because the down-commers and main steam pipings are connected to the drum.

PHOTO 3. STEAM DRUM, HITTED THEIR STOPPER.

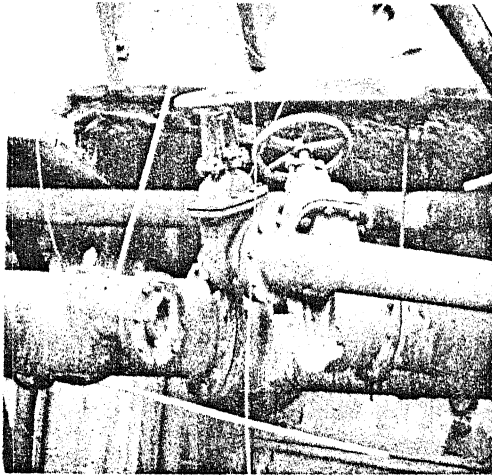
An emergency diesel engine was turned over by the liquifaction of its footing soil. This caused the result that the fire of a crude oil storage could not be suppressed at the first stage. Pumps and other equipments were pulled by pipings or crashed by collapsed structures. Iron casings of valves were cracked by the deformation of pipings at many places (photo 4).

✓ PHOTO 4. VALVE CASINGS WERE
CRACKED BY FORCES AND MOMENT
TROUGH PIPINGS

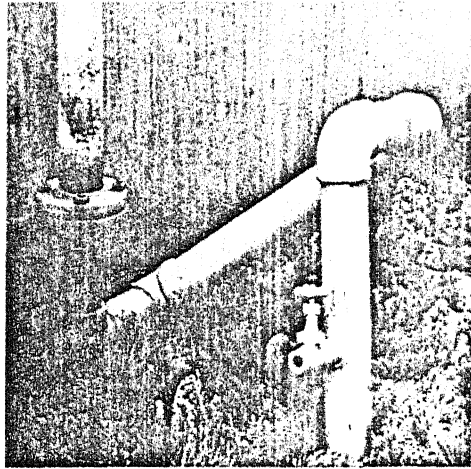
The flexible hoses connected to oil strages worked well, when they subsided in several hundred milli-meters. Only three screwed elbows inserted in a upright piping for foaming liquid endured 300 mm of the relative displacement (photo 5). It was observed that the fine thread

screws at fittings were pulled off without any damage of them. The outer ring of fittings may be expanded radially by a wedge action of thread surface under the pulling force. The strength of such couplings against the pulling force should be reconsidered.

✓ PHOTO 5. ELBOWS SAVED PIPINGS
FROM BREAKING.

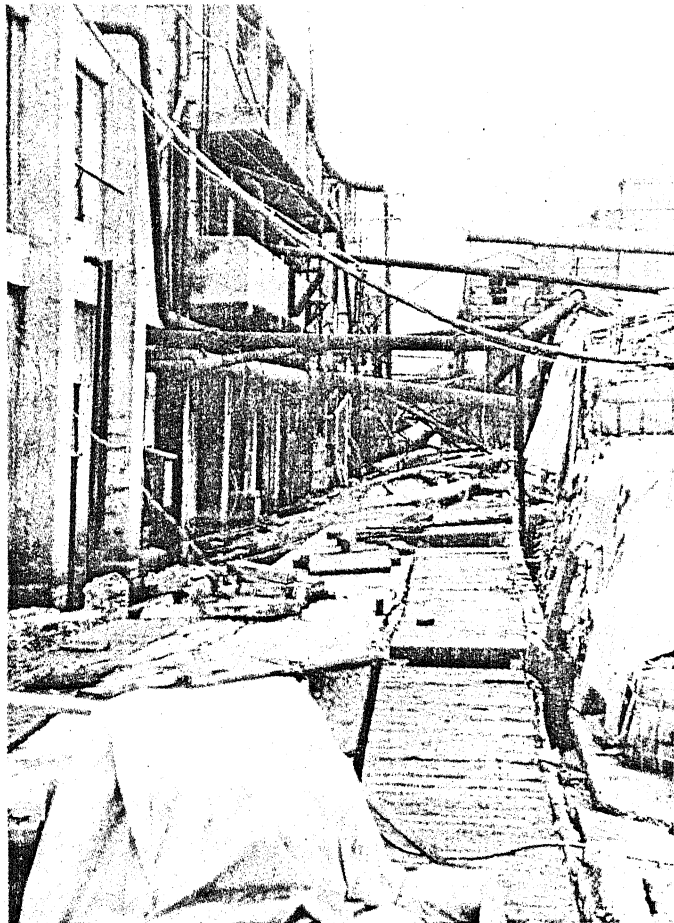
The resonance type rupture of pipings was observed at only one place (photo 6). An estimated natural frequency of this piping may be 3.6 c/s. The authors can not insist on its cause strongly, but the position of rupture is near the point at which the bending moment becomes maximum when it is supported freely. The authors have been engaged in the dynamic analysis of piping systems, but they could find no good example to prove it.

✓ PHOTO 6. DAMAGES OF PIPINGS, Z-TYPE PIPE WAS BROKEN
FROM WELDED JOINT. PIPING SUPPORT COLUMNS WERE
TURNED OVER

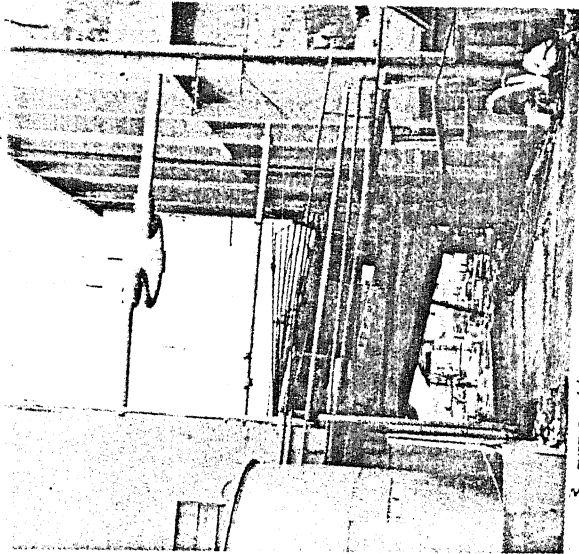
PHOTO 8. U-SHAPE LOOPS OF PIPING LINES HAD ENOUGH FLEXIBILITY TO AVOID THEIR BREAKAGES.

The second point is that the use of the piping bridge is recommendable. It is not good design that pipings are supported by individual supporting columns. At least the columns should be connected each other by the members other than pipings themselves. Even in this case, the relative motion of the two structures should be taken into account. And if necessary, pipings should be designed flexibly (photo 8).

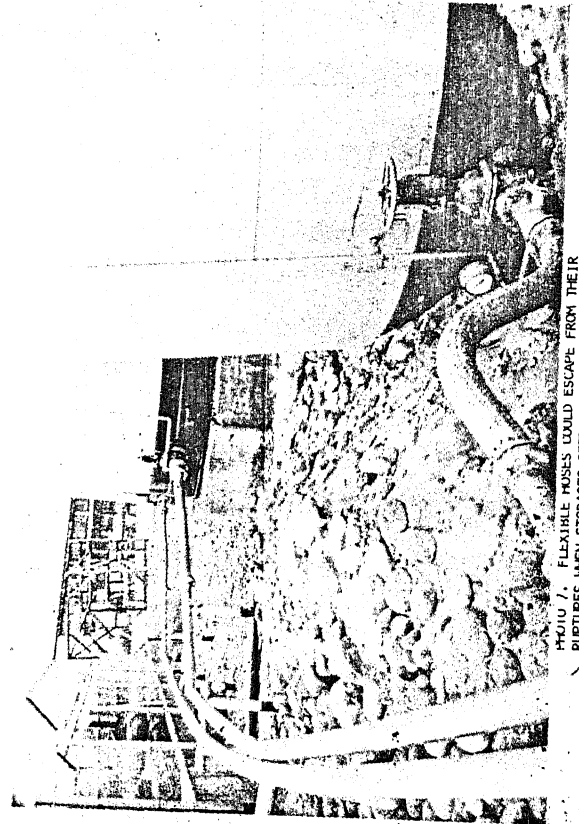
PHOTO 7. FLEXIBLE HOSES COULD ESCAPE FROM THEIR RUPTURES WHEN STORAGES SETTLED.

To prevent that such extra forces work on pipings, two points should be considered. The first point is that the piping which connects two different structures should be flexible enough. It should provide loop, flexible hose part or at least bends and the length enough to cover its rigidity (photo 7).

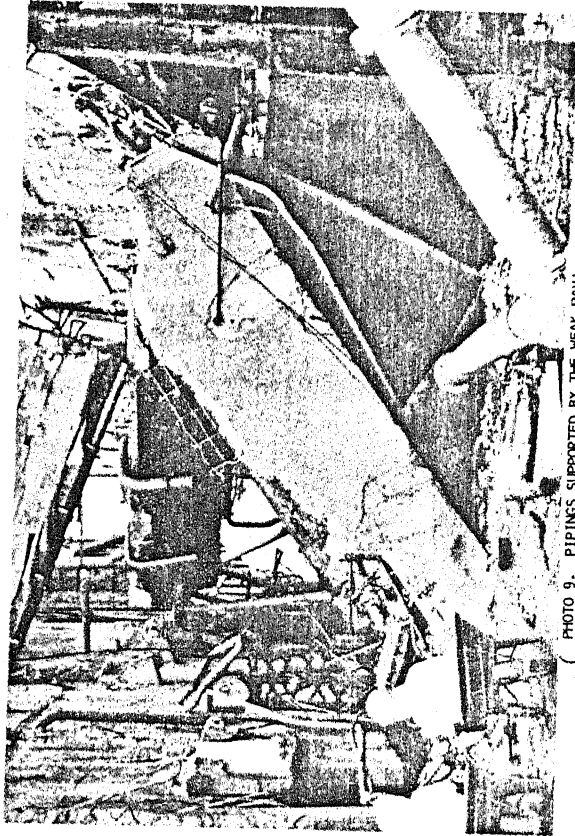
PHOTO 9. PIPINGS SUPPORTED BY THE WEAK PART OF BUILDINGS WERE CRASHED WITH IT.

Sometimes the part of buildings is designed not so strong as it may completely endure the strong earthquakes. If the designer of piping systems plans to use the building structure as piping supports, he had better to check how the building was designed (photo 9).

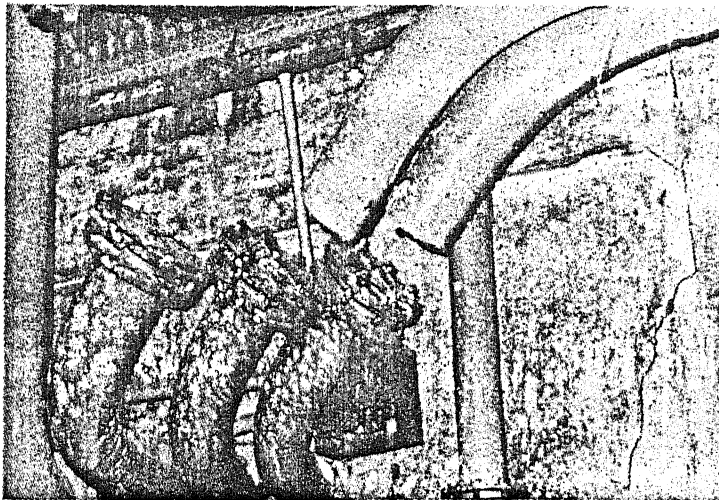
Pipe of poly-vinyl chloride is often used for low pressure steam and water, sometimes town gas. It is very brittle. They were cut off very sharply (photo 10). There was no report of the fire with town gas, but the use of poly-vinyl chloride, pipes for flammable gases should be restricted.

PHOTO 10. PIPINGS OF POLY-VINYLE CLORIDE WERE CUT VERY SHARPLY.

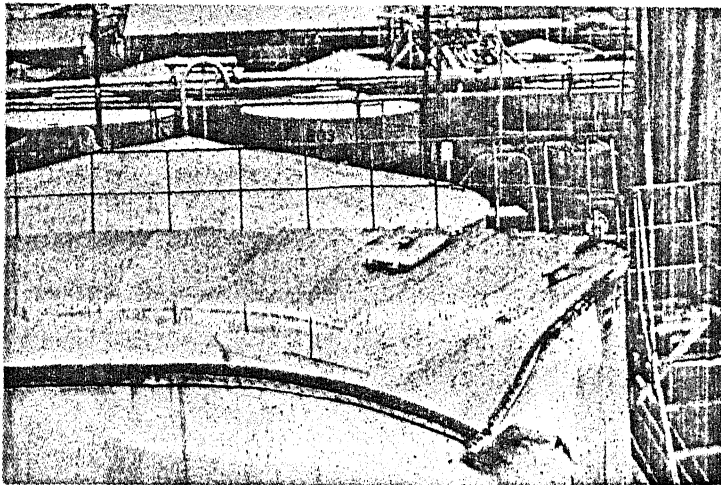
Three types of damages were reported on oil storages. One is the sloshing of oil. It made the floating roof swing or made break the fixed ceiling (fig. 3). The sloshed oil buckled the wall and ceiling, when oil level was lower than middle point (photo 11). This is the second type damage. The third type damage is the subsidence of its bed. The sloshing problems will be discussed later.

PHOTO 11. SLOSHING OF OIL MADE BUCKLE ITS STORAGE TANK.

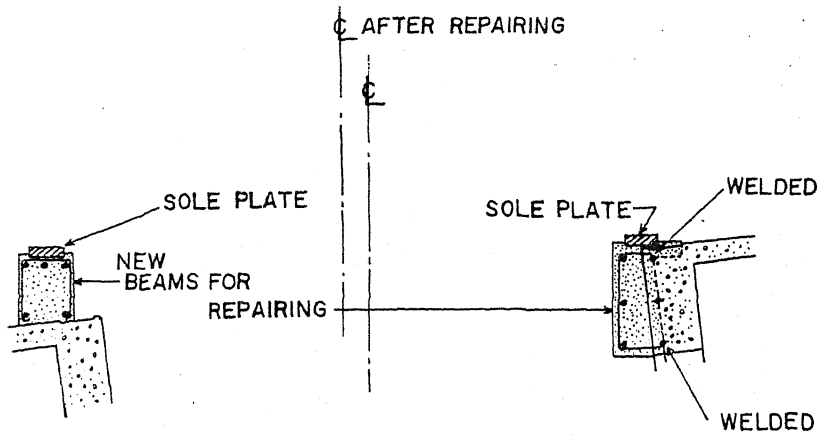
A train-type, long frame type machine in this area was a paper machine. The frame of the newest paper machine was inclined in the ratio of 600 mm to 80 m, and was cut partially. The plane gears, which were connected to a guide drum and a dryer, were disengaged each other. The amount of the off-centre of the each planes is 80 mm. This paper

machine was installed on the second floor of the reinforced concrete-building. The floor itself was inclined because of the irregular subsidence of its piled foundation. The power unit side was more settled than the other side. The way of repairing was dismembering and re-assembling after strengthening the beams and floor of the building (fig. 2).

FIG. 2 SCHEMATIC DRAWING FOR REPAIRING OF PAPER MACHINE FOUNDATION (BY COURTESY OF PAPER MANUFACTURING COMPANY).

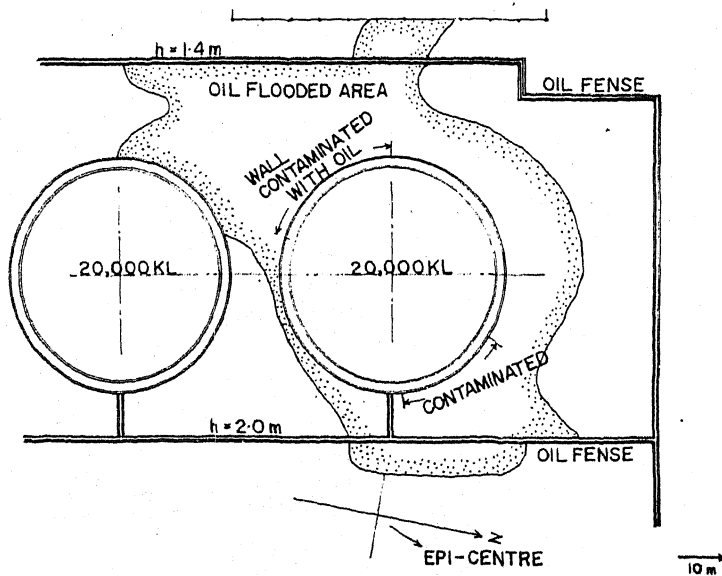
Oil was scattered very widely when it sloshed. In fig. 3 schematic view of heavy oil scattering is shown. Professor Yamamoto showed that shouting oil might reach at the point 31 m from the wall in the case of 20,000 kl storage. He assumed that the oil jet obtained the velocity of 14.5 m/s by the pressure 0.91 kg/cm² of sloshing waves.

FIG. 3 SKETCH OF FLOODED HEAVY OIL AROUND THE FLOATING ROOF TYPE STORAGE (AFTER YAMAMOTO).

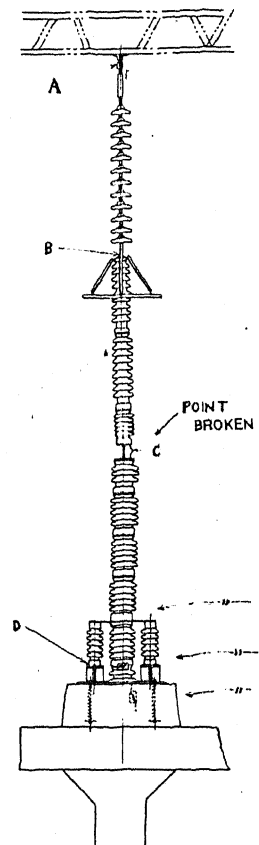
Self-standing type arresters, for 140 kV high tension lines, were broken at their feet. These arresters were mounted on the yard of a hydraulic power plant located in 140 km south-west of the epi-center. Fourteen arresters out-of twenty seven became the same condition (fig. 4). The ground of the yard is rather thin soil layer on bed rock, and an estimated seismic force was 50 Gal or so, but several plates of glass of windows on the generator room were broken. Then the authors estimated that a keen shock motion broke such brittle materials because of the wave transmission performance of hard rocks.

FIG. 4 BROKEN POINTS OF ARRESTERS FOR 140 KV HIGH TENSION LINE. (BY COURTESY OF RAILWAY ELECTRIFICATION ASSOCIATION)
