BEHAVIOUR OF TALL BUILDINGS DURING  
THE CARACAS EARTHQUAKE OF 1967

Synopsis

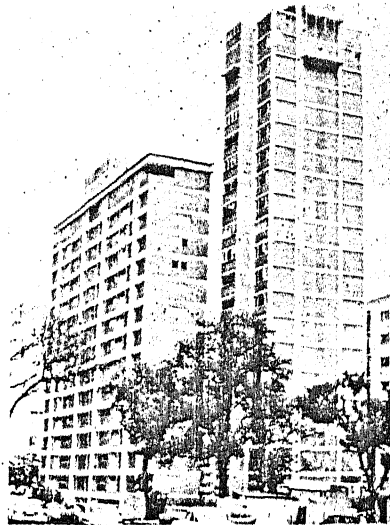
Fig. 7 - Petunia I and II

The dynamic analysis of Petunia II building (table I, ref. no. 8) performed considering the linear behaviour of a 11 degree of freedom system on an elastic foundation indicates that collapse by compression failure of the external columns occurs for a power spectral density of acceleration of about  $500 \text{ cm}^2\text{s}^{-4}/\text{Hz}$ .

The fact that Petunia II building (table I, ref. no. 8), having a coefficient of resistance of 0.10, underwent important damage can in part be explained by its cantilever behaviour which corresponds to a lower ductility than the one corresponding to frame behaviour.

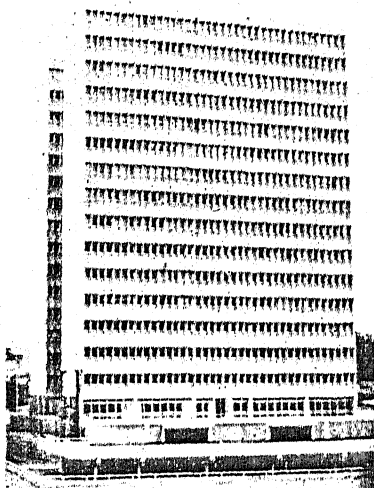
Fig. 10 - Mene Grande

For the Residence Union and Mene Grande buildings (cases 41 and 47) which are H-shaped in plan, the torsion vibration mode was detected. This mode was particularly obvious in Residence Union.

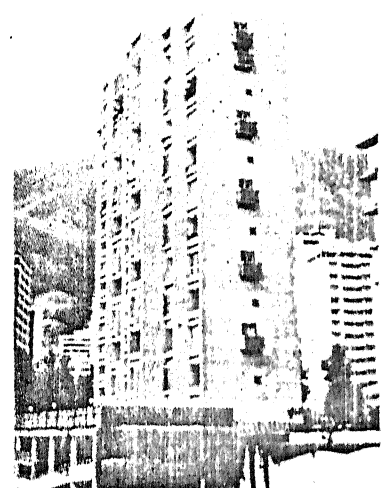
Fig. 11 - Plaza Uno

Particular reference is due to the very good behaviour of Plaza I building (table IV, ref. no. 42) having a reinforced concrete shear walls structure.

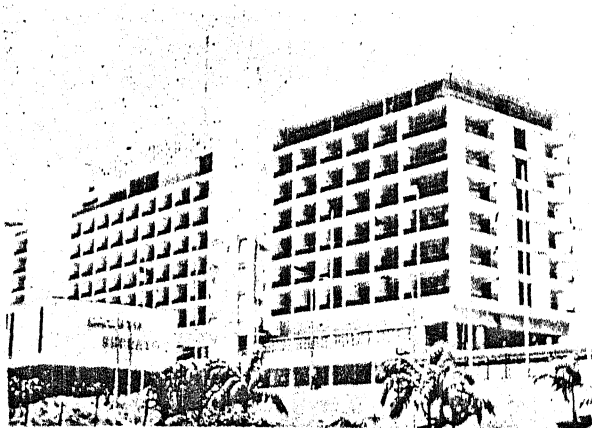
Fig. 12 - Macuto Sheraton Hotel

The computations concerning the Macuto-Sheraton Hotel main building (Table II, ref. no. 14) indicate that for a horizontal transverse force equal to 0.22 of the weight of the structure (force necessary to produce yielding of the columns) the elastic displacement above the 4th story is of about 4.5 cm. Tests on reinforced concrete models to scale 1/5.5 of the collapsed columns have shown that the amount of damage observed in the columns corresponds to residual displacements of about 3.5 cm

Thus the maximum displacement due to the earthquake can be estimated as 8 cm. By using expression 2) and by considering the natural frequency of 1.4 Hz, a spectral density of  $2400 \text{ cm}^2\text{s}^{-4}/\text{Hz}$  is obtained.

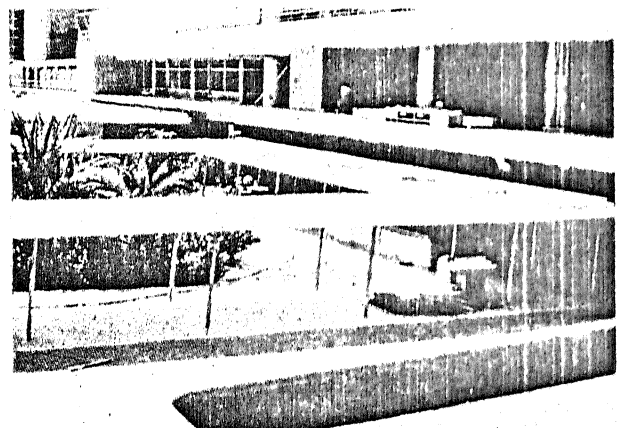
Fig. 13 - Pergola, Macuto Sheraton

For the Macuto-Sheraton Pergolas (table II, ref. no. 22 and 23) the indicated expression is no longer valid as the effect of gravity can no more be disregarded, as indicated by Husid (16). By performing a dynamic non-linear analysis taking in consideration the effect of gravity, a maximum displacement of 24 cm is reached (for  $t=13$  s) when Pergola 1 is subjected to the accelerogram of N-S El-Centro 1940 earthquake having its ordinates multiplied by  $\sqrt{1.5}$ .
