IMPLICATIONS ON SEISMIC STRUCTURAL DESIGN  
OF THE EVALUATION OF DAMAGE TO THE SHERATON-MACUTO

M. A. Sozen, N. M. Newmark, G. W. Housner

An analysis of the causes of damage to the Sheraton-Macuto Hotel in Caraballeda during the Caracas Earthquake of 29 July 1967. The paper evaluates the strength of the structure to resist lateral loads and discusses a possible sequence of events leading to the failure of the main columns.

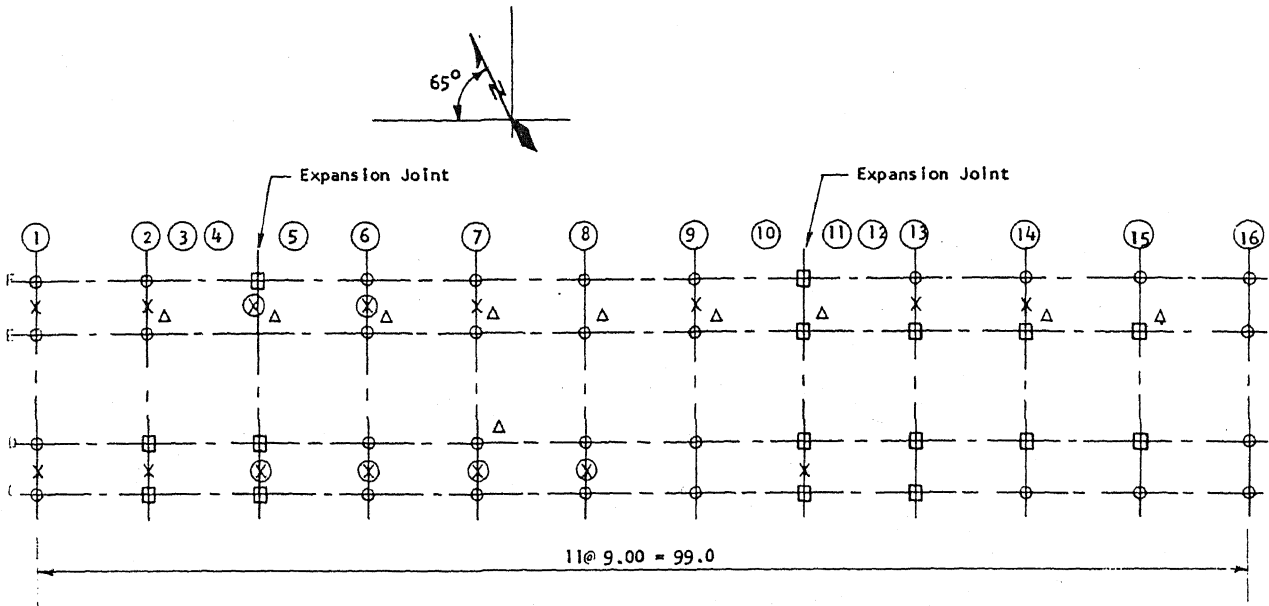
FIG. 1 COLUMN LAYOUT AT LEVEL 3, MAIN BUILDING, SHERATON-MACUTO

The locations of the damaged columns at level 3 are shown in Fig. 1. It is noteworthy that all but one of the failures occurred in line E. Only two of the columns in line E remained intact. One failure was observed in line D. (It has been reported that column D-10 was also found to have failed. The writers cannot confirm this observation because the column was covered during their inspections.)

Several of the deep floor girders connecting the columns on lines C-D and E-F at levels 2 and 3 were observed to have failed (Fig. 1). The failures were characterized by wide inclined cracks near the beam-column junctions (Fig. 5).

- △ \*Severely damaged columns at level 3
- X Damaged beams at level 3
- Damaged beams at level 2

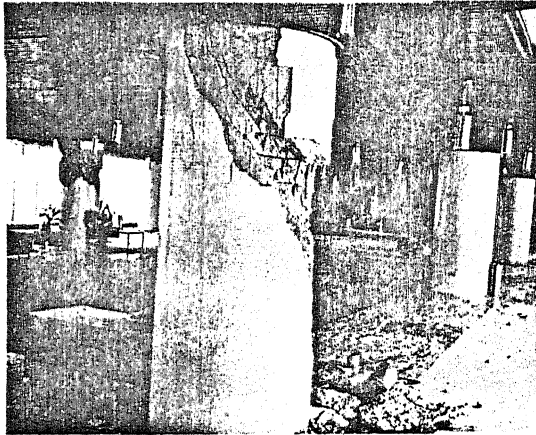
FIG. 4 COLUMN FAILURE AT LEVEL 3  
(COLUMN D7, West View)

The overall features of the column failures at level 3 were identical. An example is shown in Fig. 4. There was crushing of the concrete on the north side of the column at the junction of the column with the girder at level 4 (not seen in the photograph because of the false ceiling.) Wide cracks perpendicular and inclined to the column axis extended from the crushed concrete toward the south edge of the column. The orientation of the cracks and the location of the crushed concrete indicated that the major axis of the floor deflection at the time of the failure coincided with the magnetic north-south axis. The columns also had a network of cracks compatible with a floor deflection toward the south, but these were minor and did not lead to structural damage.

The primary cause of the column failures in level 3 is not identified categorically by the state or the failed column. There is no question that the columns were subjected to severe combinations of axial load, moment, and shear. Axial load may be eliminated as the primary cause of failure. The bias in the inclination of the cracks attributes more than secondary effects to bending and shear.

On the basis of qualitative evidence alone, it is not too difficult to make a case for shear as the primary cause of failure. The cracks are typical of shear failures. Even if it has to be admitted that all the interior columns carried the same shear, it is not awkward to claim that the maximum shear was approximately equal to the average shear strength of the columns thus causing about half of them to fail. However, the explanation is weakened when it is considered that at the assumed moment of failure columns on line E were likely to have been subjected to considerably larger axial forces (but not near the axial-load capacity of the columns) than those on line D. With shear as the primary cause of failure, more columns should have failed on line D than on line E.

A failure with bending as the primary cause is plausible in relation to the observed state of the columns after failure. The crack pattern is compatible with that observed in laboratory specimens subjected to similar loading conditions but failing under the primary influence of bending (1). As it was in the test specimens, the "faulting" in the columns may have been the effect of shear after destruction of the compressed concrete. Furthermore, the likelihood of failure on line E is stronger because the ductility of these columns is reduced as a result of the axial load.

It is apparent from Fig. 4 that the conditions of restraint of the columns were not identical at the top and bottom joints. This is also corroborated by the fact that the floor beams failed at levels 2 and 3, and the lighter columns in level 2 failed as a result of relative floor movements without distress in the heavier columns at the same level.

The damage to the building emphasizes the importance of considering in design the deformations of the entire structure under the influence of earthquake forces to make certain that all structural elements have compatible ductility and of insuring that enough web reinforcement is provided to develop the flexural capacity of beams and columns.

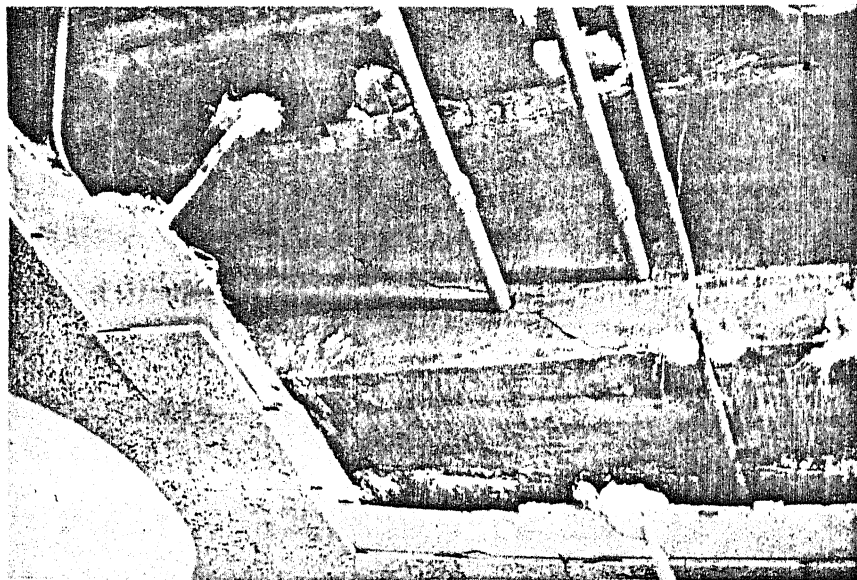
FIG. 5 INCLINED CRACK IN FLOOR GIRDER

where  $V_u$ : shear capacity,  $f'_c$ : concrete strength in  $\text{kg/cm}^2$ ,  $A_v$ : steel area in one stirrup,  $f_y$ : steel yield stress,  $d$ : effective beam depth, and  $s$ : stirrup spacing, the shear strength is estimated to be 70 tons for level 2 and 60 tons for level 3. The flexural capacities of the beams are adequate to develop the shears calculated.

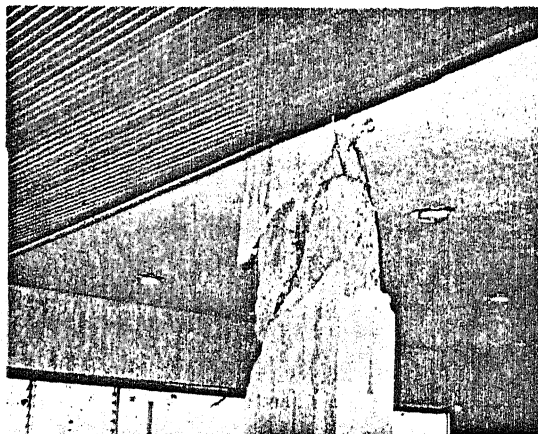
FIG. 6 COLUMN FAILURE AT LEVEL 2, LINE B

At level 2, all columns failed on lines A and B. These failures were also characterized by a wide inclined crack (Fig. 6) compatible with a south deflection of level 3 with respect to level 2.

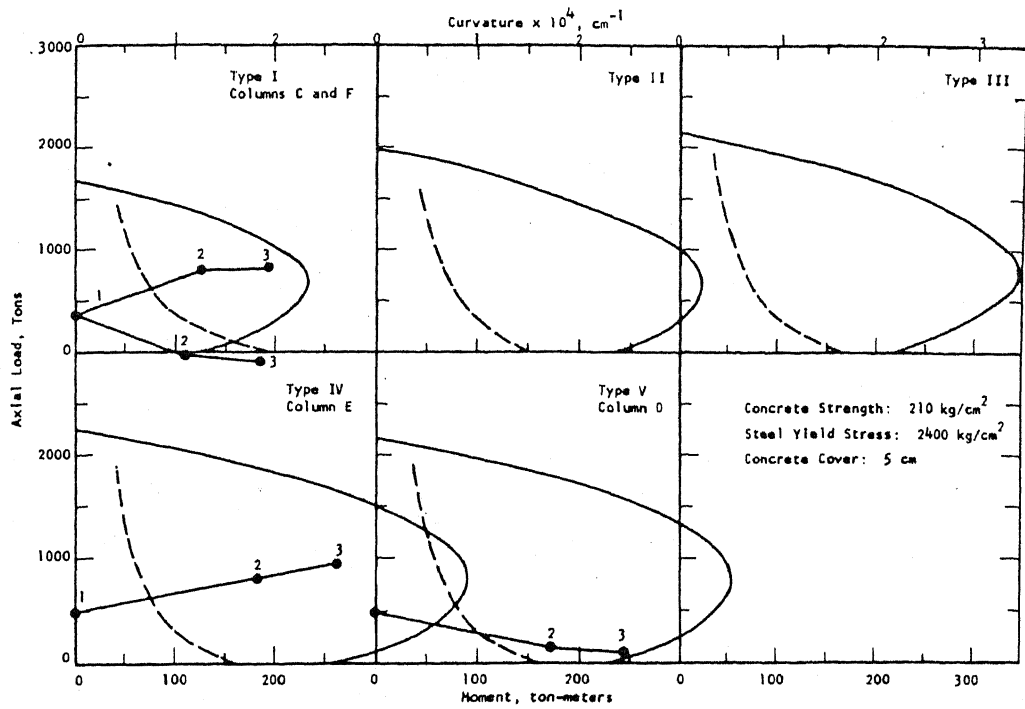
FIG. 7 INTERACTION DIAGRAMS OF LOAD, MOMENT, AND CURVATURE FOR THE ROUND COLUMNS AT LEVEL 3

The computed interaction diagrams for column types I through V (Fig. 3) are shown in Fig. 7. The broken curves represent the calculated limiting curvature.

Initially, it is assumed that the columns at level 3 are subjected to axial loads which result from the gravity loads. These loading conditions are indicated in Fig. 7 by the numeral 1.

The loading conditions on level 3 columns for a lateral load of 250 tons plus the gravity loads are indicated in Fig. 7 by the numeral 2. From the information in Fig. 7, it appears that the columns should be able to resist the load. The conditions for column F imply that this column would shed some of its moment because of increased flexibility. The shear in column E of about 76 tons is well within the computed capacity of the column. The calculated beam shear caused by the lateral load at level 2 is 57 tons. If calculated in reference to the clear span of the beam, this shear would be increased by 20 percent. Even if the calculated shear capacity of 60 tons is taken as a hard figure, it does not require hindsight to conclude that the level-3 floor girders will fail at or slightly above 250 tons. These will be followed by failures of floor girders at level 2 and columns on lines A and B. The series of failures will, in effect, rearrange the structure as shown in Fig. 9b.

The loading conditions for the top joints of level-3 columns corresponding to the rearranged structure are shown in Fig. 7 by the points marked by the numeral 3. It appears that by the time Stage 3 is reached, column F should have yielded. This is debatable. Column F may never have picked up that much moment because of a progressive reduction in stiffness. But it should be pointed out that even if it did yield, it would not have failed before the interior columns because of its greater capacity for deformation. After the ground motion stopped, any marks of yielding would be covered by the prestressing effect of the gravity load.

In reference to the Stage-3 data in Fig. 7 and assuming that column F would deform more or less plastically transferring the moment to the other three columns, columns C and D appear to be closer to failure than column E. However, on the basis of available ductility, column D is in

a more favorable condition. It can shed excess moment without serious distress. Column C does not possess more ductility, but is restrained less rigidly than column E. Consequently, column E is more likely to fail first.

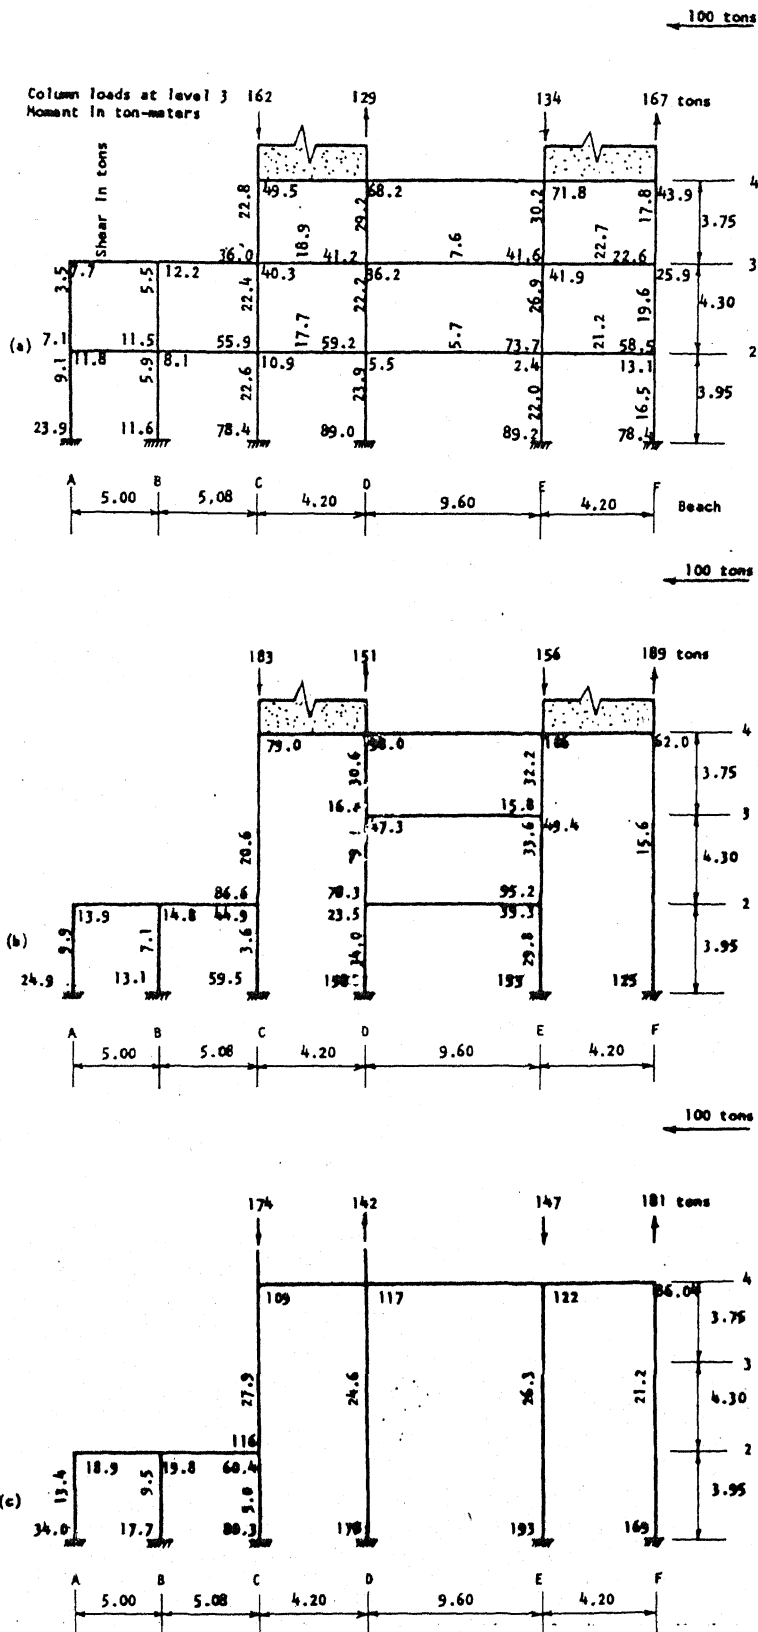
FIG. 9 RESULTS OF ELASTIC ANALYSES FOR A LATERAL LOAD OF 100 TONS APPLIED AT LEVEL 9

Figure 9 shows the moments and shears in the columns and the shears in the beams for 100 tons applied at level 9. The moments are inscribed on the side of the column where they tend to create compression. Inspection of Fig. 9 reveals that the level-3 columns are subjected to greater moments at the top than at the bottom, an observation which follows readily from the geometry of the building, that the exterior-column moments are approximately 60 percent of the interior-column moments. The column loads indicate the nearly independent action of the two shear walls.

The moments listed in Fig. 9b for a lateral load of 100 tons indicate that, for 250 tons, the remaining girders at levels 2 and 3 would yield. However, yielding of these girders have relatively little effect on the column moments at level 4, as shown by the solution in Fig. 9c. Also, it is assumed that the calculated base moments at level 1 are considerably larger than the actual ones because the damaged members are not entirely without resistance as implied by the structure in Fig. 9b.
