CARACAS, VENEZUELA EARTHQUAKE OF

JULY 29, 1967

Soil Engineering and Engineering Geology Observations

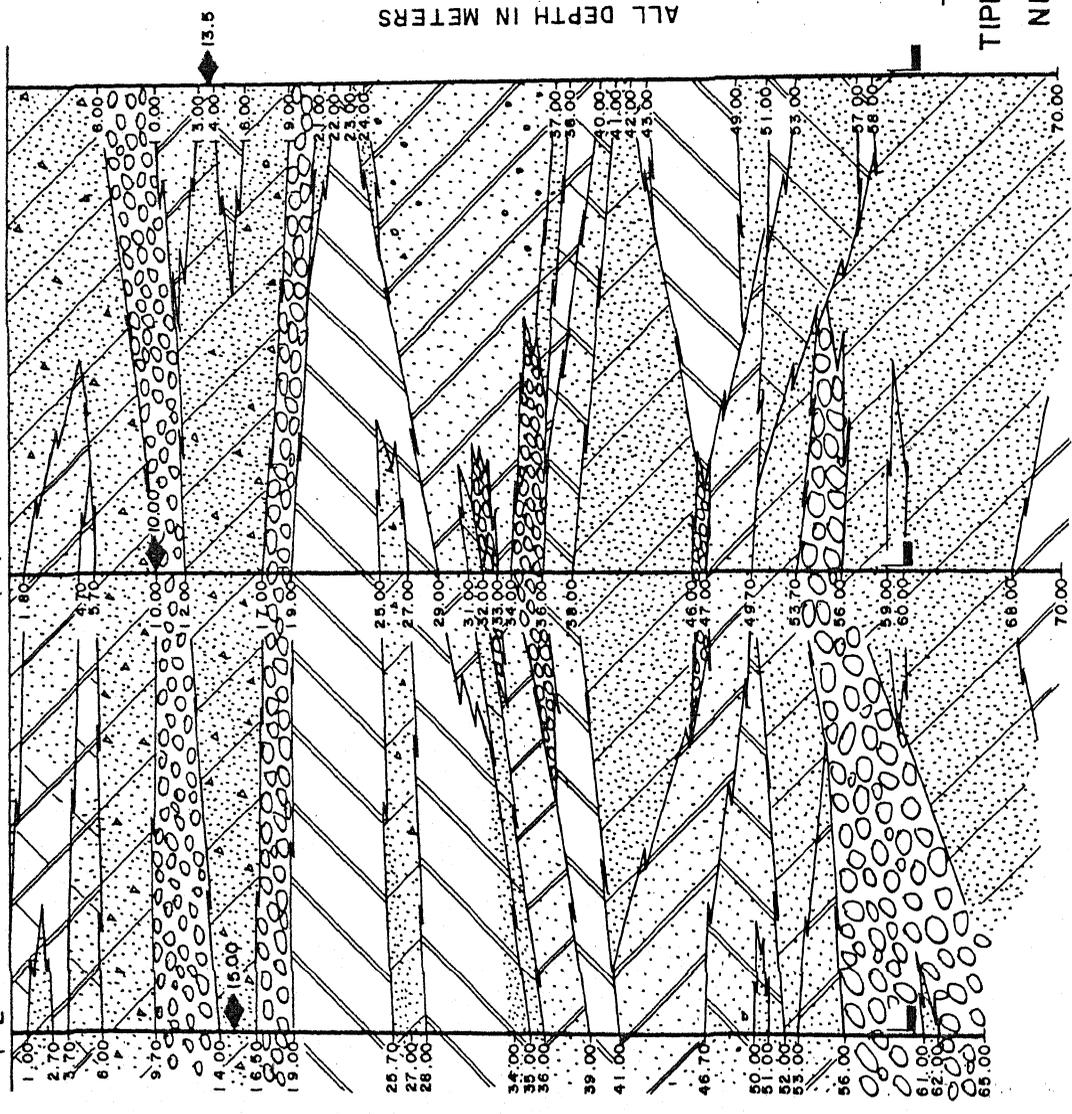
TYPICAL SUBSOIL PROFILE UNDERNEATH NEVERI AND SAN JOSE BUILDINGS

Los Palos Grandes and Altamira are located in the eastern section of the city; the sedimentary deposits at this place are quite deep. After the earthquake, some drilling was done extending to a depth of 115 meters without having reached bedrock. The composition is of a granular texture with silty lenses and layers of pebbles or of boulders. The distribution of the soils in this zone is quite erratic and irregular, which may be explained by the type of deposition that has occurred. Borings were made with the standard penetration test, with widely varying results due to the presence of pebbles and of small rock fragments which at times give very high and distorted values. However, in predominantly sandy zones, the tests indicated a rather low compactness. In the profile in Figure No. 4, of one of the most affected zones, located between two of the collapsed buildings (San Jose and Neveri), we may observe in the first place very fine sandy silt slightly micaceous and mixed with fragments of micaceous quartz schists; clayish silts with fine micaceous sand slight fragments of quartz, and clayish silt, slightly sandy in which may be seen a low plasticity. These materials are generally of a yellowish brown color and are mixed with layers of silty sands with fragments of gravel and nearly clean sands.

Of interest are the layers of gneiss boulders, with some slightly sandy weathered micaceous quartz schists. These boulders are found in a mold of fine micaceous silty sand resulting from the change in the gneiss itself. In some places these layers of boulders reach a thickness of 7 meters thick. At times it is possible to correlate these layers, but in other cases they are found forming isolated strata in an erratic manner.

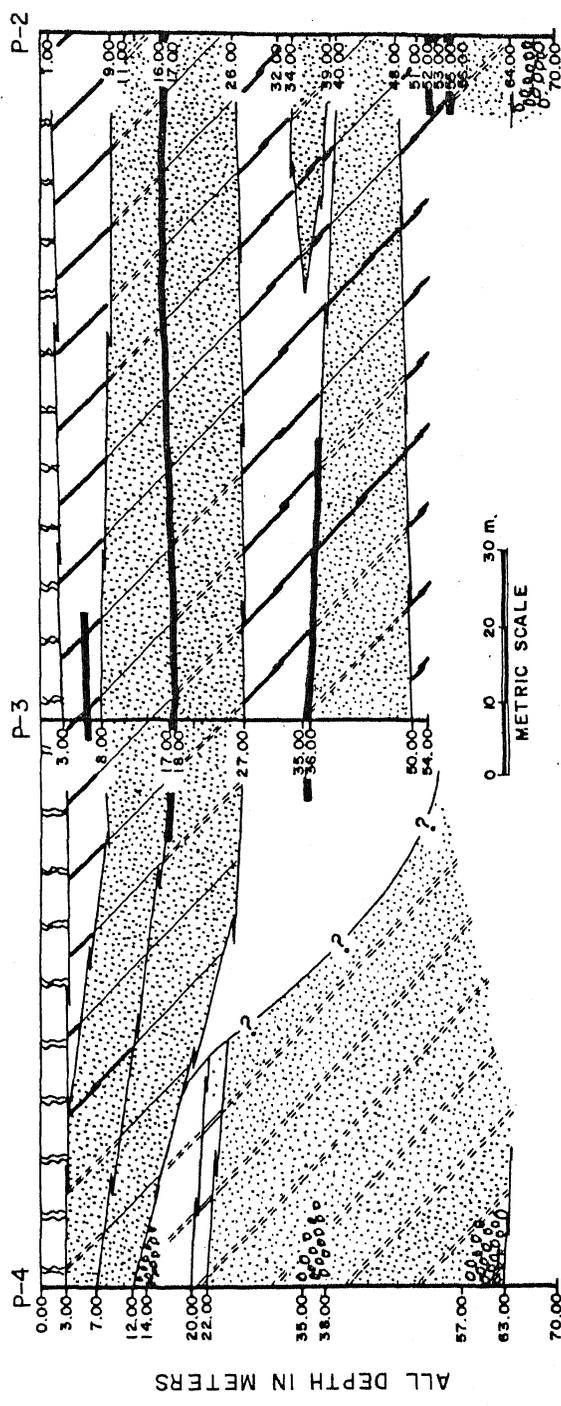
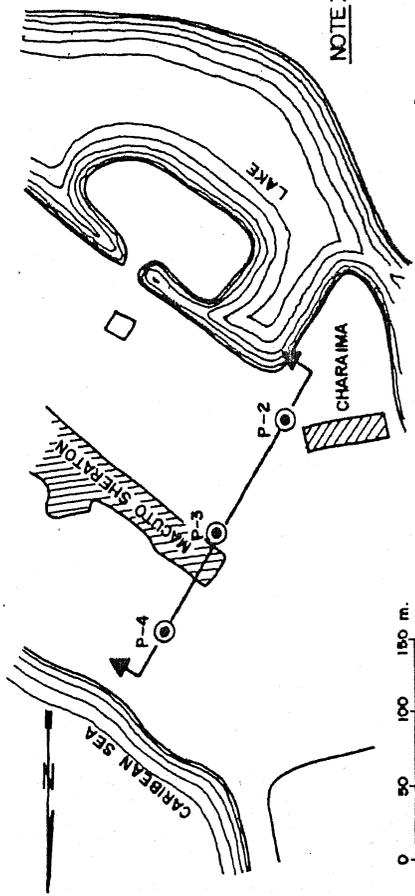
SOIL PROFILE UNDERNEATH MACUTO SHERATON - CHARAIMA

In the area where the Mansion Charaima and Macuto Sheraton Hotel buildings are located (Caraballeda and Tanaguarena), two types of deposition may be described: first a deposition of materials carried down from the mountains, which are characterized by their production of sandy material having silt, clay and fragments of gneiss, as well as by the presence of gneiss boulders, which are deeply buried and have the characteristic yellowed brown color (See Figure No. 5). Above these is a typical lagoon deposition formed by interbedded layers of micaceous elastic silt, greasy to the touch with organic decomposing matter; and silty sand with organic matter. Sea shells and peat strata are frequently found. These materials are from dark grey to black in color, with a high mica content.

In the Caraballeda zone, as shown in the geologic profile of the subsoil in Figure No. 5, there is a thick, irregular deposit. The location of the buildings most affected around the lagoon and the fissure that appeared at the beach leads us to think that the conditions of the subsoil had a pronounced effect on the collapse of the structures; unfortunately, at the time we prepared this paper we did not have available the data on geophysical measurements on which to establish more precise comparisons.
