MACROSEISMIC OBSERVATIONS FROM SOME RECENT EARTHQUAKES

N. N. Ambraseys<sup>(1)</sup>

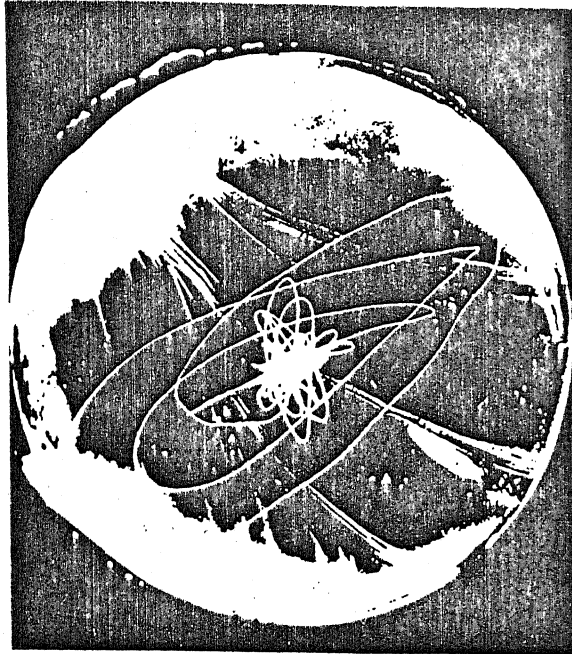
The last shock of the series, of September 1, 1966 was of smaller magnitude and the shaking lasted only a few seconds. It produced, however, far more intense ground movements than the previous shocks and these were confined within a comparatively small area. People were thrown to the ground and pack animals staggered. Heavy objects slid on the ground and water sloshed from cisterns. Nevertheless, this earthquake caused comparatively little damage. An SR-100 Wilmot seismoscope in the area of severe shaking showed a response amplitude of just over 60 millimetres or, a maximum velocity response of about 2 feet/second, Figure 2. The direction of the maximum displacement of the pendulum was at right angles to the direction of the major fault that bounds the Megalopolis graben, which is believed to be associated with this earthquake, and which is located 3 kilometres from the location of the instrument. A search for surface fault movements, however, did not disclose any conclusive evidence and the validity of fissures in alluvium near the wall of the graben as evidence of surface faulting is questionable.

Figure 2. Megalopolis seismoscope record for the earthquake of September 1, 1966.  
(Up on sheet is north from station)

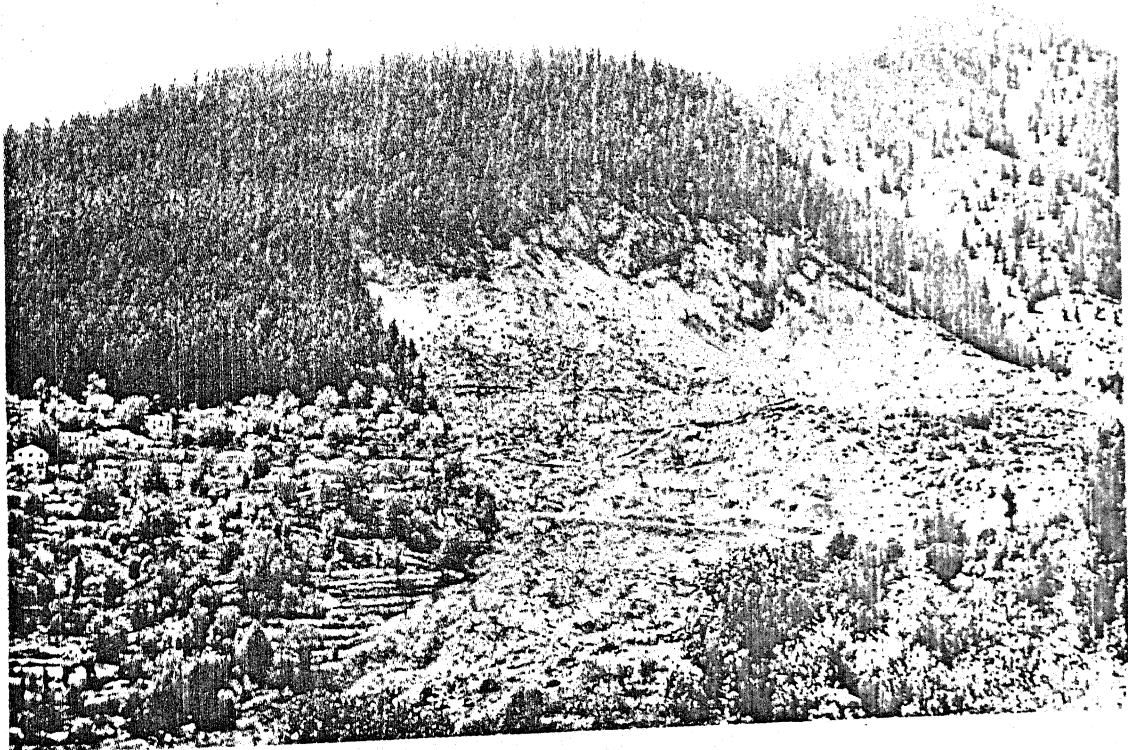
Many of these foreshocks were damaging and triggered numerous slides over a wide area around the lake. Throughout the foreshock period damage to villages neighbouring the lake increased progressively; some of this damage was due to the shocks but also due to landslides, Figure 3. The main shock of February 5, 1966 destroyed about 500 and damaged beyond repair 1,200 houses, most of them damaged already by previous shocks. The Kremasta dam, a 450-foot high rock-fill dam was not damaged, Figure 4. Leakage, however, through outcropping conglomerates along the rim of the reservoir near the left abutment of the dam was noticed reaching values, soon after the earthquake, of a few cubic metres per second, Figure 5. Hot sulphur springs which had been sealed off before the construction of the dam near its foundation reappeared, and fresh-water springs in the region dried out. No water waves were noticed in the reservoir during the earthquake, though intensive "bubbling" of the water accompanied by noise was reported.

Figure 3. Slide at Mikron Khorion, east of Kremasta lake.

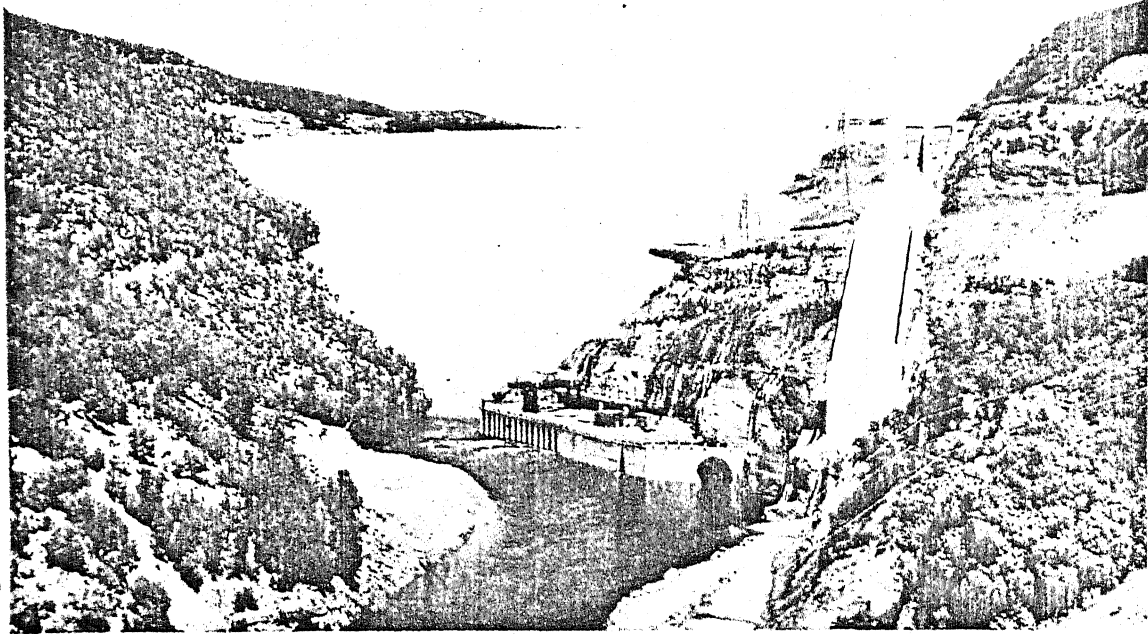
Figure 4. View of Kremasta dam; leakage on left abutment over power house.

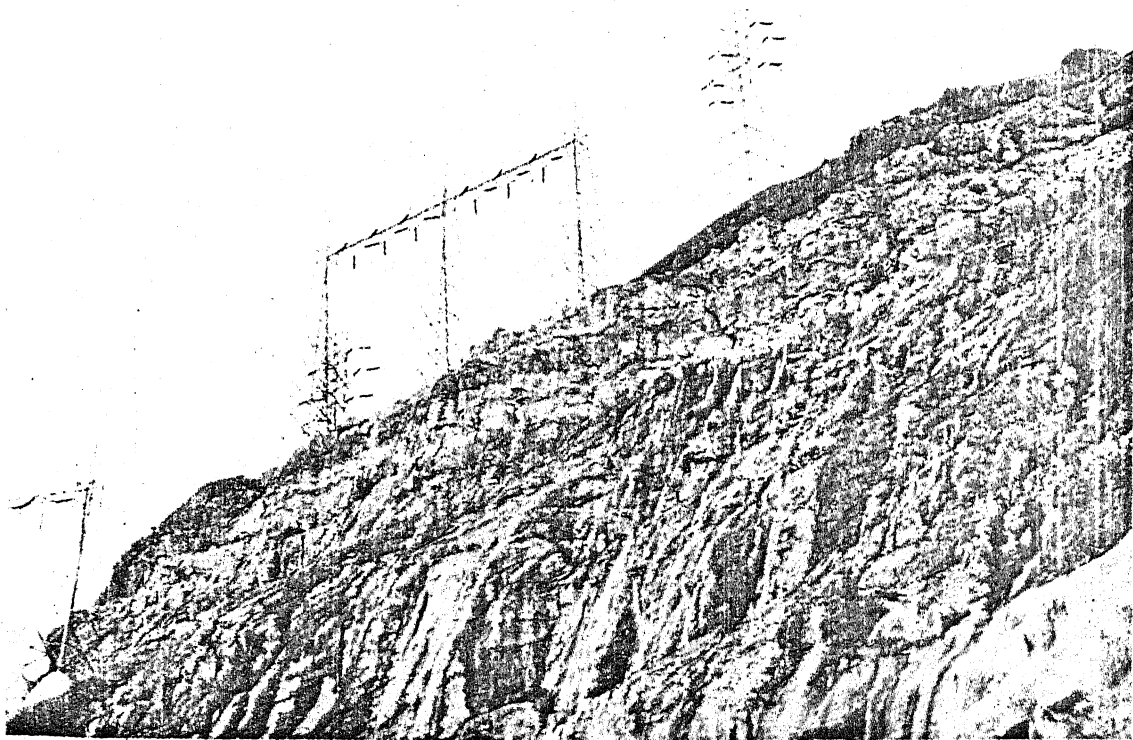
Figure 5. Leakage of left abutment of Keremasta dam.

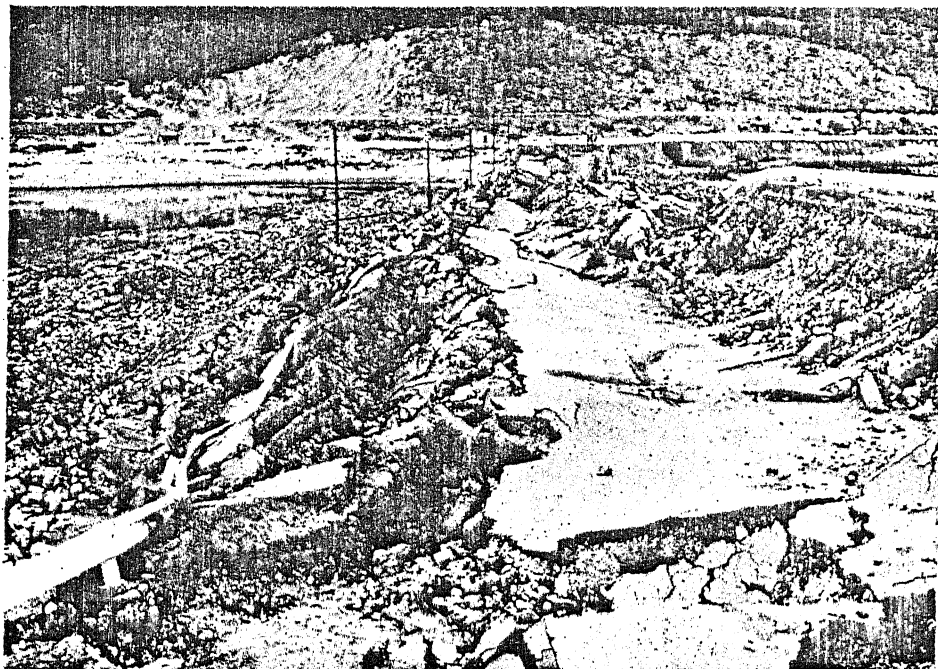
This earthquake is in fact a strong aftershock of the Kremasta earthquake of February 5. It caused considerable damage to rural districts that had already been damaged by previous shocks and many villages situated on the plains or near the coast suffered heavy damage caused by slumping of the ground and sliding. The shaking was not severe, and the damage to reinforced concrete houses was negligible. A series of cracks in the ground, about 2 kilometres long associated with slumping of the coast appeared on the beach of Amphilochia. The main road from Athens where it crosses the valley was damaged and a causeway spread laterally disrupting the communications, Figure 6. Houses near the destroyed causeway founded on solid ground, suffered absolutely no damage.

Figure 6. Slumping of causeway near Amphiloehia.

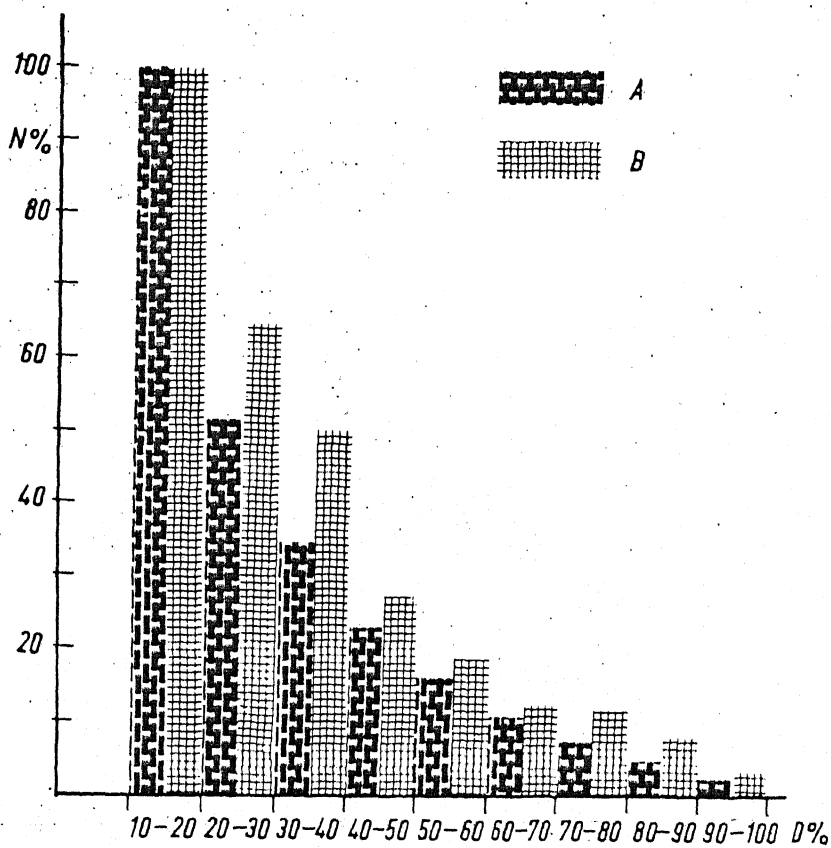
As in the case of the Buyin-Zara earthquake of 1962 (Ambraseys 1963) the Mudurnu Valley earthquake of 1967 showed that proximity to the fault-break was not necessarily associated with heavier damage. This feature was investigated more precisely, in a qualitative way in the following manner. The percentage (D) of the total number of houses destroyed in each village was calculated for the whole epicentral region of the Mudurnu Valley earthquake which covers 7,000 square kilometres. Also the number of villages (N) that suffered damage equal to or greater than (D) was calculated as a percentage of the total number of villages. A damage distribution plot was then constructed, shown in Figure 7, in which the abscissa is the percentage of the villages that suffered damage equal to or greater than (D), while (D) is the corresponding ordinate. Distribution (A) in this Figure refers to the whole epicentral region, while distribution (B) shows the damage distribution within the fault-zone, taken as a zone 4 kilometres wide and about 100 kilometres long following the fault-breaks. On such a plot, a significant increase of damage in the fault-zone, should have lead to much higher values of (N) in the (B)-distribution. Instead, there is a conspicuous similarity between distributions (A) and (B) that shows that the damage in the fault-zone which covers an area of only 400 square kilometres is a representative sample of the whole area and consequently almost independent of its proximity to the fault-break. Thus, proximity to a fault is not a criterion of heavier damage, and the displacements that can be noted on fresh fault-breaks a few hours or days after an earthquake are not necessarily those produced during the earthquake. Observable displacements contain a considerable component due to creep.

Figure 7. Damage distribution, Mudurnu Valley earthquakes 1967
