STRUCTURAL ENGINEERING ASPECTS OF THE 1967 ADAPAZARI,
TURKEY, EARTHQUAKE.

Rifat Yarar* and Semih S. Tezcan**

SYNOPSIS

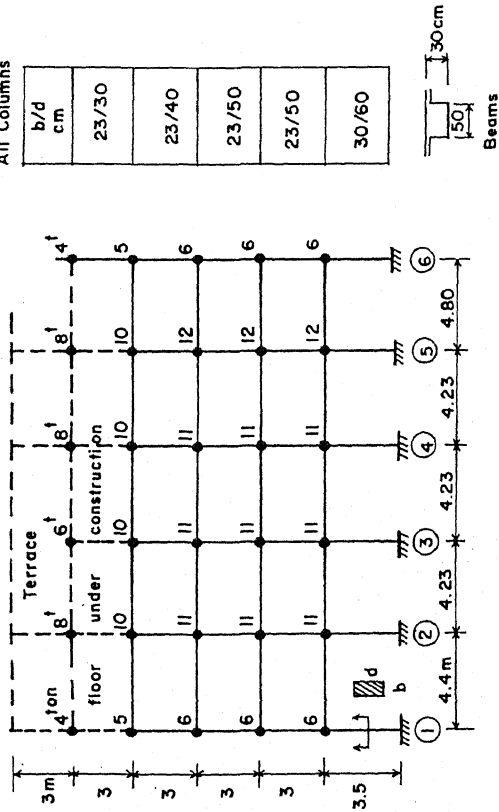
FIG. 5.- AHMET AKKOC APT., EE-FRAME (BLDG. NO. 3)

In order to compare the lateral load requirements of the Turkish Code with the others^{1,2} and also with the results of the dynamic analysis, the structural frames of the Buildings Nos. 1, 2 and 3 have been chosen (Figs.3,4 and 5). Furthermore, the ultimate capacities of some of the most highly stressed columns of these frames were calculated in accordance with the formulae of 1963 Code of the Am. Conc. Inst., and the columns were inadequate to carry the induced seismic loads. The results are summarised in Tables 1, 2 and 3. The maximum probable shears obtained by taking the root mean square of the first ten modal shears are divided by a factor of $(4/0.44 \times 1.5) = 6.1$ in order to reduce the design shears to the level of the code forces. This reduction is based on a ductility factor $\mu = 4$, an allowable yield stress ratio of $\sigma_{all}/\sigma_{yield} = 0.44$, and an overstress factor of 1.5, as permitted by the Turkish Code.
