THE CARACAS EARTHQUAKE

OF JULY 29, 1967

VENEZUELAN OFFICIAL SEISMIC COMMISSION

Fourth World Conference on Earthquake Engineering
January, 1969.

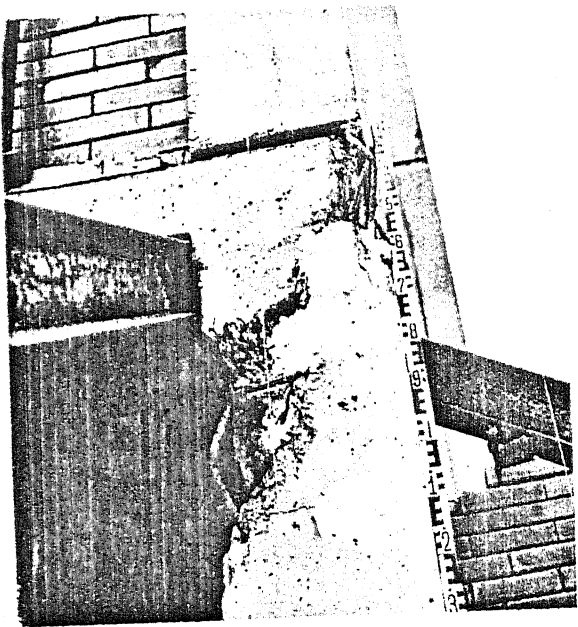
Fig. 1. Petunia II, N-W corner column. Column with combined axial and bending damage.

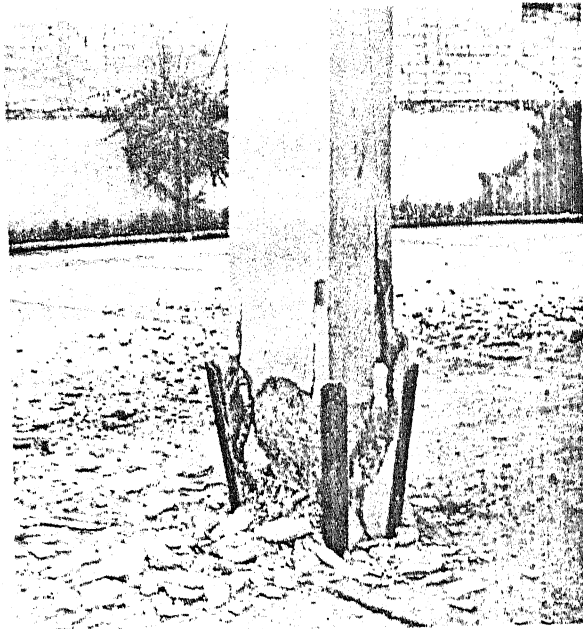
Fig. 2. San Bosco building. Damaged column at ground level. Compression failure.

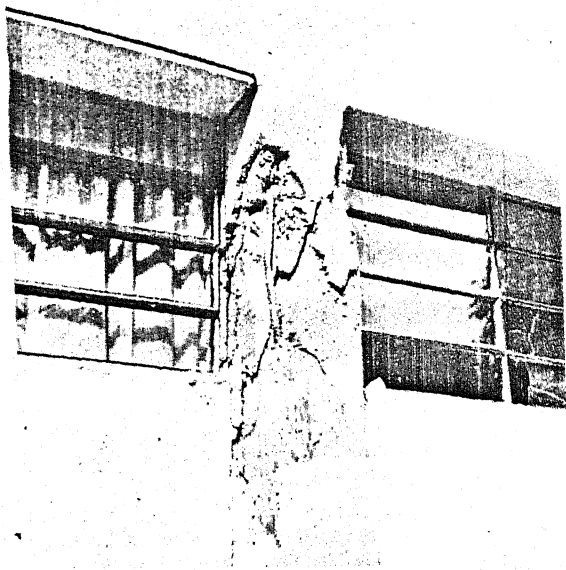
Fig. 3. La Pinta building. Damaged column at ground level. Combined stress failure.

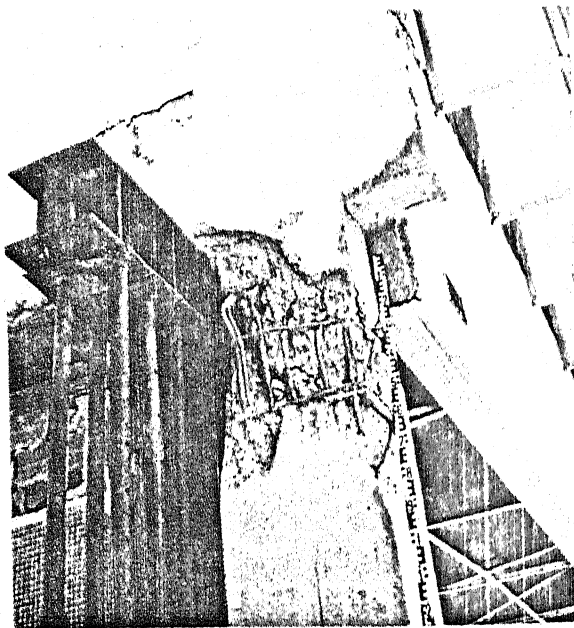
Fig. 4. Mene Grande building. S-W corner column. Combined stress failure.

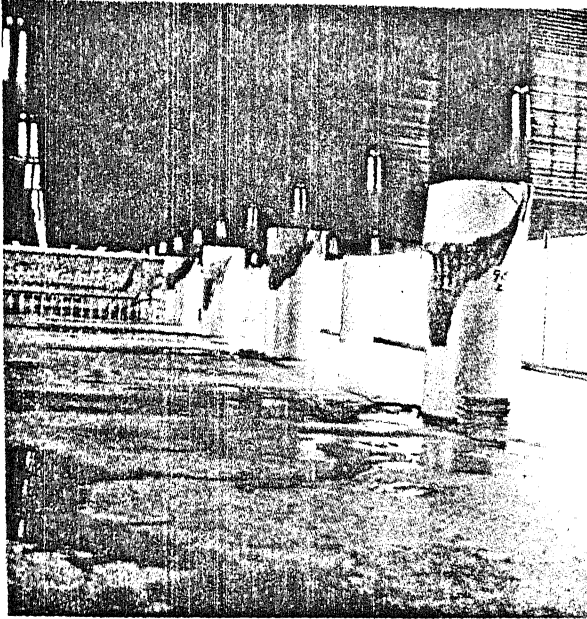
Fig. 5. Macuto Sheraton's mezzanina damaged columns.

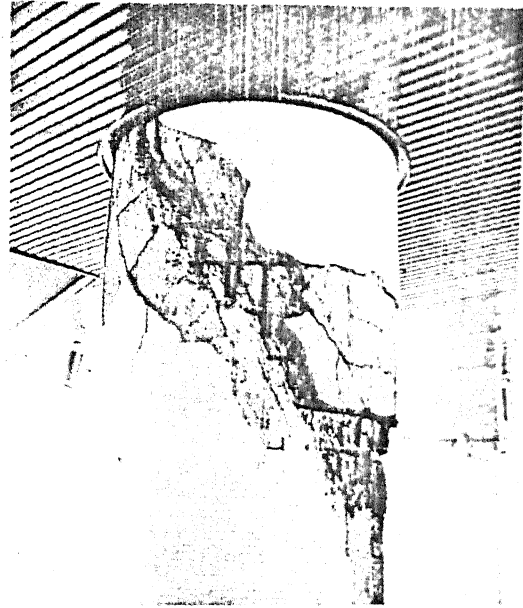
Fig. 6. Macuto Sheraton's mezzanina damaged column.

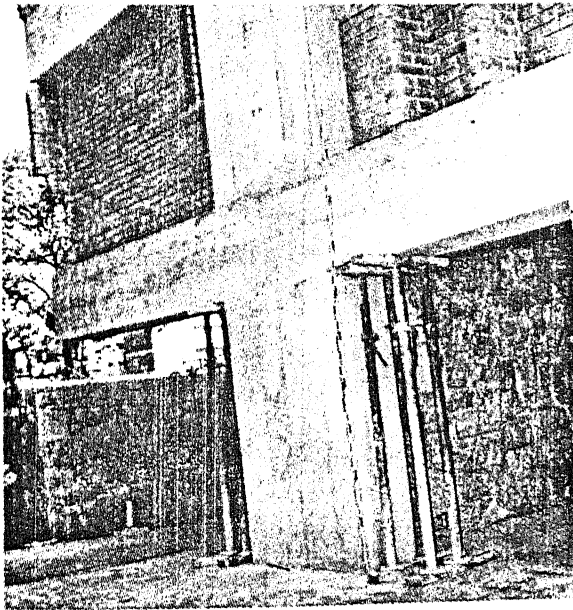
Fig. 7. Petunia I, South front. Beam with shear damage.

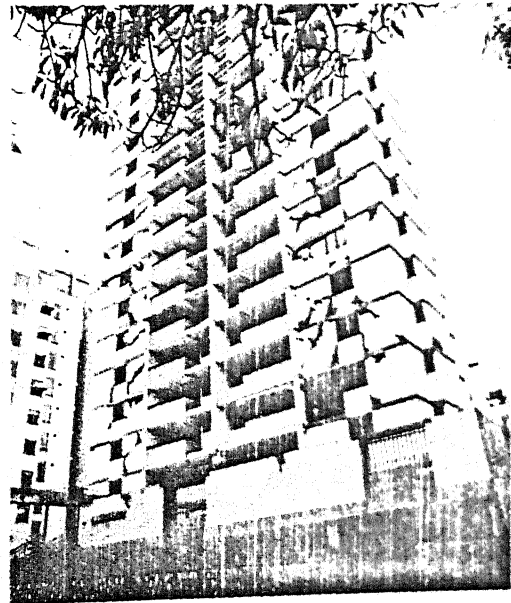
Quite a number of buildings suffered damaged front walls and interior partitions. Generally, walls and partitions are constructed with hollow tile blocks, which are very rigid but brittle. Front walls are built with tile 15 to 20 cm. thick; and interior partitions use tile 8 to 15 cm. thick.

In other cases, the front walls acted jointly with the frames as shear walls, producing a considerable concentration of forces on outside columns of open ground floors, provoking failure by compression or combined bending and compression.

Fig. 8. Castillete building. West front. Damage of hollow brick walls.
