THE JULY 29, 1967 VENEZUELA EARTHQUAKE  
LESSONS FOR THE STRUCTURAL ENGINEER

Henry J. Degenkolb (I) and Robert D. Hanson (II)

ABSTRACT

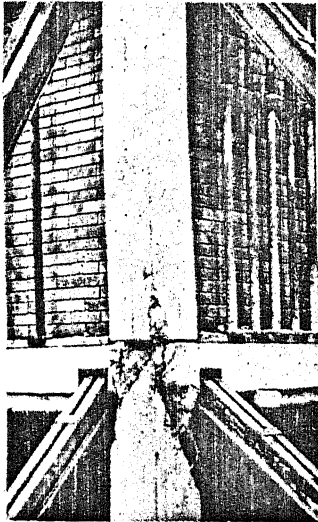
B. Overturning Forces: Aside from the column failures attributable to unwanted stiffness due to non-structural elements, this earthquake has indicated overturning forces greatly in excess of anything anticipated in previous studies, research or observations. Figure 4 shows the tension cracks that developed in the lower two floors of the columns in the 20-story Petunia II building. Other buildings, such as the 10-story Amalfi, showed similar tension cracking. The 19-story Caromay building, Figure 5, is curved in plan and had enough tile walls that it must have acted as a unit rather than as a series of individual bents. Four columns, as shown in Figure 6, suffered complete failure and two others were cracked and spalled. As can be seen from Figure 7, the failures were at the approximate mid-height of the column in the lowest story and have a symmetrical pattern that suggests failure from pure axial compression. Rough calculations indicate that the column stresses at vertical load are about 700 to 800 p.s.i. and that overturning stresses in the columns for the MOP Normas required loads or the 1967 Uniform Building Code Zone 2 loads are from 110 to 220 lbs. per square inch as shown in the following tabulation.

Fig. 4 - Failure of Column, Tension Cracks in Petunia II

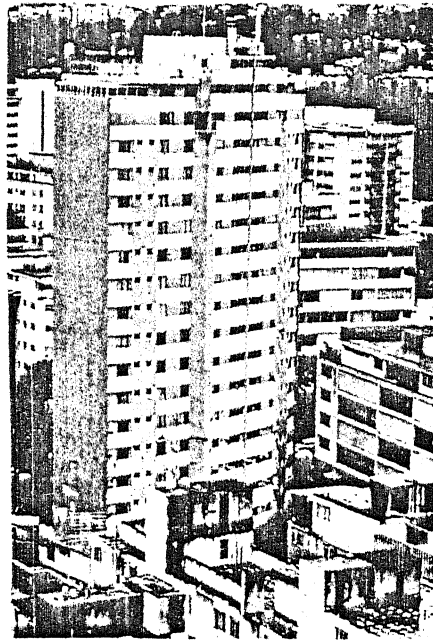
Fig. 5 - Caromay Building

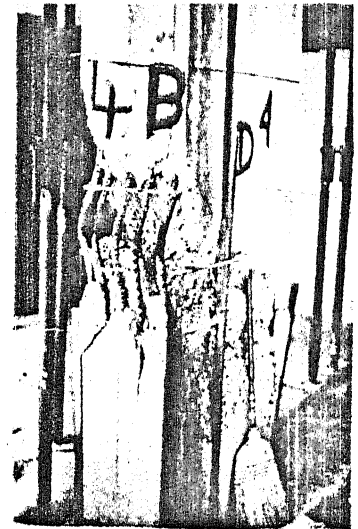
Since the actual tested cylinder strengths of the concrete were over 4000 p.s.i., it could be seen that current lateral force codes must greatly underestimate the required overturning forces. Assuming that the most highly stressed column (D7) failed at 4000 p.s.i. and taking the most liberal assumption of overturning stress, it can be seen that the base shear would be at least  $\frac{4000 - 800}{220} \times 1.32\% = 19.2\% G$ . For engineers familiar with the Uniform Building Code Zone 3 requirements, it is obvious that the change from Zone 2 to Zone 3 requirements would have had little effect on the design sizes of the members that failed.

Fig. 7 - Column Failure, Caromay Building

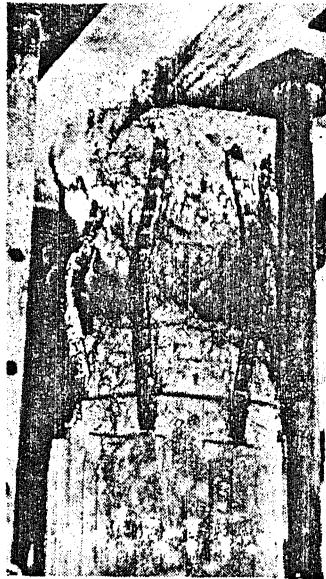
Every one of the many scores of major column failures showed buckling of the longitudinal steel, resulting from failure of the ties. Only in the failures in the Macuto Sheraton did the ties fail by tension necking down and parting. These columns had much more tie steel than our codes require. In most other cases the hooks pulled or the ties loosened in some manner. Figures 9 and 10 show column failures in the Marco Aurelio and San Bosco buildings and are indicative of many failures in many buildings. The importance of ties is being diminished or overlooked in recent United States codes. The latest ACI Code has reduced the requirements for column ties in that some cases not all bars have to be tied.

Fig. 9 - Column Failure, Marco Aurelio Building

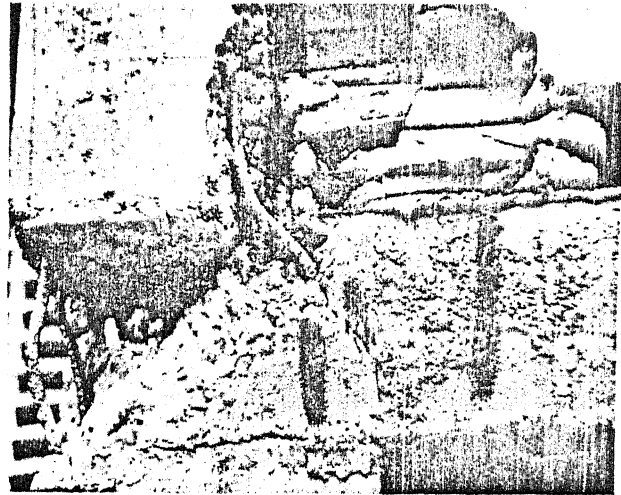
Quite a few of the connections shattered as shown in Figure 11, a connection in the fourteen story Covent Gardens. This, and other connections are designed in a very similar manner to those in most of the United States although they would not qualify under the new "ductile moment resisting frame" requirements of the limited Structural Engineers Association of California code. Possibly, in this specific connection, there was insufficient shear area to transfer the moments from beam to column. Certainly, from the smooth appearance of the underside of the column and the offset of the column, there may not be adequate shear transfer from the column to the top surface of the beam. The failure in this figure might indicate that the slab concrete is weaker than the column concrete. If so, it is an example of why engineers must be fully aware of the requirements for the transfer of column stresses through the beam or floor slab, especially at corner columns where confinement of the concrete is lacking on two faces.

Fig. 11 - Connection Failure, Covent Gardens

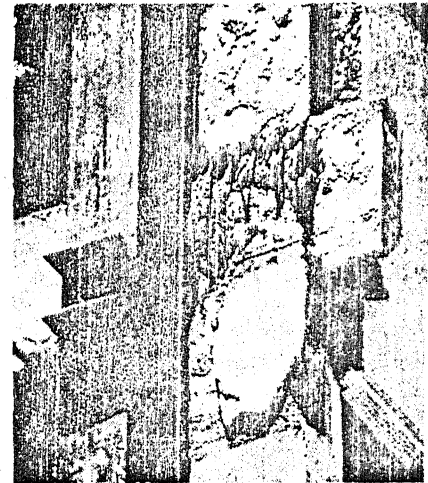
Fig. 12 - Connection Failure, Mene Grande Building

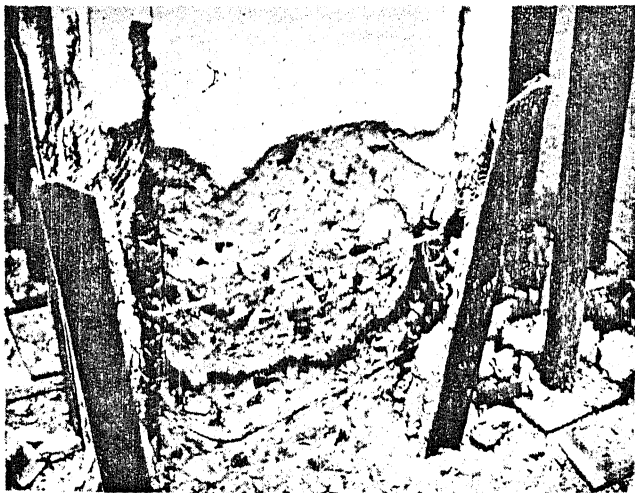
Fig. 10 - Column Failure, San Bosco Building

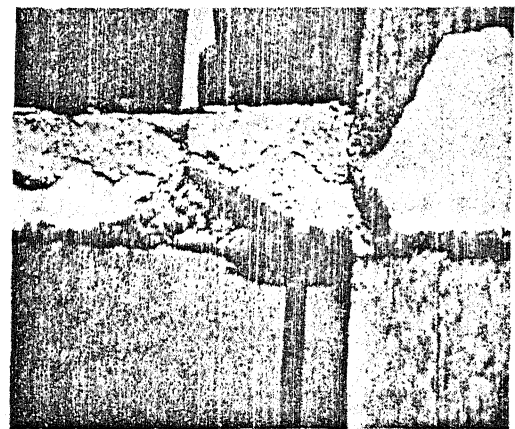
F. Shear in Wide Flat Beams or Slabs: Certain slab failures in the Alaska 1964 earthquake gave a hint that our methods of calculating shear where a slab joins a column could stand improvement, especially where accidental or calculated moments must be transferred. Numerous cracks and shear failures in the wide flat beams, which act similarly to a slab of the Caracas buildings substantiate this hint of trouble to come. Figures 13 and 14 show beam shear failures in the San Bosco and Coral

buildings. Most of these cracks were overlooked in the early stages of the investigations because of the sensational evidence of numerous column failures. After finishes were stripped and tile walls removed, it became obvious that the numerous cracks in the shallow beams near the columns were as potentially important as the column failures. The cracks adjacent to the columns in the Covent Gardens building, shown in Figure 15, while not spectacular, were alarming. While the reasons for the failure of the San Jose building may never be known, the architectural recesses at the front wall columns (Line 2), as shown on the typical floor plan in Figure 16, certainly did not help a shear situation that proved weak on other buildings with a greater area of contact of beam to column. Those of us in the United States that must furnish our architectural clients with the prominent, accented vertical line of the column in a tall building can sympathize with engineers all over the world faced with similar situations. Possibly it is time to exercise some restraint in the permissive use of this type of feature that greatly affects the performance of our structures in damaging earthquakes.

Fig. 13 - Shear Cracks in Beam, San Bosco Building

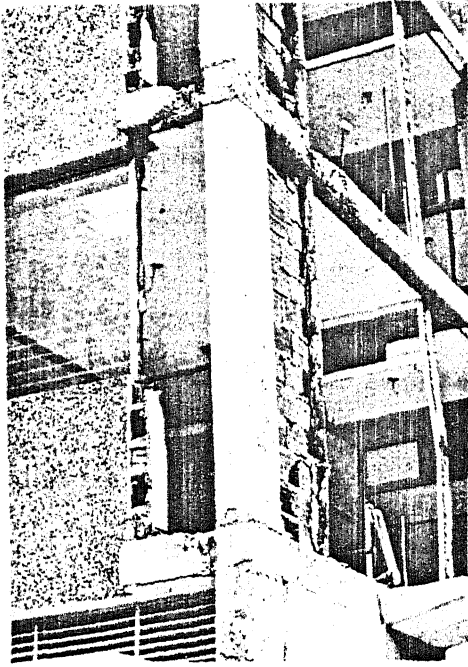
Fig. 14 - Shear Cracks in Beams, Coral Building

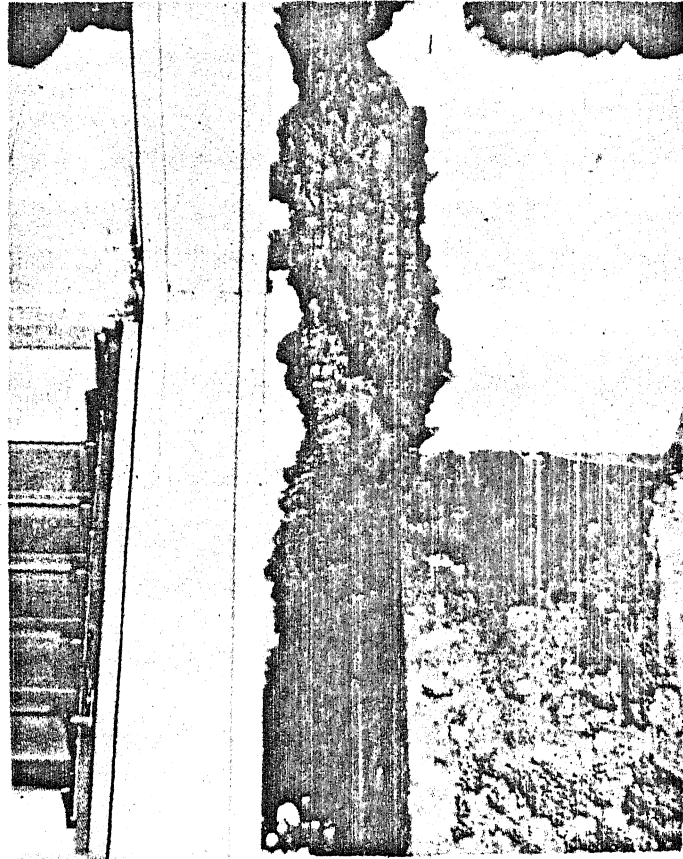
Fig. 15 - Cracks in Beam, Covent Gardens

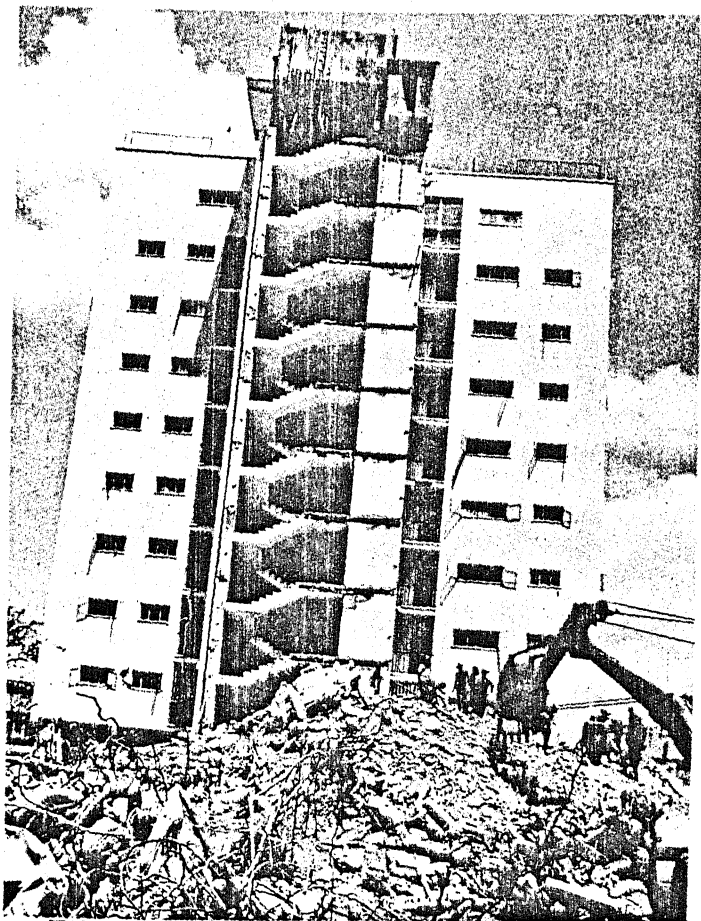
The central elevator and stair core of the Palace Corvin, shown in Figure 17, was seemingly designed to resist lateral loads as a vertical pylon. Yet, there were paper separators in the construction joints where the two wings joined the core, as shown in Figure 18, so there was no way for the transfer of the diaphragm forces to this resisting element.

Fig. 17 - Palace Corvin Building

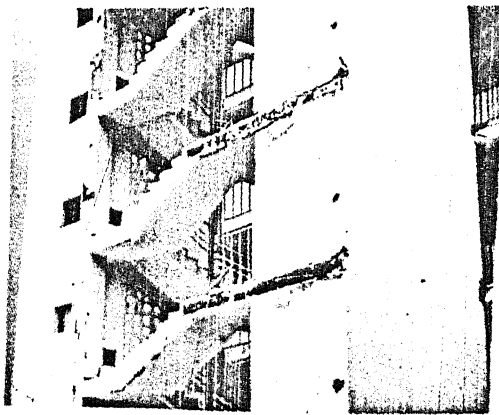
Fig. 18 - Paper Separators in Joint, Palace Corvin Building

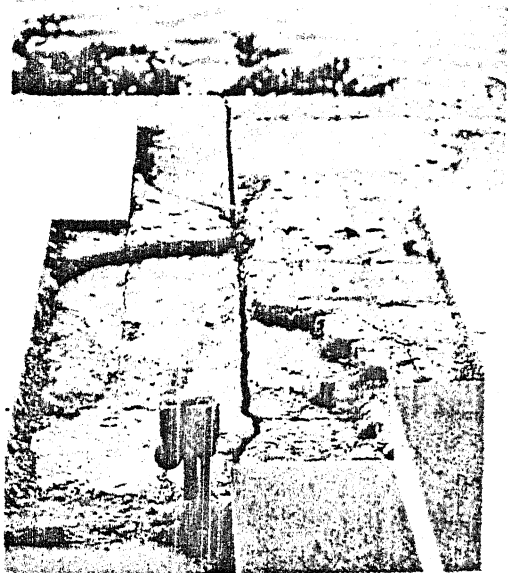
Figure 19 shows the typical floor plan of the thirteen story Bahia Del Mar, with the core shear wall extended to the fifth floor. Figure 20 shows the "tear" in the slab near Line 5 where the longitudinal forces generated in the right half of the building pulled the slab away from the shear wall. This type of failure has been observed before, but seems to have been overlooked by many engineers.

Fig. 20 - Crack in Floor, Bahia Del Mar

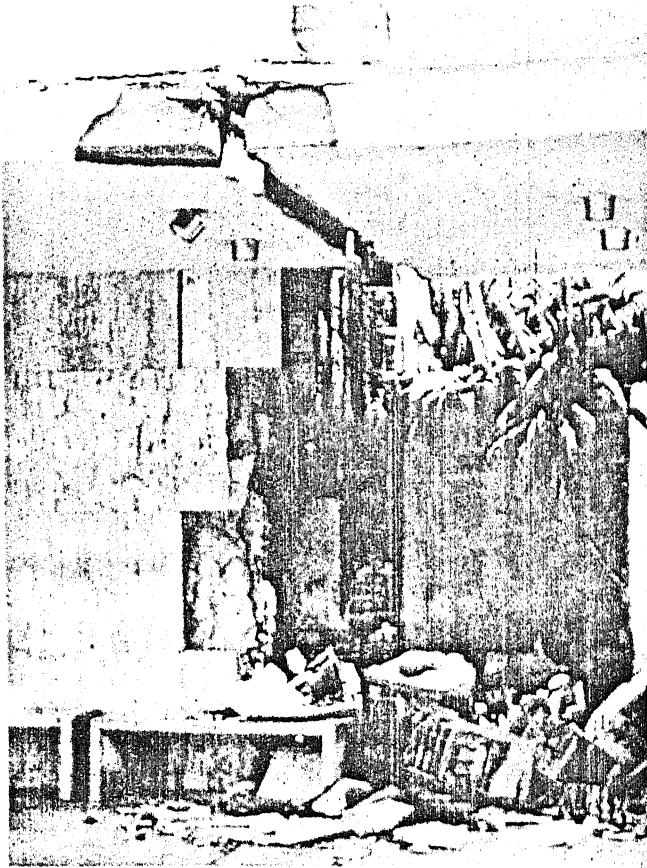
I. Pounding Damage: Previous earthquakes have repeatedly illustrated the damaging effects of the pounding of one structure against another when both are in motion during an earthquake. Although there were some examples in Venezuela, this type of damage was relatively rare because most multistory buildings in the areas reviewed were well separated. Figure 21 shows the canopy at the front of the Macuto Sheraton and the effects of the pounding of the concrete roof slab against the tile walls. After the wall and roof slab were removed, it was found that this pounding also shattered the concrete columns, as shown in Figure 22.

Fig. 21 - Front Canopy, Macuto Sheraton

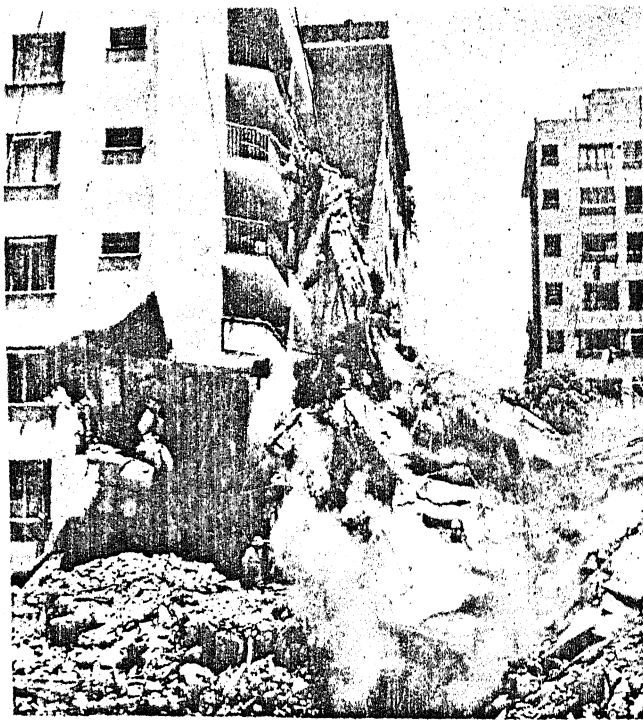
An extreme example of interstructure damage is shown in Figure 23 where the penthouse of the collapsed Mijagual building fell against the Nobel building, damaging the corner of the Nobel building.

Fig. 23 - Collapse of Mijagual on Nobel Building

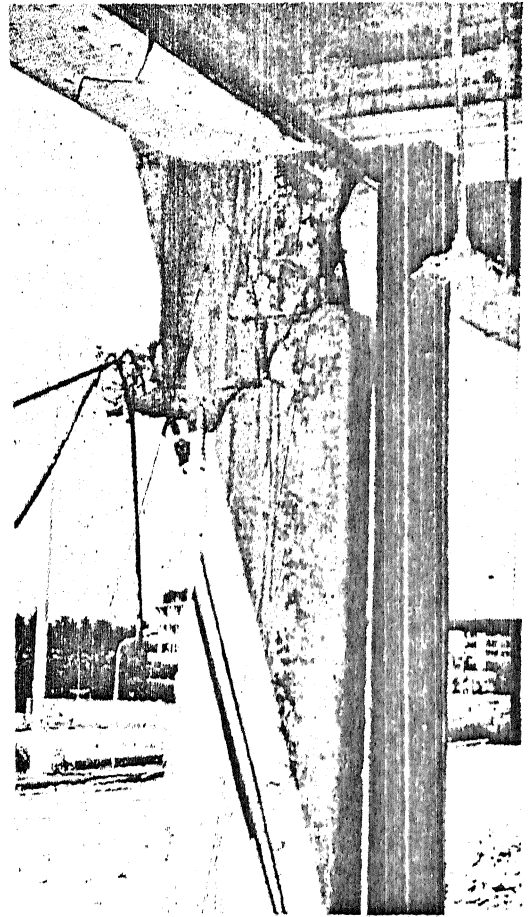
Fig. 22 - Pounding Damage at Column, Macuto Sheraton
