# SEISMIC RESPONSE OF THE VAN NORMAN RESERVOIR OUTLET TOWERS

S. A. Gadomski<sup>I</sup>

## SYNOPSIS

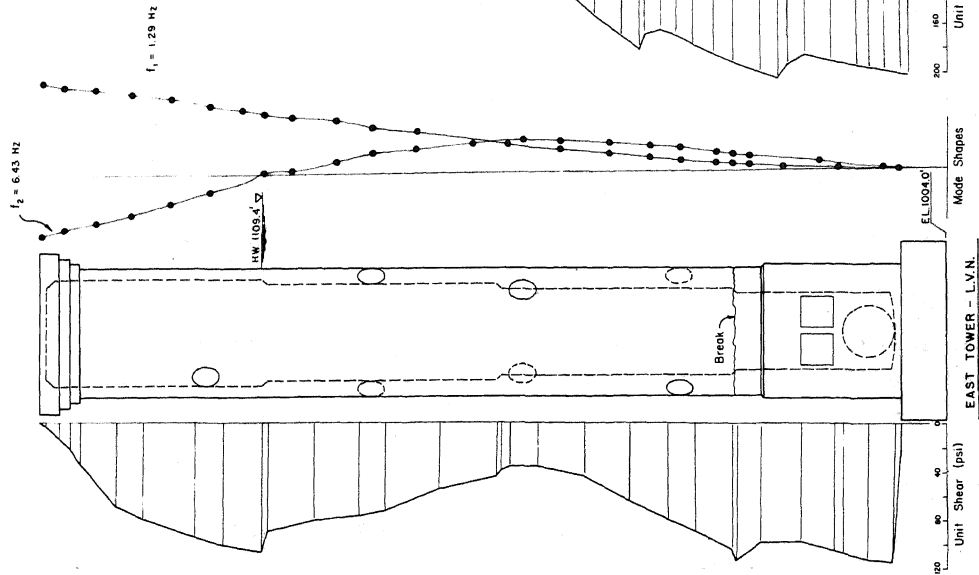
FIGURE I RESULTS OF ANALYSIS

The results of this analysis are presented in graphical and tabular form in Figure I. All three towers have very little reinforcing steel to withstand the large bending moments produced by this earthquake.<sup>(8)</sup> Although the construction drawings were somewhat sketchy on this point a conservative estimate for the ratio of steel to concrete was assumed to be 0.002. The east tower was the only tower to show extremely high stresses in flexure. The concrete stress at the outermost fiber showed stresses as high as 166% of the allowable, with the stresses in the steel reinforcement reaching 155% of the ultimate. The flexure stresses, both in the concrete and steel, in the other two towers were well within the allowables. The east tower also showed high stresses in shear reaching 115% of the allowable in the close vicinity of the failure. The Upper Van Norman Tower showed shear stresses well beyond the allowable by 155%, while the west tower showed shear stresses well within the allowables.

It is, therefore, concluded that shear was the governing mode of failure in the Upper Van Norman tower, while a combination of shear and flexure was the governing mode of failure in the east tower at Lower Van Norman. One would expect that these two towers would experience severe damage by the stresses produced by this earthquake. The upper tower was shifted 4 in. (10.2 cm) at the break. The east tower at Lower Van Norman toppled. A landslide on the upstream toe of the dam took place during the earthquake in the vicinity of the east tower. The stresses due to the earthquake loading were probably enough to damage the tower to a point where it had no strength to withstand any additional force, and the landslide was enough to topple the tower.

The reason for the wide variation in the behavior of the three towers may be explained by the fact that fundamental frequency of the west tower at Lower Van Norman was somewhat higher than the peak frequencies of the earthquake and, hence, did not reach a resonant mode of vibration as was experienced in the two towers that did fail.

This analysis showed good correlation with the actual behavior of these towers during the earthquake. The main recommendation that may be made is for an analysis of this type to be carried out on all similar structures in seismic active zones. It is impossible, at this time, to predict what the exact characteristics of a given design earthquake should be; however, an analysis of this type will aid the engineer in making decisions on the final design configuration.
