RESPONSE OF THE OLIVE VIEW MEDICAL CENTER MAIN BUILDING
DURING THE SAN FERNANDO EARTHQUAKE

SYNOPSIS

Dynamic response of the main building of the Olive View Medical Center, damaged beyond repair during the 1971 San Fernando earthquake, is analyzed and the principal cause of the severe damage identified.

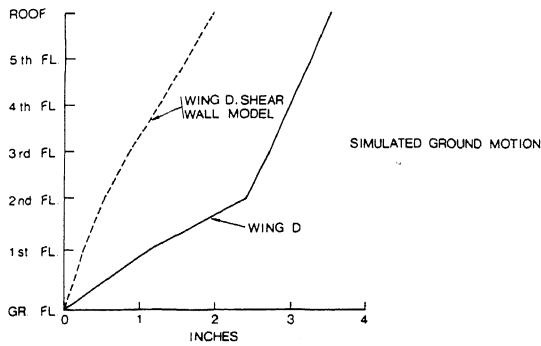
FIG.5: MAXIMUM ELASTIC FLOOR DISPLACEMENTS.

Elastic Analyses: The maximum displacements of Wing D (Fig. 5) due to the simulated ground motion indicate that the deformations are concentrated in the ground and first stories. The story shears exceed the design values by a factor of 10 or so (Fig. 6), indicating that appreciable yielding of the building, particularly in the first two stories, will result. Analysis of a modified Wing D in which the shear walls are continued down through the first and ground stories, with 14 in. and 16 in. thickness respectively, demonstrates that the deformations are now more uniformly distributed through the height.

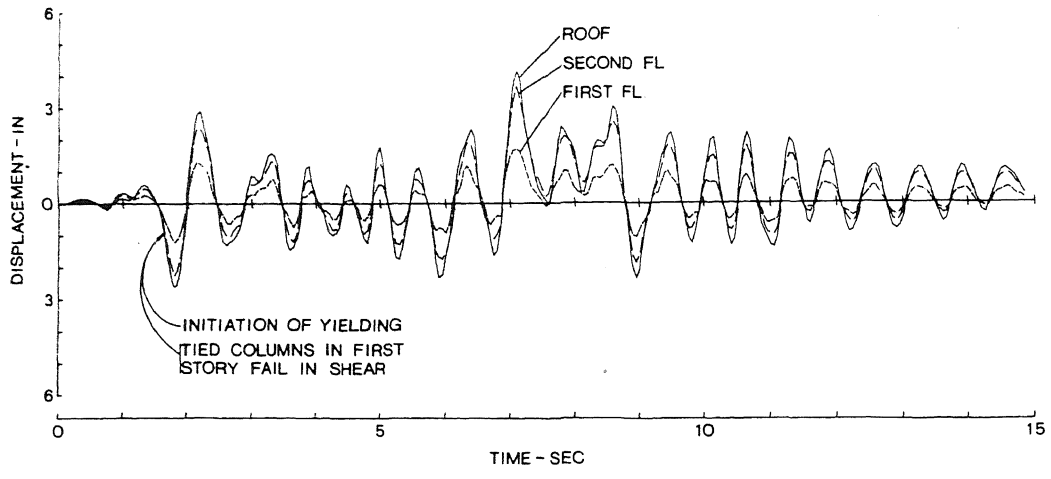
FIG.7: DISPLACEMENT RESPONSE TO SIMULATED GROUND MOTION.

Inelastic Response: A static analysis of the Wing D model for gravity loads is first performed. The response to the simulated ground motion, considering inelastic deformations and $P-\Delta$ effects, demonstrates that the slabs and columns of the lower two stories start to yield in the first two seconds even before the ground motion has reached its maximum intensity

(Fig. 7), causing elements which had low shear capacities, such as the first floor slabs and tied columns to fail prematurely and the outer shells of the spirally reinforced columns to spall. The yielding and associated large deformations are concentrated in the lower two stories (Figs. 8, 10-12).

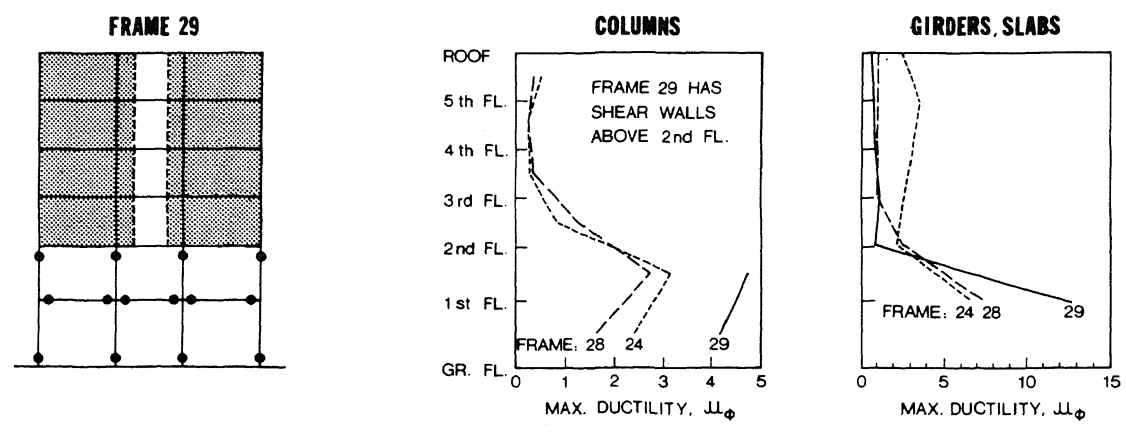
FIG.9: PLASTIC HINGES AT 1.75 SEC.

There are two main factors which account for these discrepancies. Firstly, the ground motion at the site during the earthquake is not known. Once a panel yielding mechanism (Fig. 9) forms, the subsequent response depends strongly on the characteristics of ground motion. An acceleration pulse of relatively long duration, such as in the Pacoima base rock motion (Fig. 2), may cause the first two stories to continue to yield in one direction resulting in irreversible large drifts. Secondly, failures of elements during the early phase of the earthquake and their influence on the subsequent response is not accounted for in the analyses. Thus, the damage to some columns in lines G and M due to the collapse of the terrace canopy, the drastic decrease in resistance of some of the flat slabs which failed rather prematurely, the sudden release of energy and transfer of load to the spirally reinforced columns and the decrease of story resistance due to brittle failure of the tied columns, the decrease in capacity of the spirally reinforced columns due to spalling of the outer shell (Fig. 13), and other such factors were not considered. Furthermore, torsion response is ignored and only the north-south component of ground motion is considered.

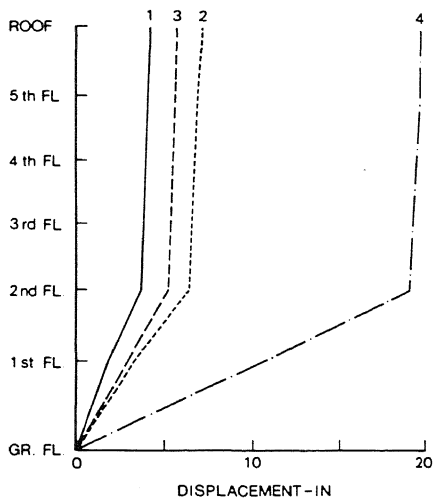
FIG.11: MAXIMUM FLOOR DISPLACEMENTS.

The response to Pacoima base rock motion (Fig. 2) demonstrates that the long duration acceleration pulses indeed cause much larger deformation in the first two stories and significant permanent distortion (Figs. 11, 12, 15). Although, as mentioned, the analysis procedure has a number of limitations, it seemed worthwhile to determine the response to more intense ground motions which may cause larger displacements consistent with those observed. For this purpose, the two ground motions of Fig. 2 were amplified arbitrarily by a factor of 2. The results (Figs. 11, 12) indicate that very large displacements are caused by the amplified Pacoima base rock motion. Among the four ground motions considered, this is the only one which causes first floor displacements to exceed 4 in., indicating impact against the warehouse. Once that happens, the building has two 'soft' stories when vibrating to the south but effectively only one when vibrating to the north, which will result in a large increase of drifts in the first story over those in the ground story.

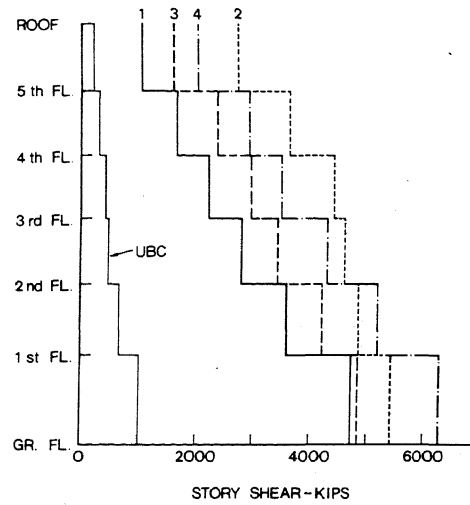
FIG.14: MAXIMUM STORY SHEARS.

The computed story shears indicate that the strength of the lower two stories was about four times the design value (Fig. 14). The strength of upper stories must exceed the design value by a much larger factor because of the presence of shear walls. That the building was much stronger than

intended by the code and yet severely damaged is primarily because the ground motion was rather severe and the 'soft' lower two stories were called upon to absorb almost all the energy thus undergoing very large inelastic deformations.
