THE MAJOR PAPUA NEW GUINEAN EARTHQUAKES NEAR MADANG (1970)
AND BENEATH THE NORTH SOLOMON SEA (1971)

I.B. Everingham¹

SYNOPSIS

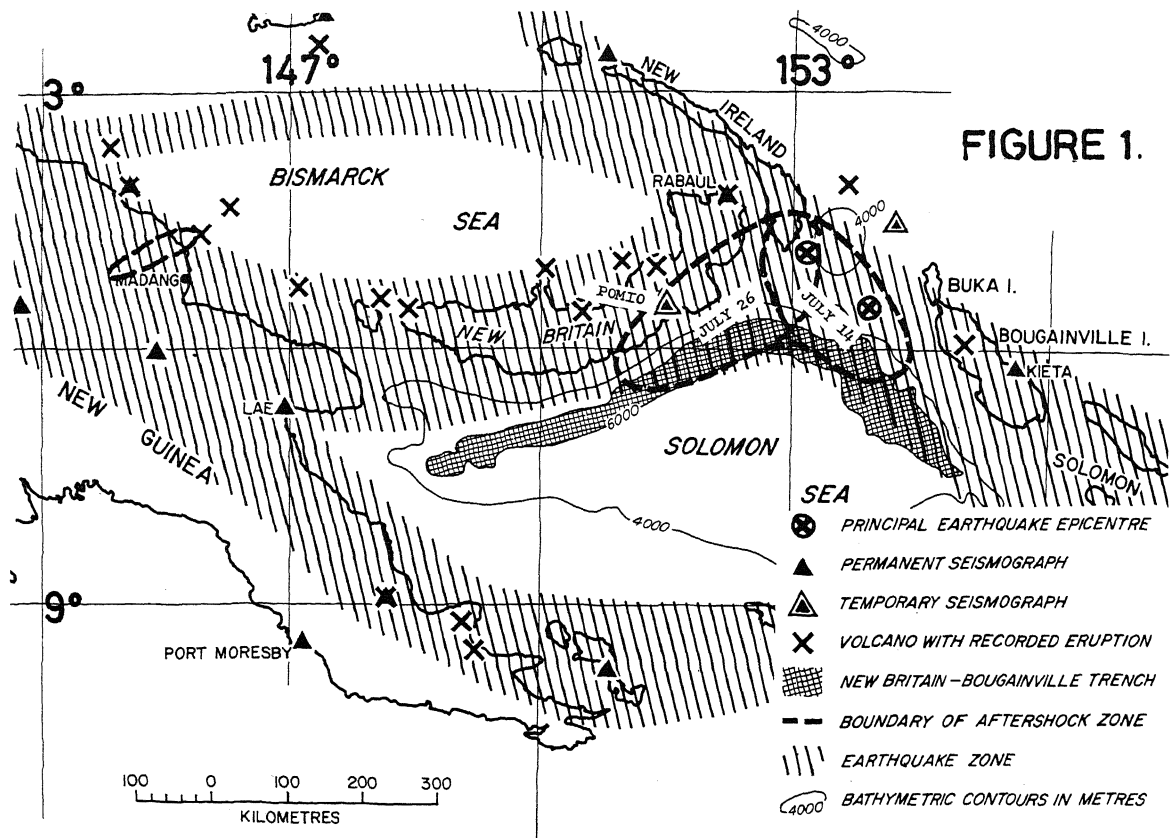
The fault-plane solution and hypocentre pattern suggested a near-vertical, left lateral, strikeslip fault trending ENE near the north coast of New Guinea (Fig. 1). Maximum intensities were at least MM8, and MM7 intensities were experienced over an area of about 25 000 km². Extensive landsliding occurred in the epicentral region, and half the village houses were destroyed. Damage in Madang (population 15 000), 30 km from the fault, was mainly to unreinforced masonry structures and corrugated iron water tanks. Bridges, wharfs, and roads in the Madang District were also damaged.

shocks with MS greater than 6.9 have occurred in the area since 1900. Aftershock and fault-plane solutions suggest that the earthquake resulted from faulting of two parts of a single fault zone that extends from west of Bougainville Island along the trend of the trench to Pomio on the south coast of New Britain (Fig. 1).

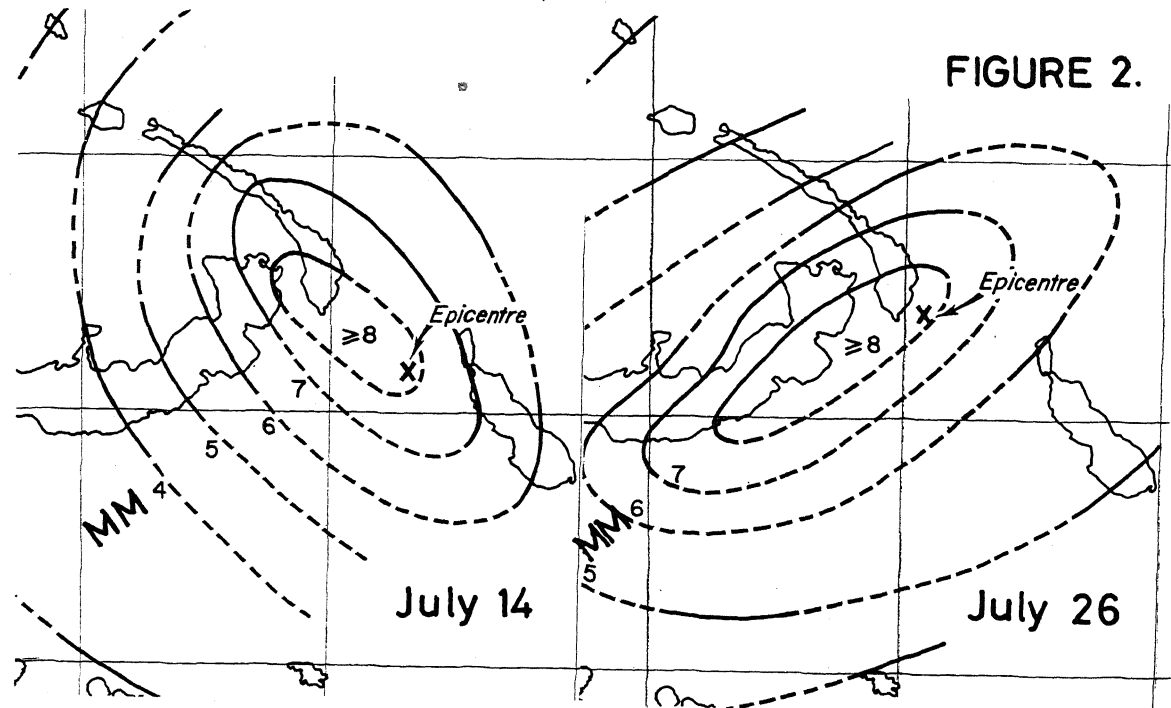
Maximum intensities were at least MM8, and the MM8 isoseismal approximately enclosed the zone of aftershock epicentres for each earthquake; i.e. the shaking appeared to be directly related to distance from the faulted zone, not the epicentre (Fig. 2). Hence although Rabaul was twice as far from the first epicentre as from the second, the intensities at Rabaul during the two earthquakes were about the same. The longer axes of the elliptical MM7 isoseismals were roughly 500 km long, and for each 'quake the area with MM7 intensities is estimated to be roughly 400 000 km².
