EVALUATION OF OLIVE VIEW HOSPITAL BEHAVIOR
ON EARTHQUAKE RESISTANT DESIGN

SYNOPSIS - Results from field, capacity and structural dynamics studies on the Olive View Hospital Main Building are correlated and discussed. The relationships of these findings to design are discussed.

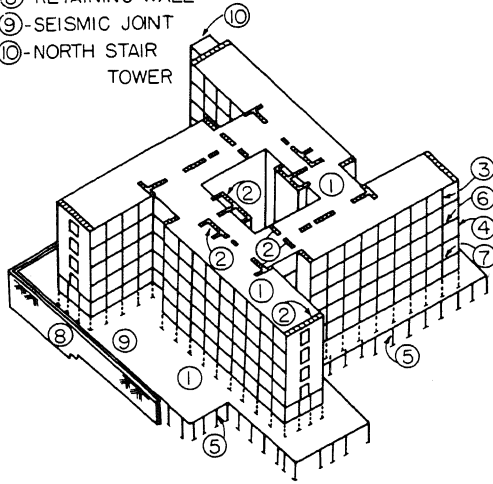
FIG. 1 STRUCTURAL FRAMING & MODE SHAPES OF OLIVE VIEW HOSPITAL MAIN BUILDING.

DAMAGES - Investigating the ground floor, the first through fifth floors, and the roof(Fig.1) the following could be observed: 1) the ground story was framed with single story tied columns, multistory square spiral columns, and beam and slab-drop panel systems; a one story retaining wall, separated at the top from the first floor slab by 4in., restrained motion of the building on the north and west sides; hinging occurred at the base of the spiral columns and in the first floor beams and drop panels above; a number of the drop panels punched due to moment; all tied columns on this floor failed in shear; intrastory drift was 6 in. north and 3 in. east; the north retaining wall was pushed 2 in. north at the top and 1 in. north at the ground floor level; 2) in the first story which was framed with multistory square spiral columns and beam and slab-drop panel systems hinging occurred at the top and bottom of the spiral columns; the drift was not uniform due to intrastory rotation; the components of drift were 27 in. north and 13 in. east on the northwest and 13 in. north and 3 in. east on the southeast corners of the building; 3) in the second story,

STRUCTURAL DYNAMICS MODELING - Using initial stiffnesses a normal mode analysis was performed; a 420 coordinate three dimensional idealization was used. The shape characteristics, ϕ , and periods, T, of the six lowest modes were: ϕ_1 , first east-west translation, $T_1=0.71$ sec. (Fig.1); ϕ_2 , second north-south translation, $T_2=0.70$ sec.; ϕ_3 , first rotation, $T_3=0.53$ sec.; ϕ_4 , second east-west translation, $T_4=0.21$ sec. (Fig.1); ϕ_5 , second north-south translation, $T_5=0.19$ sec.; and ϕ_6 , second rotation, $T_6=0.15$ sec.

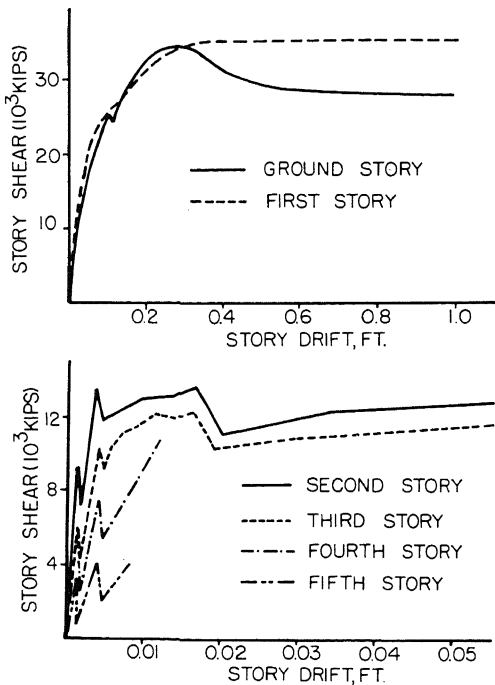
FIG. 3 STORY SHEAR-DRIFT RELATIONS.

In order to perform three dimensional modeling up to displacements achieved in the field realistic force-deflection relations for beams and columns were required. For ductile reinforced concrete elements, the moment-curvature models of Ref.(7) were generalized to include biaxial behavior. Column and beam incremental stiffness elements with 12 degrees of freedom (Fig.2) were then devised by integrating the coupled incremental biaxial moment-curvature and axial load-axial shortening relations over the length of the element. To check the element idealization the spiral column test performed at Kajima Institute(8) was modeled as a 48 degree of freedom system. Measured and computed results agree closely(Fig.2). Further refinements for modeling of buckling corner bars which were outside the core and spalling of the shell were added. Tied column failures were modeled using a biaxial shear failure law. In the upper floors similar laws were used except in shear walls where pre- and post-cracking capacities were recognized. Story shear drift relations(Fig.3) demonstrate the effects of various types of framing, hinging, tied column failures, and shear wall stiffness. The ground and first story shear-drift results imply that the large drifts in the first floor were caused by the retaining wall.

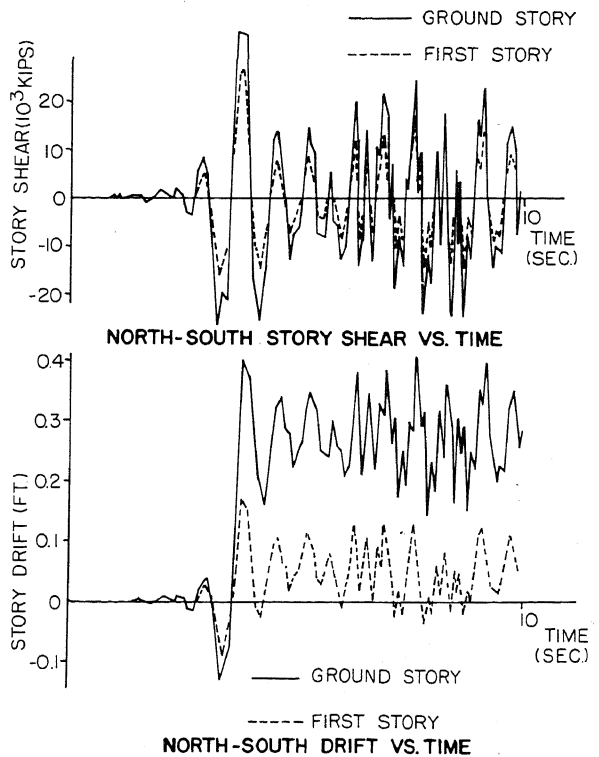
FIG. 4 STORY SHEARS AND DRIFTS, PACOIMA DAM ACCELEROGRAM

Using a coordinate reduction procedure a three dimensional building response history was computed for the Pacoima Dam(1) accelerogram(Fig.4). A 0.4ft. north drift was found in the ground floor, and a 0.2ft. north drift was obtained for the first floor. This result supports the argument that the impact on the retaining wall caused the large first story drift. Another important implication of this result is that ground shaking equivalent or greater than at Pacoima Dam occurred at the site.
