# INVESTIGATIONS ON THE PERUVIAN EARTHQUAKE OF MAY 31, 1970

By Julio Kuroiwa<sup>I</sup>, Ernesto Deza<sup>II</sup>, and Hugo Jaen<sup>III</sup>

## SYNOPSIS

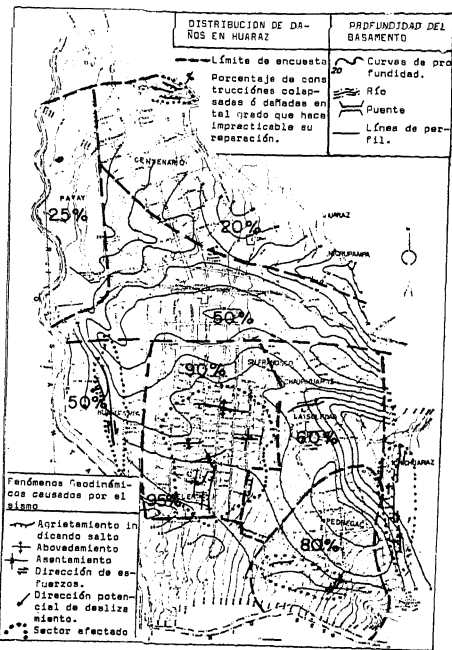
raz (Fig.4) show that while in the downtown area damages reached 90%, in Centenario, 2 kilometers north, the damages were 20%. The most notable characteristics of the soils in downtown Huaraz and Centenario are in that order, as follows: ground-water level, 0-2.7 m. and 5.00+ m.; soil settlement, yes and no; carrying capacity of the soil, 0.5-1.0 and 1.5-2.5 kilos/cm<sup>2</sup>; predominant period of the soil, 0.25-0.33 and 0.25 sec. It should be noted that in downtown Huaraz, due to the height of the adobe buildings and the narrowness of the streets, more than 10,000 persons perished. In some of the smaller towns it was noted that there was no direct relation between the damage and the distance from the epicenter. In Coishco, 40 kilometers from the epicenter and on rocky soil, the damage was minimum and many of the adobe buildings survived and are inhabited. In Andahuasi, 150 kilometers from the epicenter in an area of transition between alluvial and rocky soil, buildings similar to those in Coishco suffered 100% damage. At this stage it was also decided that it was economically feasible to repair the concrete and brick buildings, and not those of adobe. The greater part of the repairable buildings were located in Chimbote.

Fig. 4 - Map of the earthquake damage distribution, contour line of the depth of the rock foundation and geodynamic effect in Huaraz.

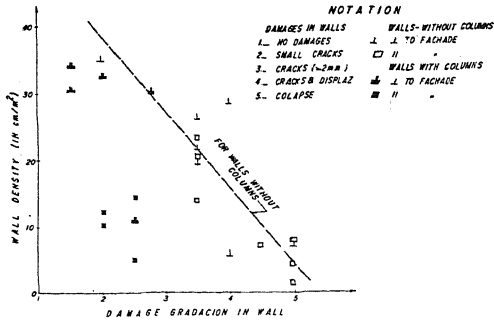
Brick buildings.- The damage done to hundreds of brick buildings was studied, especially in the Chimbote area. The results are shown in Fig.6. Each point corresponds to the average damage of groups of buildings of the same type. Failures were noted in walls having unit shearing stress as low as 0.2 kilos/cm<sup>2</sup>. This could be attributed to the low quality of the materials used and/or to a progressive failure of the walls, starting with the most rigid.

Fig. 6 - Damage vs wall density in houses with brick bearing walls

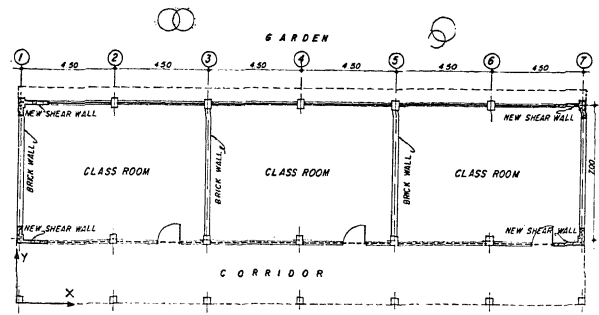
Fig. 7 - Plan of a typical school building

Concrete buildings.-More than 80% of the damage suffered by concrete buildings was due to the fact that they were not created taking seismic forces into consideration. This allowed a concentration of stresses on elements which resulted critical. Errors of 200-500% in the unit stresses were found in short columns when their true rigidity was not taken into account in the initial hypothesis of calculations. An example is found in a typical school building (Fig.7,8, and 9) where it can be observed that the central column has a clear height noticeably shorter than the other two columns, in direction X. As a result the short column received almost all of the shearing stress in that direction.

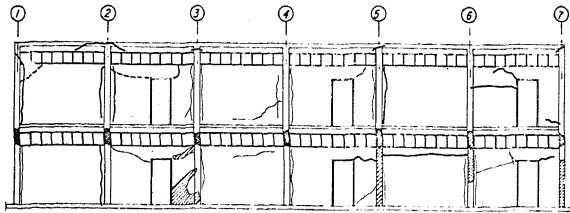
Fig. 8 - Damages (elevation)

The method followed for the preparation of the projects of repairing and reinforcing can be summed up as follows: 1<sup>o</sup>) Detailed inspection in the field of all of the structural and non-structural damage and their layout on specially prepared plans made for this purpose (Fig.8 and 9b).

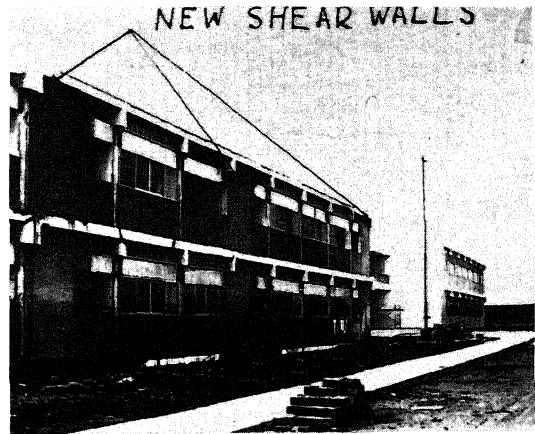
Fig. 11 - Repaired building

5°) Design of the new structural system and preparation of the details for the repairing of the damaged elements, and 6°) Preparation of the plans, technical specifications, quantities, and budget. Repairing and reinforcement projects for about 100 concrete and 2,000 brick buildings were made using this method. In cases of serious damage in short columns and walls, the cost of repairing averaged between 30 and 40% of the value of the building. Where the foundations had settled this percentage sometimes reached 50 to 60%, but even in these cases it was decided to repair the structure in order to recover part of the investment and to gain experience in repairing techniques.
