## ENGINEERING ASPECTS OF THE JULY 8, 1971 EARTHQUAKE IN CENTRAL CHILE

R.M. Lastrico (\*) and Joaquín Monge (\*\*)

This paper presents a review of the effects of the earthquake on several structures like hospitals, schools and dwellings showing the comparative behaviour of different materials. Damages to harbour facilities, bridges, earth dams, tailing dams, railroads and water supply systems are discussed. Design practice is commented.

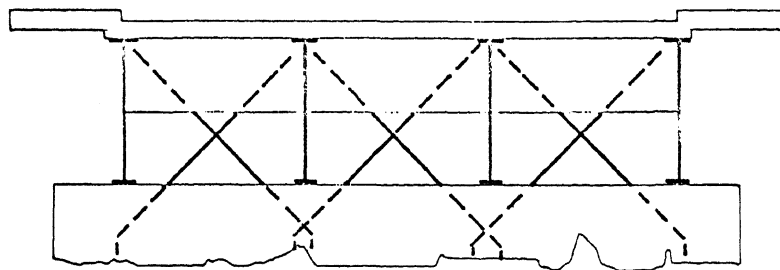
FIG. 8 DETAIL OF SEISMIC BARS DISPOSITION

A skew bridge located at Pullalli west of La Ligua suffered during 1965 earthquake the fall of one section of the superstructure, Fig. 5. The hinged connection had no protection against lateral or upwards displacement except for some steel bars connecting both slabs. After the earthquake the connection was improved by building reinforced concrete beams providing thus a continuous support, Fig. 7. In 1971 earthquake the same joint suffered a lateral displacement but the continuous support worked well. The north section, however, failed at a similar hinge where no reinforced concrete transverse beams had been provided, Fig. 6. Other two sections of the superstructure fell down. It was found that the standard chilean design of seismic bars shown in Fig. 8 was incomplete. It had been neglected during the construction and part of the bars had been added later, welding them to the webs of the steel beams. The welded connection were broken by earthquake loads. Other factors in the failure were the fact of the bridge being skew, losing support surface for rotations of the slabs about vertical axes; and large oscillations of piers founded on 13 m. deep caissons surrounded by very soft material.

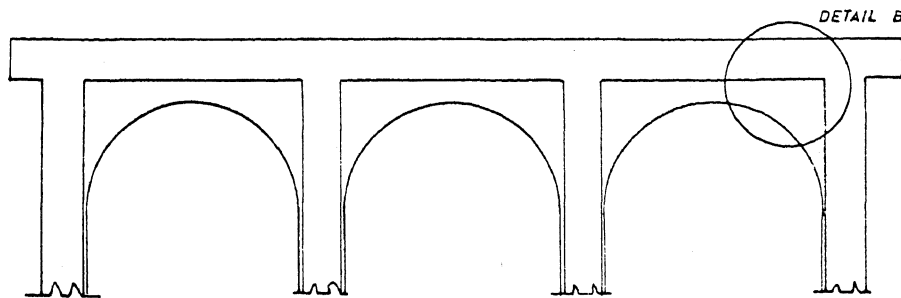
FIG. 9 DETAIL OF ARCHED PIER LLAY-LLAY OVERPASS

An overpass at Llay-Llay over the Santiago-Valparaíso railroad suffered damages in 1965 at the interior part of an arched pier, Fig. 9. Stirrups were insufficient for preventing the curved main reinforcement to straighten under the seismic stresses. The same kind of damage, though more extense, occurred in 1971 earthquake, when also damages to abutments and handrails were observed.

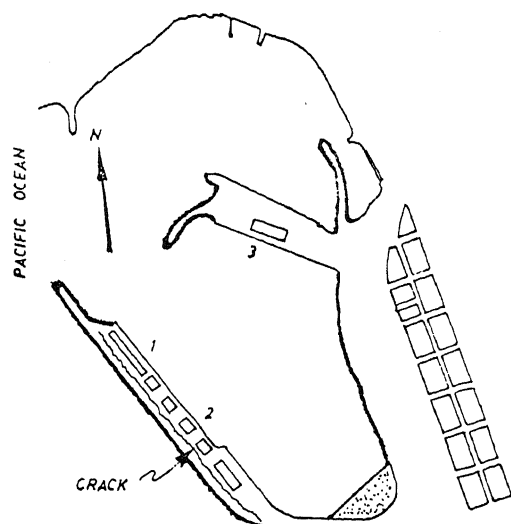
FIG. 10 PORT OF SAN ANTONIO

warehouses disturbed their normal operation for many months. San Antonio Port, Fig. 10, has 3 sites for 18.000 Tons. ships plus other sites for smaller ships. Quaywalls 1 and 2 suffered tilting with maximum displacements of 60 cm. and subsidence of the backfill up to 60 cm. Cranes had to be fixed. A longitudinal crack, Fig. 10, was observed. Warehouses were heavily damaged and had to be demolished. A group of undamaged steel silos was disassembled in order to reduce the loads acting on the quaywalls. Site 2 was inactive for 6 months; site 1 was still inactive by December 1972; site 3 remodelling began before the earthquake and was not yet finished by that date.

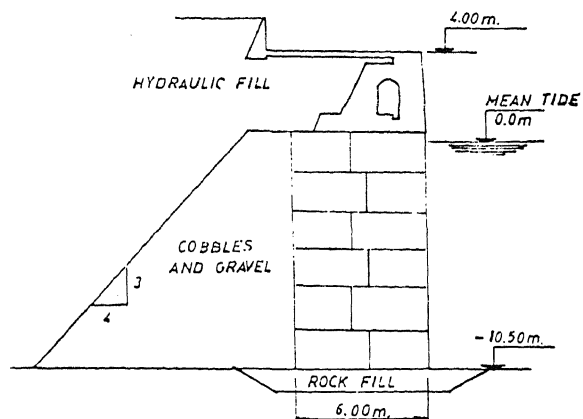
FIG. 11 QUAYWALL AT SITES 1,2 SAN ANTONIO

| k | Sliding | | | Bearing capacity | | |
|---|---|---|---|---|---|---|
| San Antonio 1,2 | 1.9 | 1.1 | - | 1.8 | < 1 | - |

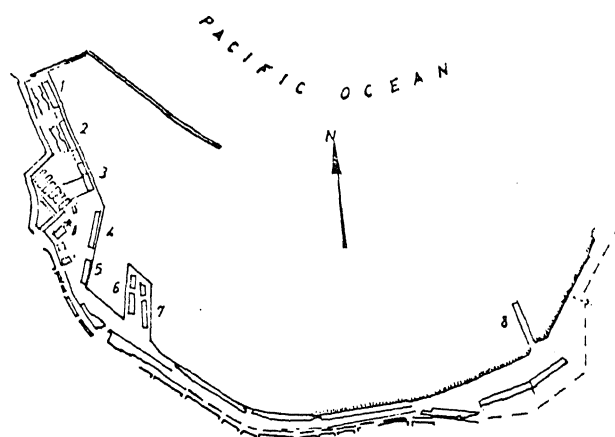
FIG. 12 PORT OF VALPARAISO

In Valparaíso, site 1 and 5 and pier 8, Fig. 12, were operating with 18.000 Ton. ships; sites 6 and 7 were remodelled. Tilting of quaywalls 4 and 5 with maximum displacements of 5 cm. and subsidence of the backfill up to 40 cm. immobilized trains. Semi-portal cranes were also fixed because of the separation of the rails. Warehouses at site 5 had to be demolished. After 17 months, site 4 is again in operation with fixed cranes; new warehouses at site 5 were not finished by December 1972. Site 6 enter into operation by that date. Other damages affected the quaywall between sites 5 and 6 and the front wall between sites 6 and 7, with displacements up to 30 cm.

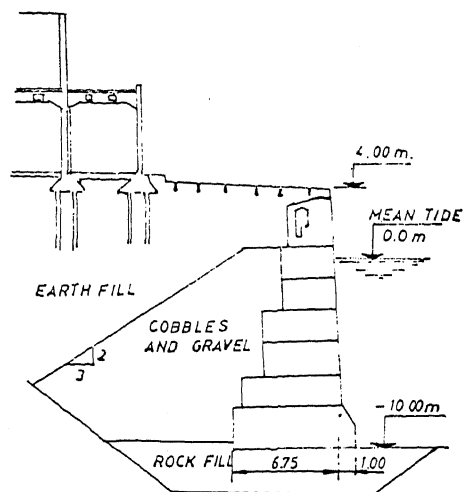
FIG. 13 QUAYWALL AT SITES 1,2,3,4,5 VALPARAISO

These quaywalls were constructed in the period 1911-1930 without consideration of earthquake forces. After 1960, gravity quaywalls and sheetpiles bulkheads are designed for an horizontal acceleration of 0.2g.

| k | Sliding | | | Bearing capacity | | |
|---|---|---|---|---|---|---|
| Valparaíso 1-5 | 2.0 | 1.2 | 0.8 | 4.4 | 3.5 | 1.5 |
