THE LUZON EARTHQUAKES OF AUGUST 2, 1968 AND APRIL 7. 1970

by
A. R. Flores

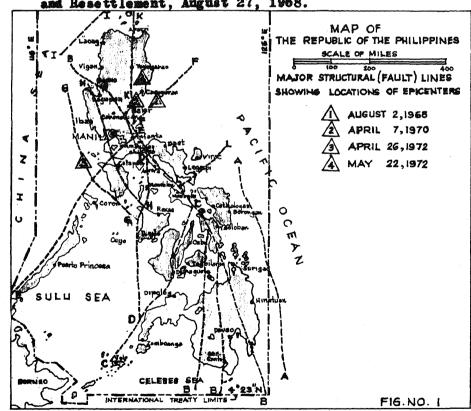
The Republic of the Philippines lies along the Circum-Pacific Earthquake Belt and is criss-crossed by fault lines (Fig. No.1). Manila, the commercial and cultural center, located at the Manila Bay of Luzon Island, has been the victim of much destruction due to its critical location at the mouth of the Pasig River. Records show that since 1589 to 1899 damaging earthquakes with Intensities RF-6 and above occurred once in 15 years, and since 1900, ence every 35 years. The recent Luzon Earthquake of August 2, 1968 with Intensity RF-7.3, epicenter 230 Kms., N 43° E from Manila, triggered the collapse of the Ruby Tower killing 322 persons, wounding about 300, and damaged more than 30 buildings. Another shock on April 7, 1970 with Intensity RF-7.2, epicenter 165 Kms., N 42.5° E from Manila, damaged also few buildings including some still undergoing repairs. The people have developed such seismic phobia that lighter shocks of Intensity RF-6 on April 26 and May 22, 1972 scared them again running down stairways and away from buildings.

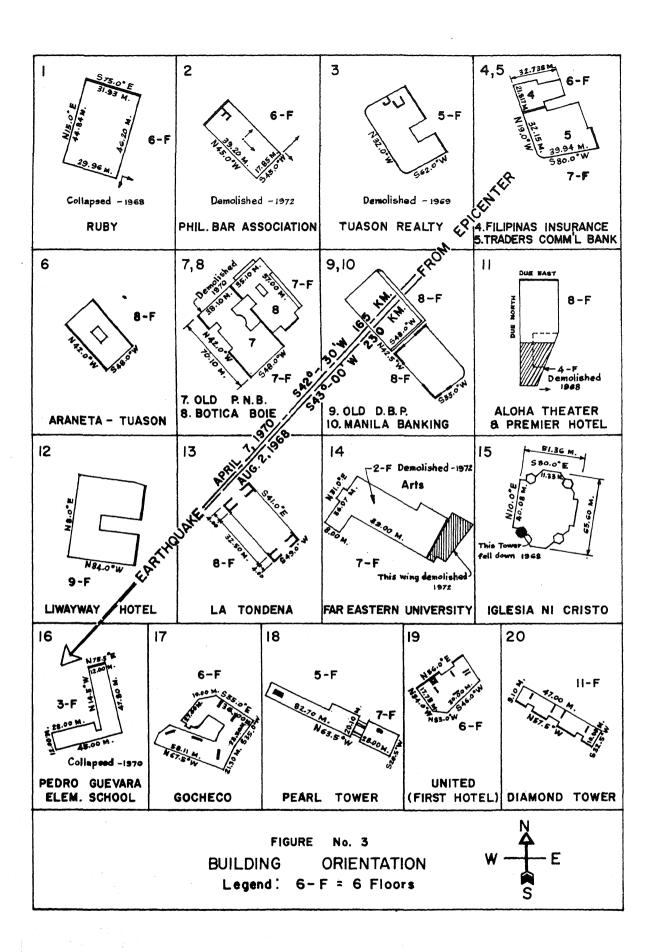
Fig. No. 2 shows the location of buildings damaged in 1968 and 1970 - all within the alluvial area, predominantly on the congested area north of the Pasig River. They are generally of reinforced concrete construction with masonry block partitions. The various degrees of damages may be classified into: (1) Total failure or impending collapse due to buckling of columns and shear failure in beams such as the Ruby Tower, the Pedro Guevara Elementary School and the Philippine Bar Association Bldg.; (2) Moderate damages due to cracks in the columns and beams at their intersections, cross-cracks in wall panels, shear cracks along construction joints, cracks in partitions and at corners of doors and windows with planes oriented along the seismic waves in about 60% of the damaged buildings. (3) Light damages, usually architectural, such as plaster cracks, removal of tile and/or marble finishes, breakage of glazing and wision glasses, and hammering of adjacent buildings. It might be mentioned here that there were many other buildings with architectural damages, but never reported officially.
