Design Implications of Damage Observed
in the Olive View Medical Center Buildings
by V.V. Bertero, B. Bresler, L.G. Selna,
A.K. Chopra, and A.V. Koretsky

DESIGN IMPLICATIONS OF DAMAGE OBSERVED IN THE
OLIVE VIEW MEDICAL CENTER BUILDINGS

DESIGN IMPLICATIONS OF DAMAGE OBSERVED
IN THE OLIVE VIEW MEDICAL CENTER⁽¹⁾

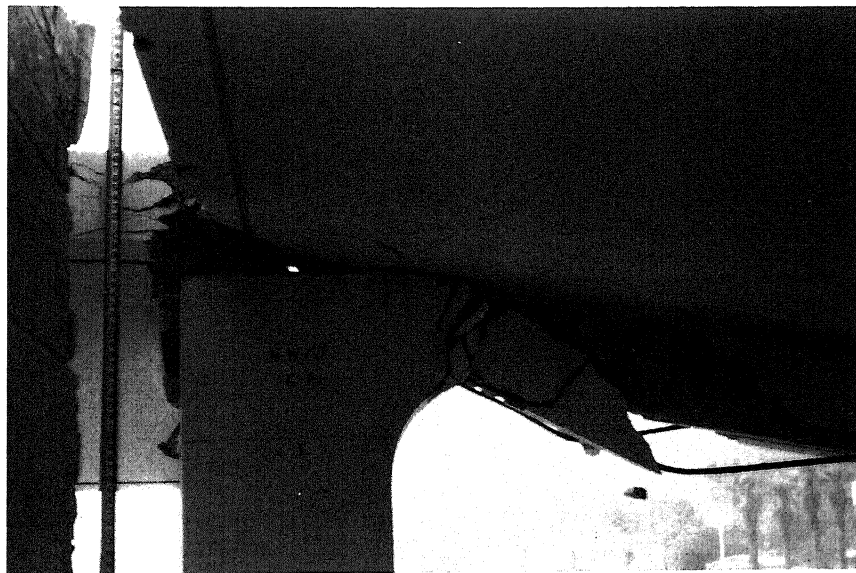
Field studies also confirm that moment in the joint was the principal cause of the failure. The sequence of the failure can be reconstructed by study of one of the damaged joints (Fig. 1). The failure started at the top left hand side of the column due to flexural tension. The tension crack then propagated to the right hand side of the column where a tension failure was initiated in that part of the edge beam protruding below the shade slab. There was no reinforcing steel at that elevation in the edge beam to resist the tension so that a complete failure ensued. Note that the #6 bars at the bottom of the edge beam popped out. It can be seen in Fig.1 that the direction of the diagonal failure which resulted as concrete dropped away from the inside face of the edge beam is opposite to a crack which would result from torsion due to gravity plus dynamic vertical load.

Based on these analytical and field studies it was concluded that the poor bar detailing was the principal cause of the failure.

Fig. 1 Exhaust Pavilion Joint Damage
