PERFORMANCE OF UNDERGROUND STRUCTURES  
AT THE JOSEPH JENSEN FILTRATION PLANT

by Loring A. Wyllie, Jr.<sup>1</sup>, Frank E. McClure<sup>2</sup> and Henry J. Degenkolb<sup>3</sup>

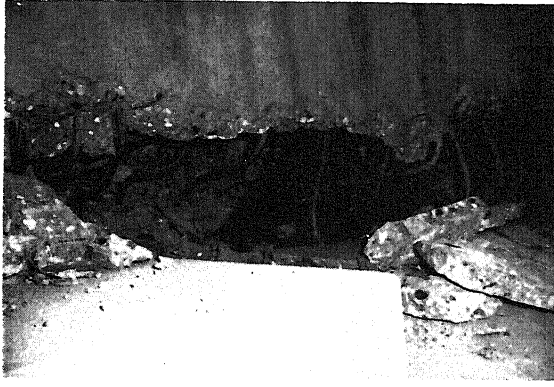
Structural damage to the reservoir was very extensive and spectacular. The west wall failed at its base for over 400 feet, see Photograph Number 1. The actual failure took place at the top of the reinforcing steel dowels, about 2 feet 3 inches above the floor slab drop panel, Photograph Number 2. As the wall failed the earth pressure pushed the wall into the reservoir and it dropped, lowering the roof slab over 2 feet. The east exterior wall also failed at its base and moved into the reservoir as much as 2 inches. Furthermore, the east wall had numerous horizontal cracks, was bowed inward as much as 4 or 5 inches, and had a massive wall failure near the north end.

Photograph Number 1. West wall of reservoir failed at its base. Wall has pushed in and dropped. Concrete in foreground is floor slab drop panel.

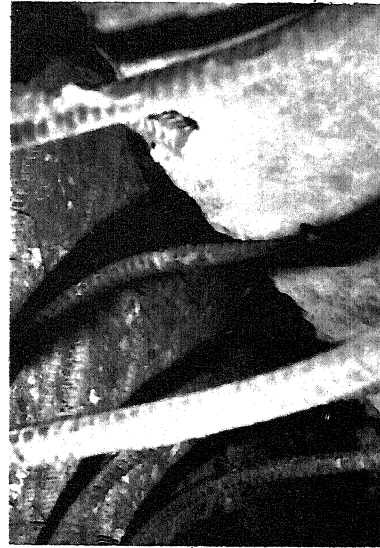
Photograph Number 2. Close-up of west wall failure at base of wall. Rebar is inner face wall reinforcing. Horizontal break in concrete occurs at top of dowels.

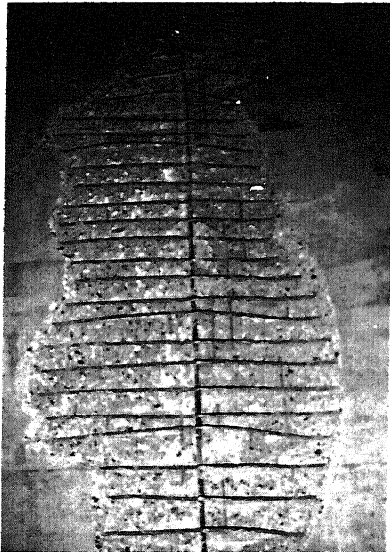
Photograph Number 3. Typical view of construction joint on line 24-1/2. Width of spalled concrete is approximately 5 feet wide. Note how reinforcing bars have been stretched.

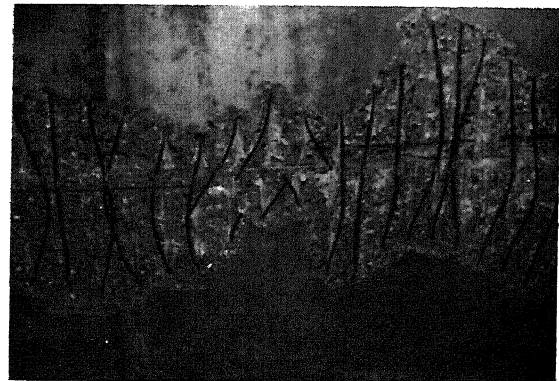
Photograph Number 4. Construction joint on line 24-1/2 where three reinforcing bars failed by necking in tension. Measurements indicated that the joint slid a minimum of 15 inches one way, 11 inches the other way.

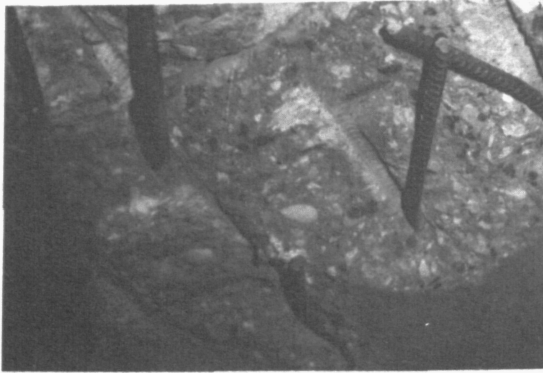
Photograph Number 5. Close-up of broken reinforcing bars in Photo Number 4. Note tension failures of reinforcing and scratch marks of deformations on bars on the concrete surface.

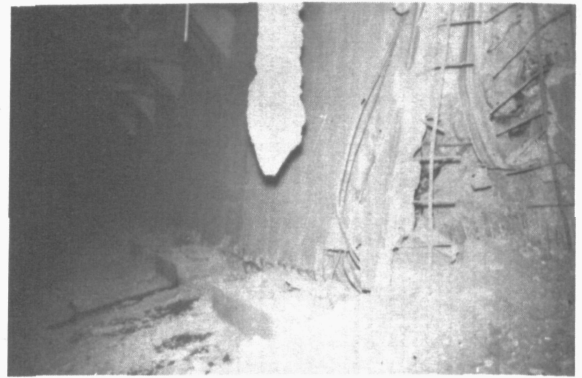
Photograph Number 6. West wall of reservoir at line 24-1/2, looking south. Wall has moved inward 3 feet and dropped about 2 feet.

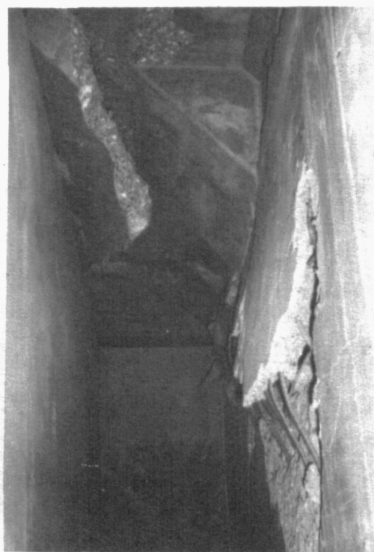
Photograph Number 7. East wall of reservoir near line 24 looking north. Wall at left is cantilever overflow wier wall. Note slab failure above.

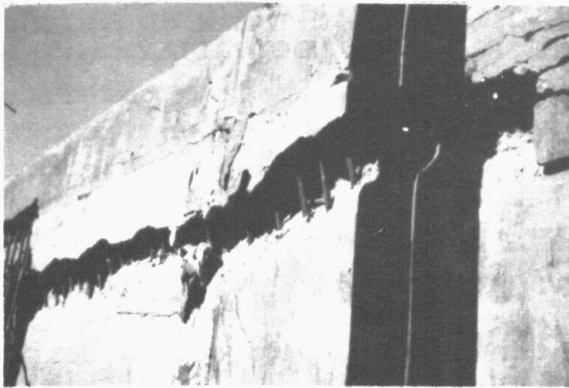
Photograph Number 9. East wall of double box Effluent Conduit after backfill removed. This was the point of heaviest damage.

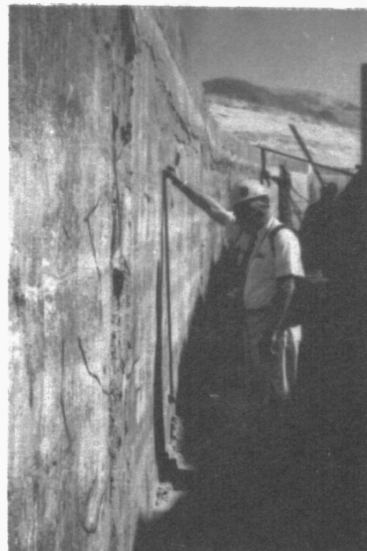
north end to moderate at the start of the "S" curve, severe in the "S" curve area, moderate south of the "S" curve, and severe at the junction of the conduit and the reservoir inlet structure. The conduit generally experienced differential displacements and/or rotations at most expansion joints. Horizontal cracking occurred near the top and bottom of all three walls. This cracking was minor in the northern portions of the conduit, but was severe in the "S" curve area where it increased to spalling and fracturing of the walls as the roof slab moved to the east, see Photograph Number 9. There were longitudinal horizontal cracks near the middle of the exterior walls and at the top of the foundation dowels at some locations. Approximately 500 feet of the box structure had been "racked" 4 inches maximum out of plumb to the east, see Photograph Number 10.

Photograph Number 10. East of wall of Effluent Conduit in "S" curve area after backfill removed. Note out of plumb of wall, which was 4 inches maximum for 8-1/2 foot inside height.

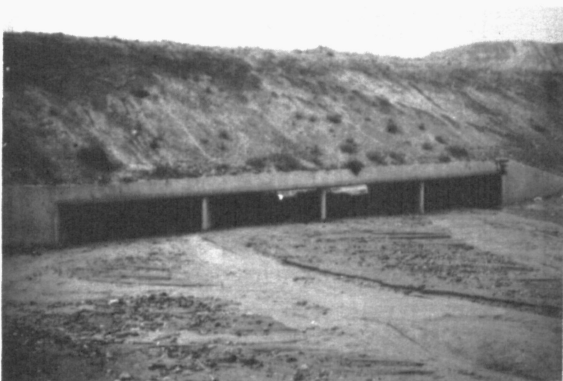
The box culvert is a partially buried structure with the west abutment having more extensive backfill than the east abutment. Earthquake induced inertia forces of the structure and embankment fill caused lateral movement toward the unconfined eastern edge. The inertia forces combined with differential lateral earth pressures and displacements resulted in the lateral racking and failure of all the walls.

Photograph Number 11. Box Culvert for railroad spur line looking north. Culvert is half full of mud and silt. Culvert racked to east or right by 4 to 6 inches.

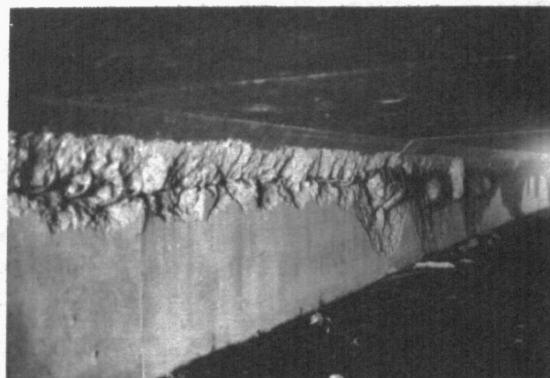
Photograph Number 12. Interior wall of Box Culvert which failed at its top.
