ENGINEERING LESSONS TAUGHT BY EARTHQUAKES

Glen V. Berg^I and Robert D. Hanson^{II}

SYNOPSIS

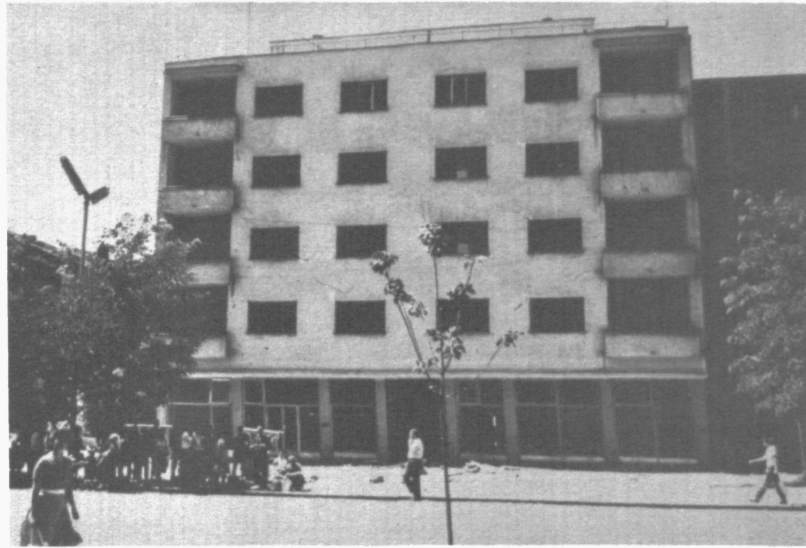
In multi-story buildings the ground story is often more flexible than the upper stories, sometimes intentionally and sometimes not. Upper stories are usually stiffened by structural or nonstructural walls and partitions, and ground stories are often open, with the number of walls and partitions held to a minimum in order to provide maximum flexibility in the use of the building. Outside walls are often glass show windows on the street side. The result is a rigid box atop a flexible ground story. The predictable earthquake behavior is shown in Fig. 1, a building in Skopje. Another graphic example was the 10-story Palace Corvin apartment building in Caracas. The front half which had small stores, with partition walls, at the ground floor, remained standing while the identical rear half with automobile parking, no partition walls, at the ground floor, collapsed.

Fig. 1. Soft ground story, Skopje

The soft ground story is not without its proponents; indeed, some have advocated the use of a soft ground story to limit the inertia forces imparted to the structure above. In effect, this uses the ground story as a structural fuse. To be useful, a fuse must be expendable; ground stories are not. Experience should have taught us to avoid the soft story.

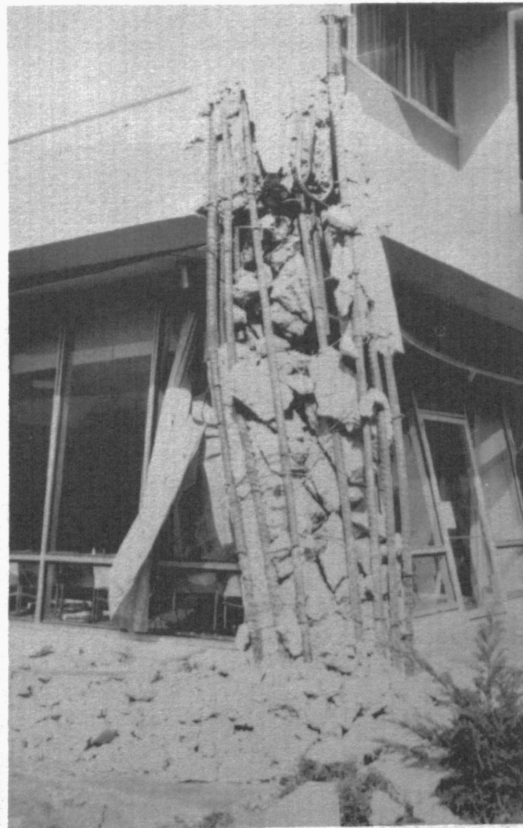
failure, on the other hand, occurs by yielding of the stirrups or ties or by tension fracture of the concrete between them. Shear failure is basically brittle; when it occurs the member loses its capacity to resist shear. The difference in behavior was shown dramatically in the columns of Olive View Hospital in San Fernando. The corner columns, Fig. 2, were tied and failed in a brittle manner. The intermediate columns, Fig. 3, are spiral columns and retained their load-carrying capacity through equally large deformations.

Fig. 2. Brittle failure of tied column, San Fernando

The maximum possible shear in a reinforced concrete column is the sum of the ultimate moment capacity at each end divided by the effective length. In many cases it is possible to avoid shear failure simply by proportioning the column to accommodate this amount of shear force.

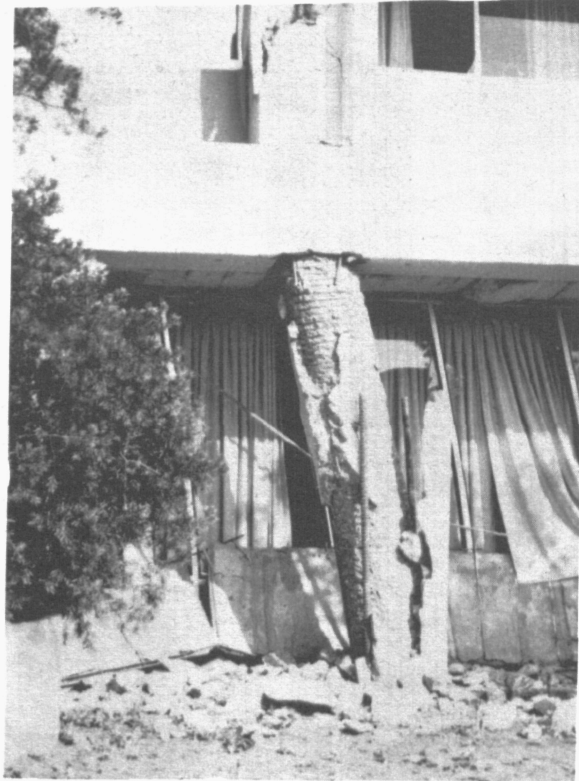
Fig. 3. Ductile behavior of spiral column, San Fernando

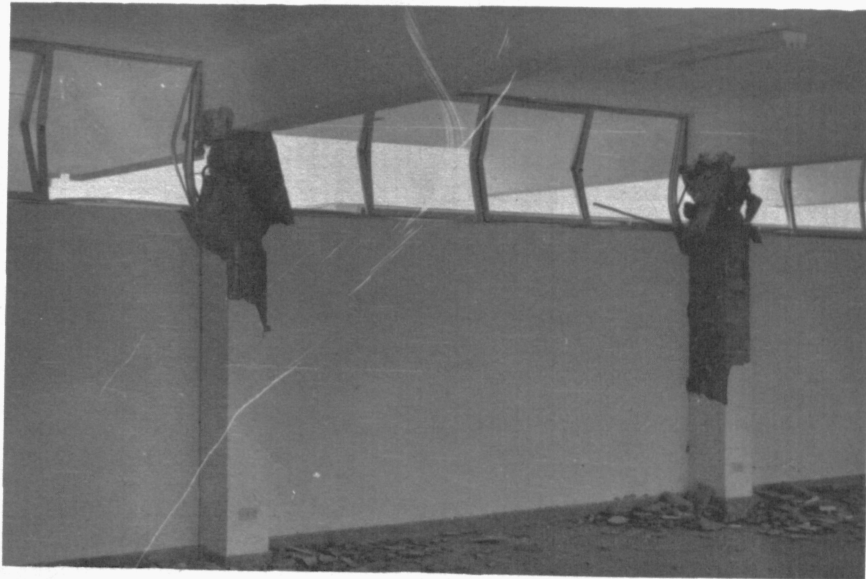
The nonstructural element is somewhat misnamed. Any element in a structure affects the behavior of the structure unless it is built in such a way that it remains undeformed throughout the response of the structure. Window glass is often mounted so the sash can deform without straining the glass. "Nonstructural" unit masonry partitions are usually built in contact with the adjoining structural frame, and even though they are not relied upon to provide strength to support the structure, they do provide strength up to their capacity if they are deformed by the structural response. The school buildings of Chimbote utilized reinforced concrete frame structures in which some of the columns were restrained by masonry walls. Whether the strength of the walls was considered in the design or not, it gave the columns a very short effective length and correspondingly high shear forces. The columns failed in the brittle type of shear failure mentioned earlier, as shown in Fig. 4.

Fig. 4. Columns restrained by adjacent walls, Chimbote

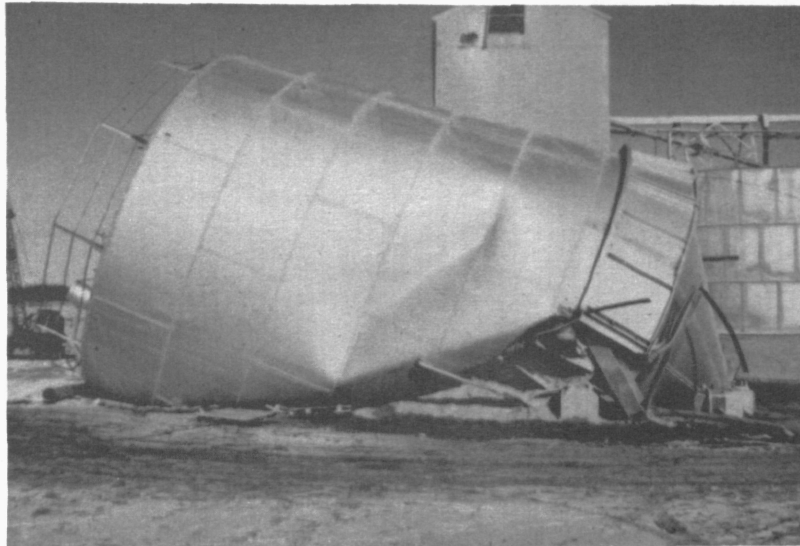
In general it is easier to design structural members than the connections that join them. Yet members seem to get the greater share of the designer's attention. In much of the U.S. it is the custom for the engineer to specify the type of structure and the details of the structural members quite strictly, but to allow the builder or fabricator considerable freedom to choose the connection details best suited to his own facilities and practice. To a degree this makes sense, but it also imposes the requirement that the engineer appraise the performance capacities of the connections to be used, and to be sure they are adequate to meet the requirements of the structure. This is risky. Most fabricators and builders envision the function of the connection as transmitting the forces associated with gravity loads. Seismic forces are apt to be the farthest thing from their minds. The Permanente cement bin in Anchorage, Figs. 5 and 6, is an extreme example. The columns were securely X-braced, and the bearing plates were firmly anchored to the concrete pedestals. Alas, only a token weld attached the column to its bearing plate. The connection was entirely adequate for gravity load and probably for wind also, but it was worthless for seismic force.

Fig. 5. Collapsed cement bin, Anchorage

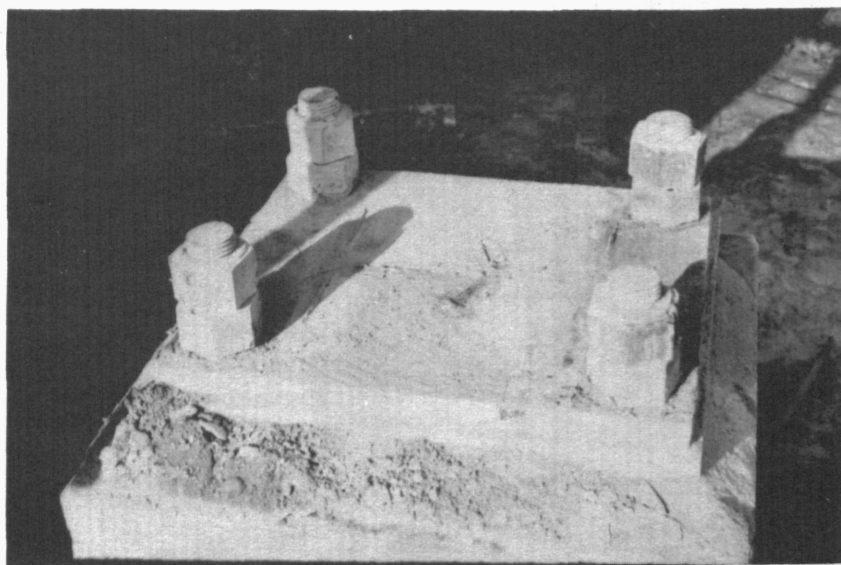
Fig. 6. Base plate for cement bin column, Anchorage

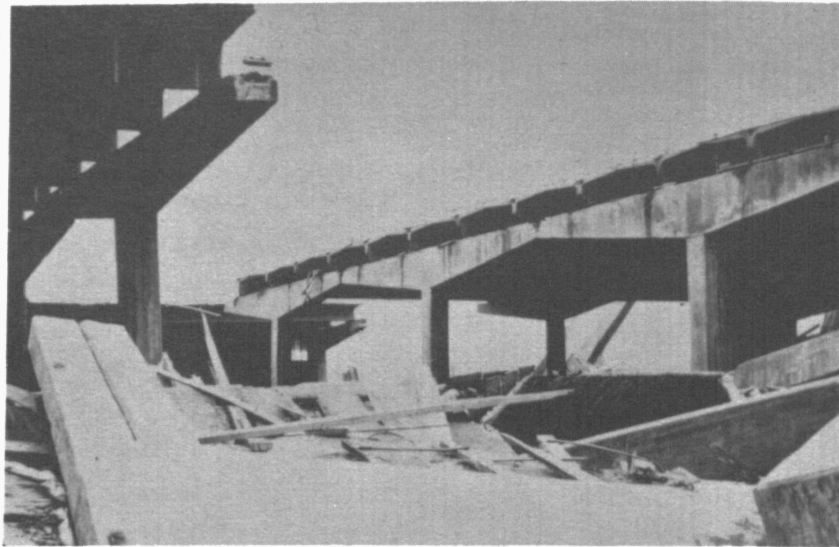
Examples of connection failures abounded in Anchorage. The Alaska Sales and Service Building, Fig. 7, was precast concrete. The structural

members were adequate, but the connections were weak. Many of the structural members survived the fall to the ground and were salvaged for use in the rebuilt structure, in which the connections were more generously proportioned.

Fig. 7. Precast concrete structure, Anchorage

In its ultimate behavior, the structure must absorb or dissipate the energy imparted to it by the earthquake. Energy dissipation involves structural deformations beyond the elastic range. Generally members can be proportioned to exhibit ductile behavior well beyond the elastic range, but connections are more limited. Hence it is desirable to keep the connections elastic, and throw the inelastic behavior into the main members. Whenever feasible, connections should be proportioned to develop the ultimate force that can be transmitted to them by the members they join.

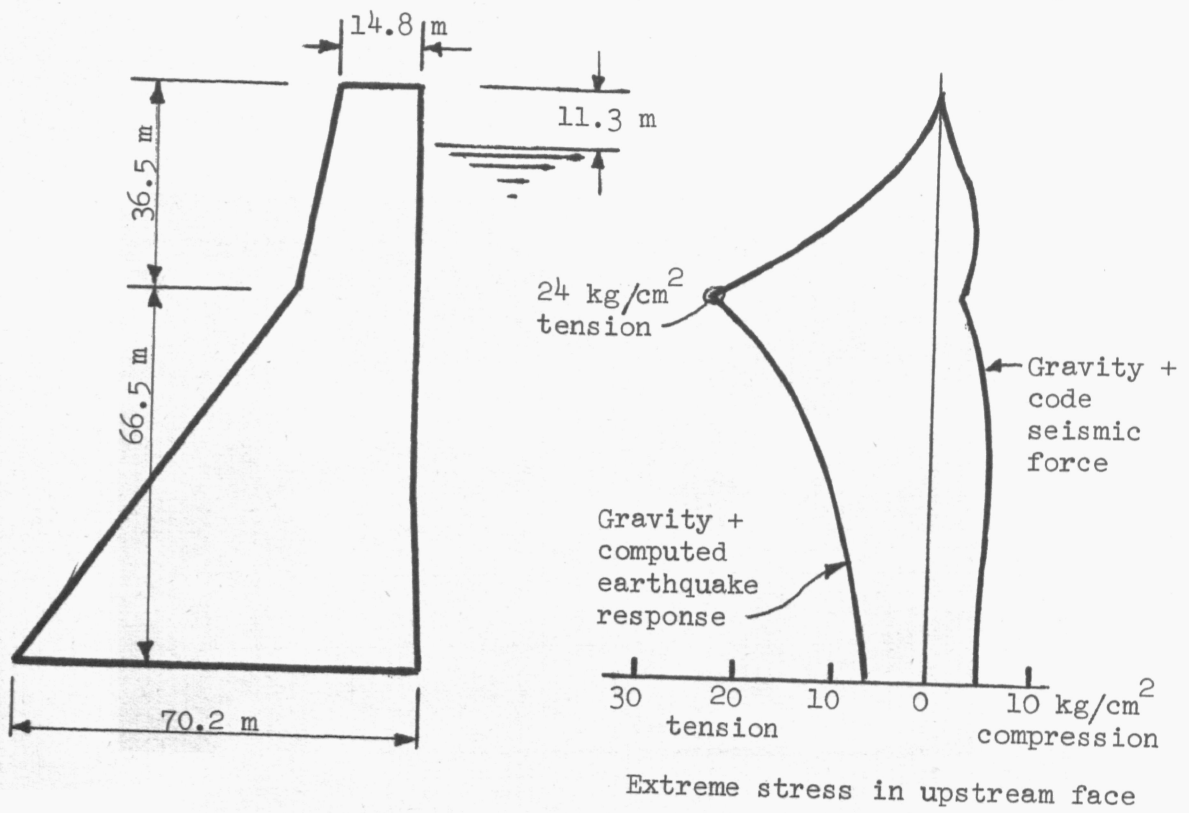
Most seismic building codes require that structures be designed to withstand specified equivalent static lateral forces without exceeding specified stress limits. It is recognized that the specified static lateral force is considerably less than the actual dynamic forces that would be induced in the structure by the earthquake. We rationalize this by saying that after all, the structure is designed on an elastic basis and the materials can tolerate deformations far in excess of those corresponding to the design stresses. Within limits the rationale works; however, it may be misleading, for the seismic force may act in either direction, and may augment or counteract the effect of gravity loads. A good example is Koyna Dam, a straight concrete gravity dam. Its cross-section, shown in Fig. 8, has an unusual break in the slope of the downstream face because an unanticipated planning change required switching from a two-stage construction operation to single stage after construction had begun. Under normal service load the vertical stress is compression throughout the entire section for any reservoir level. With the reservoir full, the upstream compressive stress is small, especially opposite the break in slope of the downstream face, and the lateral seismic force reduces this further. Computing the effect of the extreme lateral force specified by the seismic code, one finds the upstream face to be in compression for the full height, albeit a small compression opposite the break in slope of the downstream face. This is shown in Fig. 8.

The Koyna earthquake was recorded in the dam. The effect of gravity plus the computed first mode of response to the recorded earthquake is also shown in Fig. 8. This shows a computed tension in the upstream face well in excess of the tension capacity of the concrete. The dam fractured at that location and extensive repairs had to be undertaken.

Fig. 8. Koyna dam section and stresses

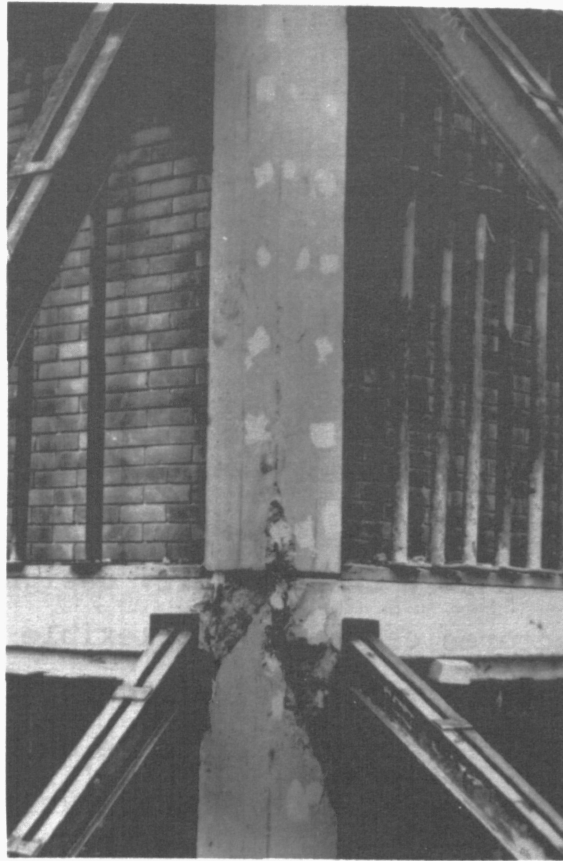
Another potential problem area from seismic overload occurs in exterior columns of tall buildings, where the overturning effect of seismic forces may more than offset gravity load effects, leading to tension in columns. Perhaps the best example of this is the Petunia II Apartment Building in Caracas, shown in Fig. 9. These column tension forces require proper splices for steel columns and appropriate reduction in flexural strength in reinforced concrete columns.

Fig. 9. Tension effects in column, Caracas

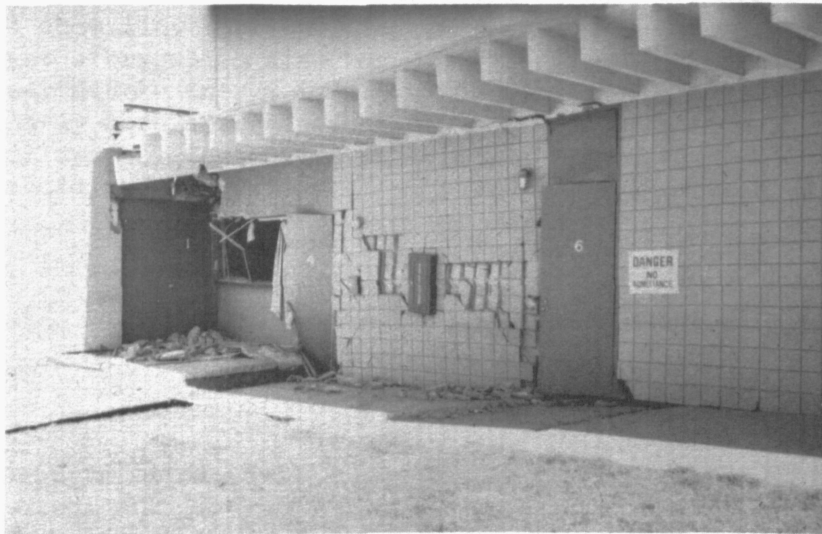
We have gained a valuable lesson from our experience with grouted masonry walls. The State of California requires that masonry walls in certain buildings be grouted to meet specified standards. For concrete block walls the essence of the requirement is that the cores of the units be reinforced with vertical bars and filled with grout. Figure 10 shows block walls at the Juvenile Hall in San Fernando after the 1971 earthquake. A surface fracture of the ground ran through this facility and damage was extreme. We leave it to the reader to imagine what might have happened to this building if these had been unreinforced block walls. The merits of grouting are clear.

Fig. 10. Grouted block walls, San Fernando
