AN EXAMPLE OF EPOXY MORTAR REPAIR
OF A REINFORCED CONCRETE BEAM-COLUMN JOINT

by
R. Michael McCafferty^I and Martin L. Moody^{II}

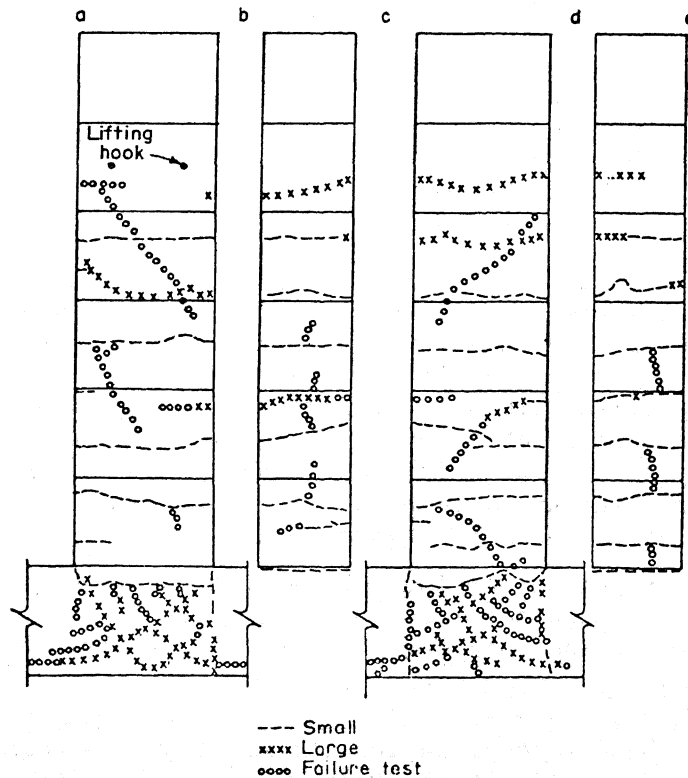
The reinforced concrete specimen showed a significant drop in stiffness after the small energy transient loading, as indicated by the fundamental frequencies in Figure 2. The specimen had no cracks in it for the first set of frequency and damping determinations. From a practical viewpoint, the specimen with minor cracks is probably the best approximation of what exists in a real structure. The series of dynamic tests caused increasing numbers of cracks as shown in Figure 1. Associated with increased cracking are a decrease in fundamental frequency and an increase in damping as shown in Figures 2 and 3.

Figure 1 - Crack Patterns Before Repair

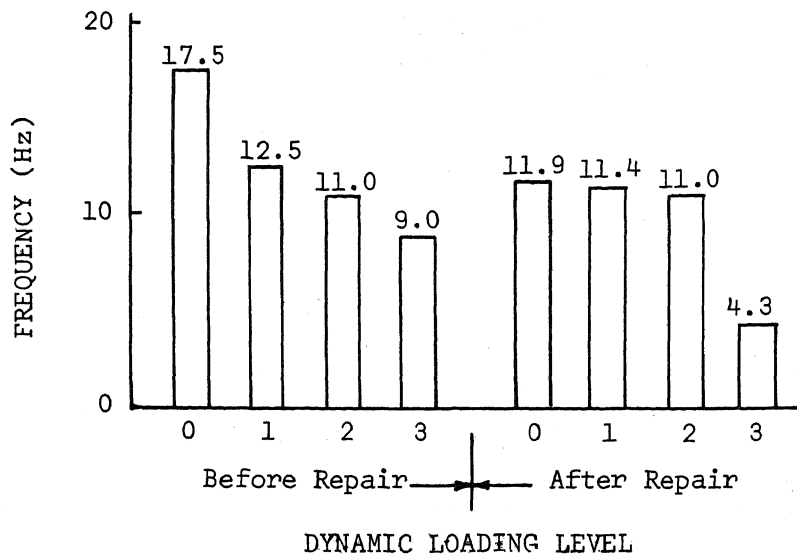
Tests of the repaired specimen showed that some of the stiffness was restored according to the natural frequencies shown in Figure 2. The joint repair restored the specimen to a level of performance similar to

that originally observed after the small transient. There was little change observed in the frequency and damping values of the repaired specimen after it had been tested with the small and large transient loadings. The frequency changed from 11.9 Hz to 11.0 Hz and the percent of critical damping increased from 2.2 to 2.5. No new cracks developed in the beam or column during these tests and the mortar repair remained uncracked. However, during the shakedown test a brittle failure was observed within the epoxy mortar, indicating less ductility in the repaired joint than in the original joint. The failure moment observed in the beam of the original specimen was 155 ft-kips, whereas the failure moment in the beam of the repaired specimen was 140 ft-kips. Even more significant was the difference in deflections which increased by a factor of approximately 14 in the repaired specimen for the shakedown test. The specimen performed poorly after cracks formed in the epoxy mortar. These cracks had the appearance of a brittle failure, occurred suddenly, and large pieces of material fell out of the joint during this final test. There was excellent bond between the concrete and mortar with most of the cracking occurring entirely in one material or the other. In a real structure where gravity loads are present in addition to the dynamic loads, the type of joint failure observed would probably have resulted in collapse of the structure.

Figure 1 -- Frequency vs. Dynamic Loading Level;
 (0) no load, (1) small transient,
 (2) large transient, (3) failure

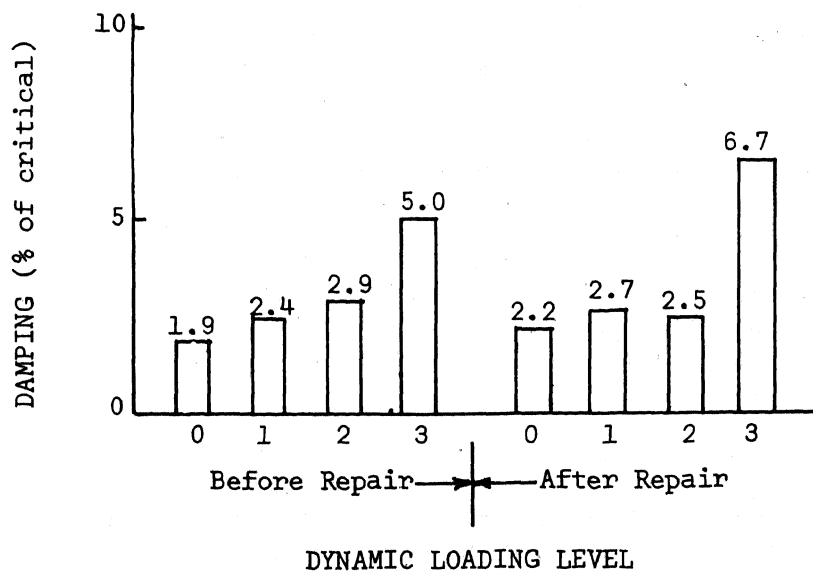
Figure 1 -- Damping vs. Dynamic Loading Level;
 (0) no load, (1) small transient,
 (2) large transient, (3) failure
