# REPAIR OF BUILDINGS DAMAGED BY THE 1969 BOLAND EARTHQUAKE

C.J. THOMPSON<sup>I</sup>

On the 29th September, 1969, at 10.00 p.m., the Western Cape in South Africa was severely shaken by an earthquake which caused damage estimated at R15 million (\$18 million). This paper provides a general description of the damage caused to masonry structures near the epicentre, describes repair techniques and methods of surveying the damage and specifying the repair details.

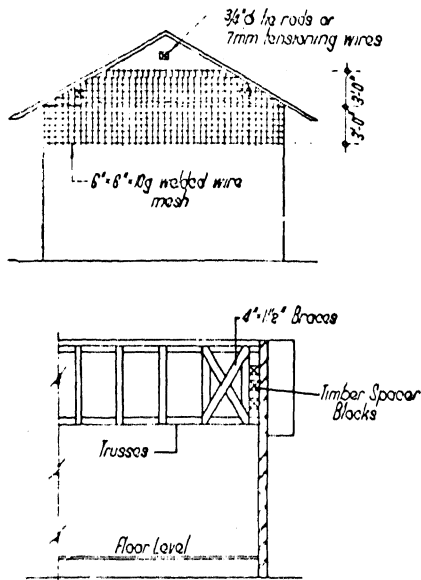
TYPE VIII- REPAIR OF GABLES

Type VIII was applicable to the repair of gables and required the bracing of roof trusses in order to provide some lateral support for the gable walls. The cracks in the gable walls were repaired using a variation of the Type I detail and the gables were restrained from outward displacement by means of a number of tie bars.

Note The manner of repair refers to gables which have horizontal cracks and which are stable.

1. Chip down all plaster 3/4" on either side of the main cracks and roughen the surface of the cracks.
2. Fix 6" x 6" x 10g welded wire mesh on both sides of wall if possible with 10g wire ties.
3. Plaster with 2 coats plaster Mix A or B for baked and unbaked bricks respectively.
4. Drill 1/4" holes for the rods/thread bars and complete as per type III.

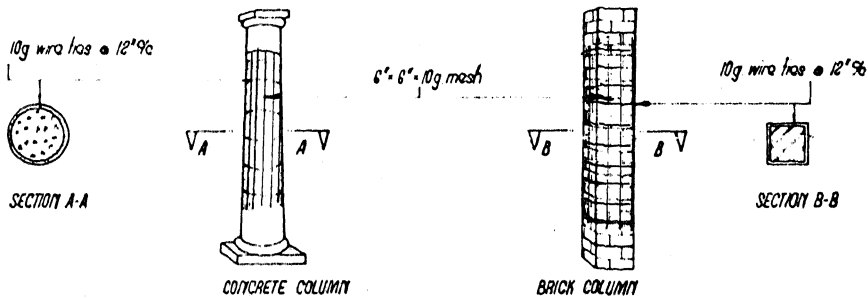
TYPE X- REPAIR OF COLUMNS

Note This type of repair refers to columns that are lightly cracked or alternatively the manner in which columns are to be strengthened after being rebuilt.

1. In the case of brick columns chip down all plasterwork and in case of circular columns roughen the surface wall.
2. Wrap mesh around column and fix wall.
3. Fix 10g wire ties @ 12" oc.
4. Replaster in 2 coats.

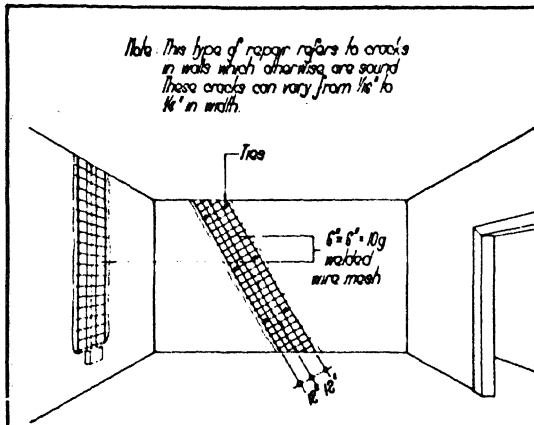
**TYPE I-REPAIRS OF MINOR OR ISOLATED CRACKS**

Note: This type of repair refers to cracks in walls which otherwise are sound. These cracks can vary from 1/8" to 1/2" in width.

1. Chip down all plaster for 12" adjacent to crack.
2. Chip out crack and grout if possible.
3. Fill 6"x6" walled wire mesh with 1/2" ties.
4. Plaster with 2 coats Mix A or B for baked and unbaked bricks respectively.

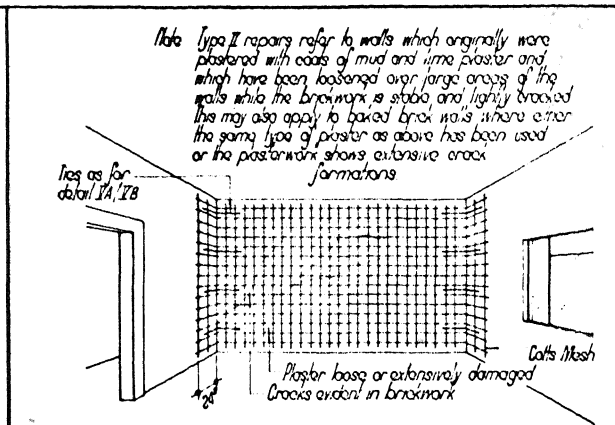
**TYPE II-REPLASTERING OF WALLS**

Note: Type II repairs refer to walls which originally were plastered with coats of mud and lime plaster and which have been loosened over large areas of the walls while the brickwork is stable and lightly cracked. This may also apply to baked brick walls where either the same type of plaster as above has been used or the plasterwork shows extensive crack formations.

1. Chip down plasterwork over whole wall.
2. Fix 6"x6" walled wire mesh to walls using 1/2" tie wires, through predrilled holes in wall of approximately 4"x4" in both ways.
3. Apply 2 coats plaster using Mix A or B for baked and unbaked bricks respectively.

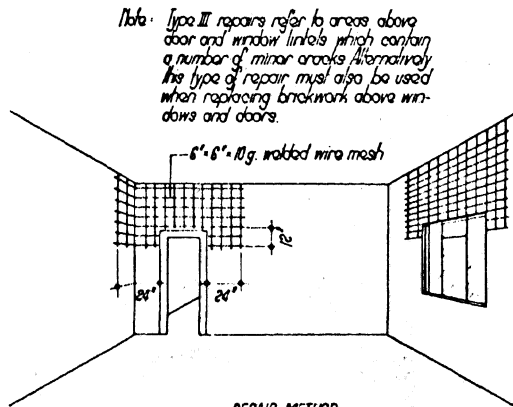
**TYPE III-REPAIRS TO WINDOWS & DOORS**

Note: Type III repairs refer to areas above door and window lintels which contain a number of minor cracks. Alternatively, this type of repair must also be used when replacing brickwork above windows and doors.

- Note:
1. Chip down all areas shown above, including all base plasterwork.
  2. If necessary, chip into the crack surface to roughen.
  3. Nail 6"x6" walled wire mesh to both sides of prepared surface.
  4. Replaster in two coats using Mix A or B for baked and unbaked bricks respectively.
  5. Where the brickwork has been badly damaged and is loose, it shall be replaced if specified using new baked bricks, mesh reinforcement and plaster shall be applied in accordance with Note 3 and 4 above.

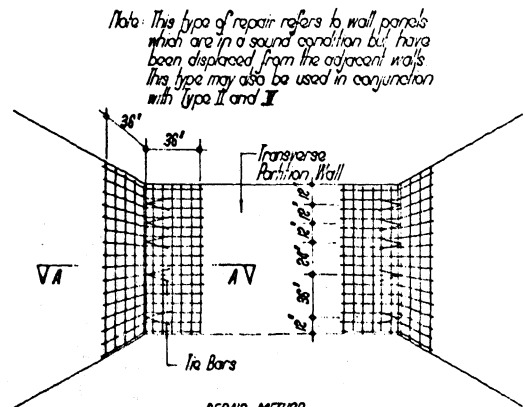
**TYPE IV-TYING IN OF PARTITION WALLS**

Note: This type of repair refers to wall panels which are in a sound condition but have been displaced from the adjacent walls. This type may also be used in conjunction with Type II and III.

- Note:
1. Chip down plaster for a distance of 36" on the transverse partition wall and 36" on longitudinal wall at the corners on both sides of partition wall. Chip down plaster over 5'0" on face of longitudinal wall opposite partition wall (see Section A-A).
  2. Apply 6"x6" walled wire mesh to exposed brickwork faces and fix these through walls using 1/2" wire ties at 3'0" up wall.
  3. Drill holes in longitudinal wall adjacent to corner at intervals shown on elevation and fix ties through wall.
  4. Where practicable, insert plastic ties into crack as specified.
  5. Replaster in 2 coats using Mix A or B for baked and unbaked bricks respectively.
  6. Grout crack using mix specified.

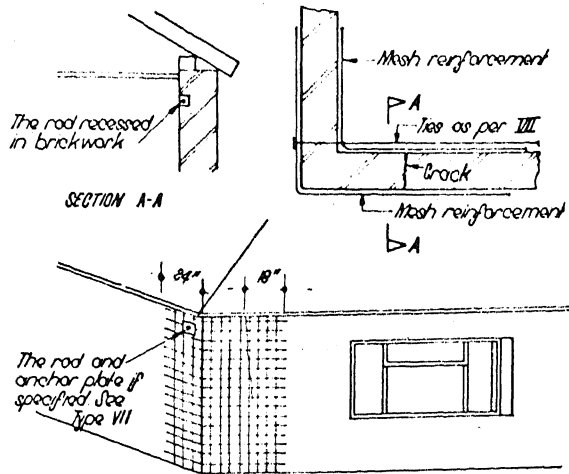
**TYPE V: TYPE V INTERNAL CORNERS**

Note This type of repair refers mainly to corners which have only one vertical crack

1. Chip down and remove all plasterwork as indicated
2. Chip open crack and inject grout as specified
3. Fix 10g x 8" x 8" webbed wire mesh to walls with 10g tie wires
4. Apply 2 coats plaster III A or B for baked or unbaked bricks respectively
5. The rods as per type III may be used with this detail where specified

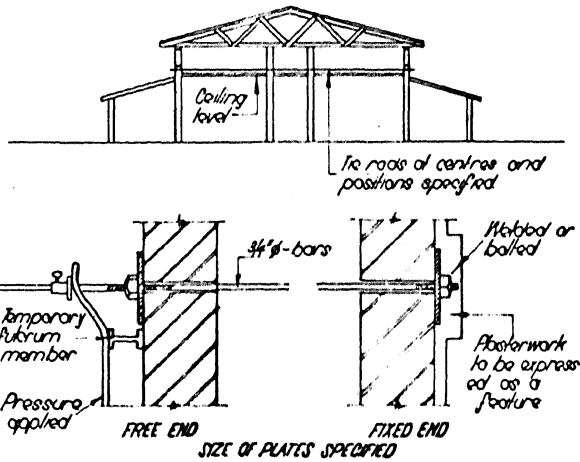
**TYPE VII A: MILD STEEL TIE BARS**

Note These tie bars are used to maintain walls in present positions. No attempt shall be made to restore

1. The attic wall shall be reinforced mesh plastered as given in type II for a distance of 2' at least 3/4' on either of the tie rod positions
2. Drill 1/4" holes through walls and thread 3/4" tie bars
3. Weld or bolt on the anchor plate at fixed end
4. Remove slab in tie rod at free end, and fix to anchor plate by means of welding or other suitable methods
5. Paint with an approved protective coating and plaster over

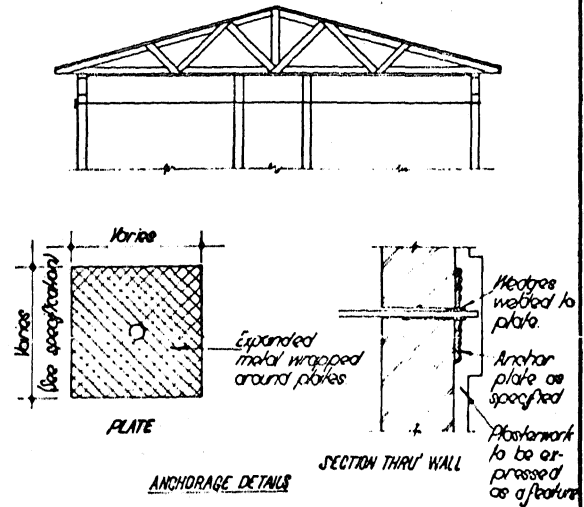
**TYPE VII B: PRESTRESSED TIE BARS**

On the 14th April, 1970 these Repair Details were subjected to a full scale test when a severe aftershock of 6,5 on the Richter Scale occurred. An inspection of the repairs to a number of prototype properties already completed indicated isolated hair cracks in green plasterwork and a number of prestressed tie bars whose anchorages had failed.

Note These tie bars are used to maintain walls in present positions. No attempt shall be made to restore walls to original positions.

1. Walls shall be reinforced mesh plastered as specified
2. Drill 3/4" holes through walls and thread 7mm ties
3. Stress and weld the anchor to plate at both jacking and fixed ends
4. Paint with an approved protective coating and plaster over
