DESIGN LESSONS LEARNED FROM THE PERFORMANCE
OF INSTRUMENTED HIGH-RISE BUILDINGS
IN THE SAN FERNANDO EARTHQUAKE

William E. Gates ^I

SYNOPSIS

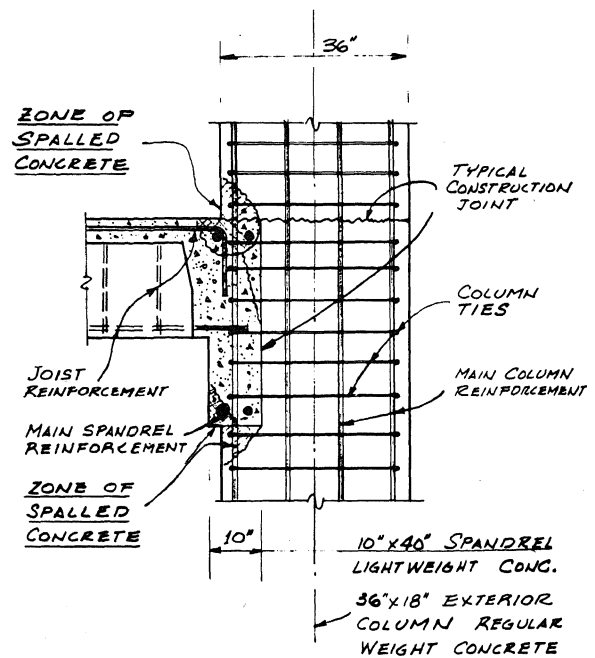
FIGURE 2 TYPICAL CONSTRUCTION DETAIL OF EXTERIOR COLUMN-SPANDREL-JOIST CONNECTION, FROM 4TH FLOOR TO ROOF BANK OF CALIFORNIA (1)

Prior to the San Fernando Earthquake, reinforced concrete moment-resisting space frames under 160 feet in height were not required to be designed to ductile standards. The Sheraton Universal Hotel (Table 1) was the only concrete frame among those investigated that was designed to ductile standards. There were five steel frames which also met the code standards for ductility. During the earthquake none of these structures experienced forces large enough to produce inelastic behavior. However, three of the reinforced concrete moment-resisting space frames, constructed without the special ductile design features, experienced large enough forces to perform inelastically. In two of these structures -- the Holiday Inns -- the moment-resisting frames exhibited a degree of ductility with little sign of spalling or reduction in moment capacity at the beam-column joints. However, in the case of the 12-story Bank of California, significant spalling occurred at the spandrel-to-column joints in the exterior moment-resisting frames. The spalling started at the fourth floor level and extended upward. The large portions of concrete which spalled from the lightly reinforced spandrel-to-column joints (see Figure 2) produced a significant reduction in moment-resisting capacity, as well as vertical load-carrying capacity.

The almost brittle behavior of the spandrel-girder-to-column connection above the fourth floor is attributed to a combination of several factors. To facilitate construction, the connection detail was redesigned as shown in Figure 2. Starting with the fourth floor, a construction joint was introduced in the connection between the lightweight concrete floor and spandrel system and the normal weight concrete column. Confinement of the lightweight concrete in the spandrel at the connection was only partially provided by the column ties. As seen from Figure 2, this was the area of major spalling.

The Subcommittee was particularly concerned about the loss of moment-resisting capacity and reduction in lateral load resistance associated with the brittle joint spalling. To protect such structures against possible collapse under earthquake forces in excess of standard design, the Subcommittee recommended that all reinforced concrete moment-resisting space frames designed with a $K=0.67$ should be designed with ductile characteristics, regardless of height.

The City of Los Angeles in their Interim Seismic Design Code (9) and the SEAOC in their Appendix F (6) have adopted the following standard -- "All concrete space frames required by design to be part of the lateral force-resisting system shall be ductile moment-resisting space frames."

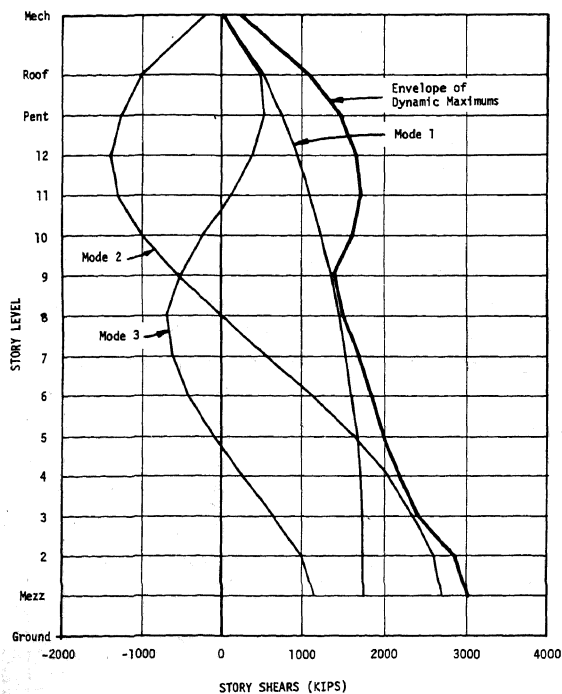
FIGURE 3 MAXIMUM STORY SHEARS NORTH-SOUTH DIRECTION CERTIFIED LIFE BUILDING (1)

A significant result of the post-earthquake analysis was the discovery that a majority of the medium high-rise buildings (12-20 stories) experienced larger force response in the second and third modes of vibration rather than in the first mode, as normally implied in code design. An example is shown in Figure 3 where the peak story shears for the first three modes have been superimposed. In this case, the peak second mode shears exceed the first mode values in the top five stories. Even the envelope of maximum modal shears, with all 8 modes of vibration included, has a distinct second mode contribution in the top six stories, as indicated by the bulge in the envelope plot.

In several of the steel-frame structures, yielding of girders was calculated to have occurred only in the upper stories. This was attributed to the high second and third mode response.

Design overstress in the upper story girders points out a weakness in current code seismic design. Higher mode whip is considered significant only in the design of tall, slender high-rise buildings with height-to-base width ratios in excess of 3. In these structures a concentrated lateral force is added to the normal triangular force distribution, at the top level.

The Subcommittee recommended that current code practice be modified to incorporate higher mode force design in medium-rise structures, as well as high-rise. No code revisions have been made along these lines. However, where dynamic analyses are included in the design process and earthquake motions from nearby faults are considered in the analysis, the

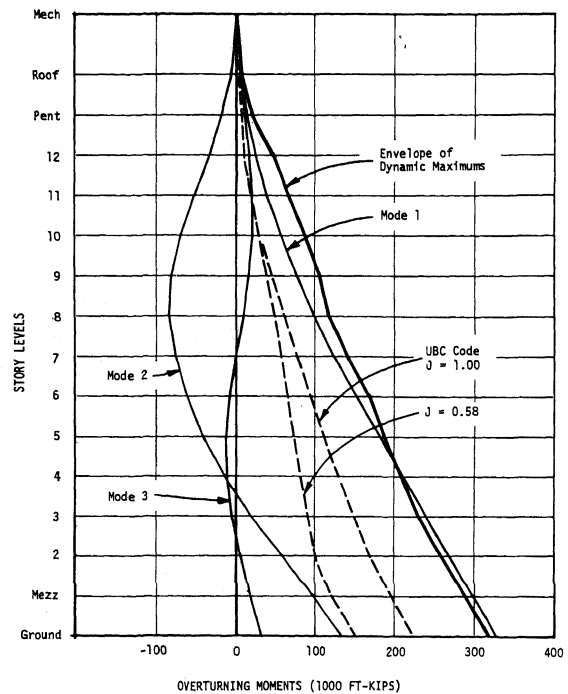
FIGURE 4 MAXIMUM OVERTURNING MOMENTS NORTH-SOUTH DIRECTION CERTIFIED LIFE BUILDING

However, the computed response from the 11 instrumented high-rise buildings did not show a cancellation of overturning moments due to higher mode response. Figure 4 presents a plot of peak overturning moments in each of the first three modes, along with the envelope of maximum overturning from all 8 modes. In the upper half of the structure higher modes contribute significantly to the net overturning moment response, while in the lower stories there appears to be little increase or decrease in first-mode response due to higher mode consideration. Similar results were obtained for the other buildings. Overturning moments computed by code procedures with and without reduction (i.e., $J=0.58$ and $J=1.0$) are superimposed upon the figure for comparison.

In 1970, shortly before the earthquake, SEAOC recommended that the "J" factor be omitted from the seismic design of new structures until further study could justify its applicability to normal building construction (see Section 2312(h) of Reference 6). The results from the instrumented building investigation provide justification for permanently eliminating the overturning moment reduction factor from the code.
