DEFORMATION OF THE VAN NORMAN RESERVOIRS AREA,
NORTHERN SAN FERNANDO VALLEY, CALIFORNIA^I

R. F. Yerkes^{II}, T. L. Youd^{III}, and J. N. Alt^{II}

SYNOPSIS

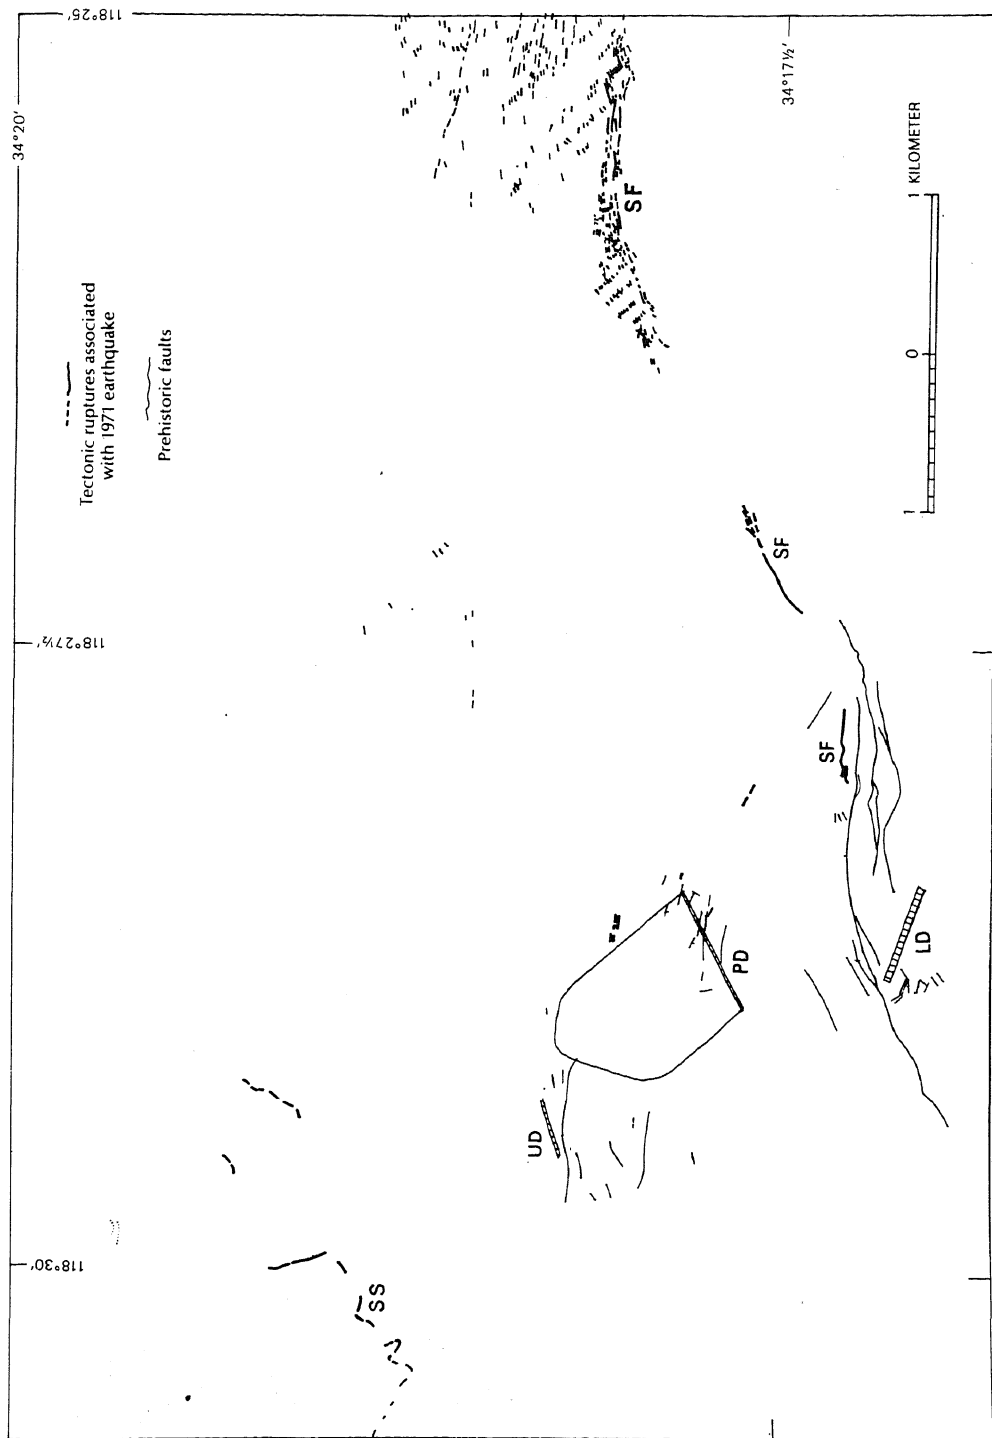
The 1971 San Fernando earthquake ($M 6\frac{1}{2}$) occurred on one of the east-trending, north-dipping reverse faults of the mountain-front zone. Surface ruptures of the fault traversed the northern San Fernando Valley for 6 km just east of the lower reservoir and thence east for another 9 km along the base of the San Gabriel Mountains; this zone of surface ruptures is named the San Fernando fault zone. Maximum measured components of displacement on the 1971 ruptures were: vertical, 1.4 m; horizontal (left-lateral), 1.9 m; horizontal shortening across the fault, 0.6 m; net (left-oblique-reverse) slip, 2.4 m. Geologic, topographic, and hydrologic evidence shows that the 1971 ruptures followed a long-established zone of similar fault movements. Radiometrically dated ancient wood was found beneath a buried fault scarp more than 1 m high, which is aligned with 1971 ruptures having vertical separation of less than a meter. If the buried scarp is due to a single event, a larger earthquake probably occurred along the San Fernando fault zone 200 ± 100 years before present.^{2/}

FIGURE 3.--Map of northern San Fernando Valley showing tectonic ruptures associated with the 1971 San Fernando earthquake, and known prehistoric faults in the Van Norman reservoirs area. UD-upper dam, PD-proposed dam and reservoir, LD-lower dam, SF-1971 tectonic ruptures along the San Fernando fault zone, SS-tectonic(?) ruptures along the lower trace of the Santa Susana thrust. Based in part on U.S. Geological Survey Staff³.

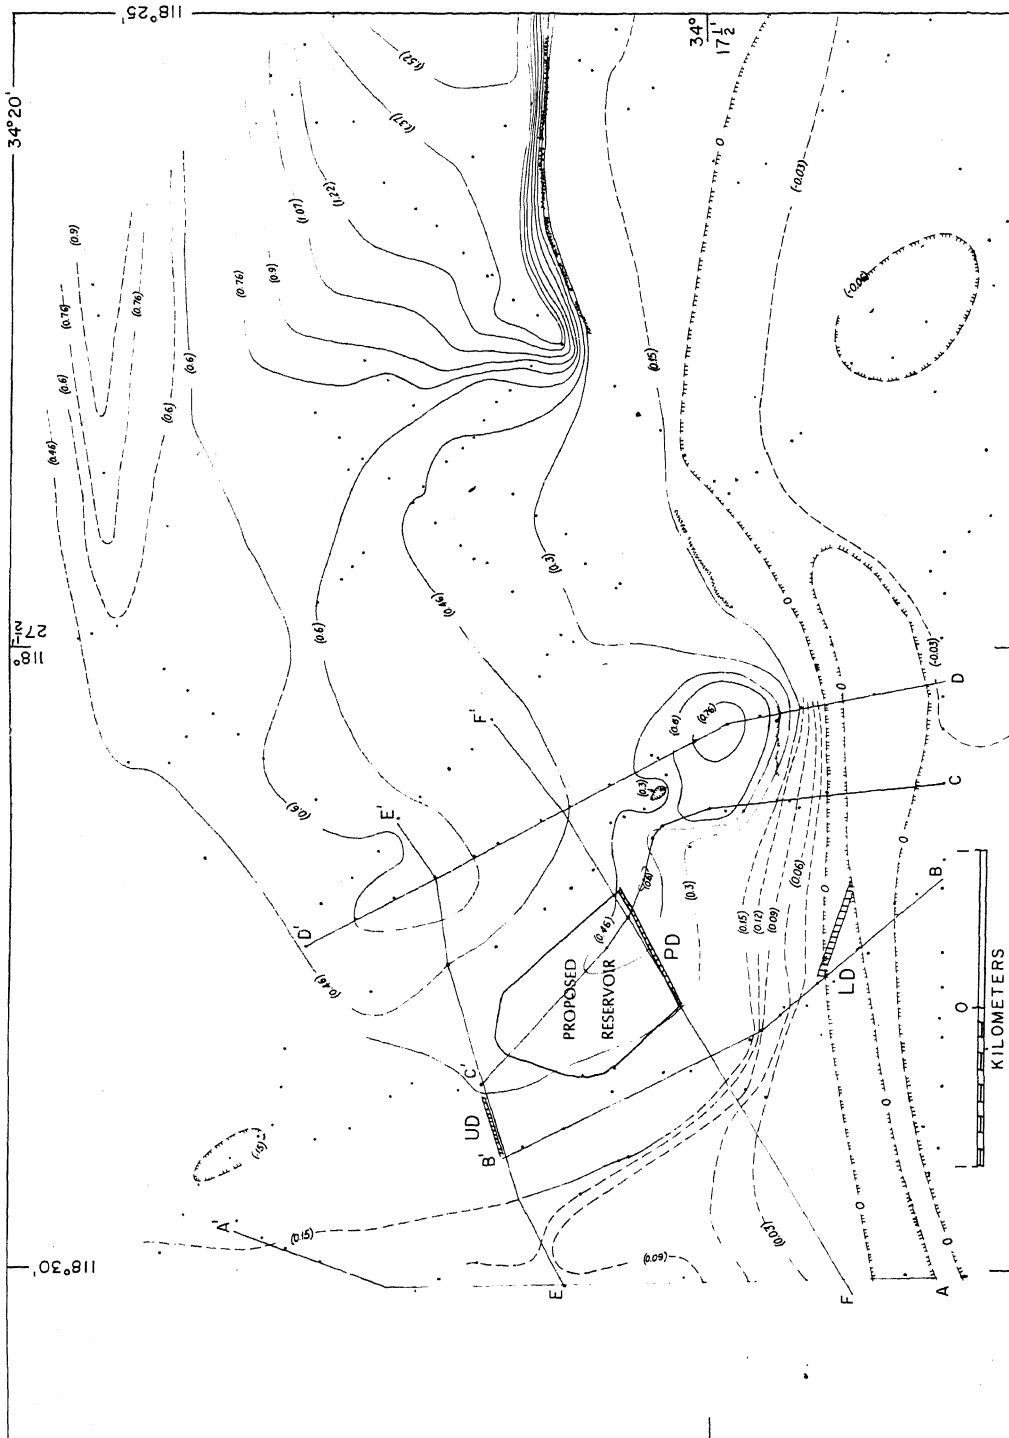
Deformation of the ground surface associated with the 1971 earthquake has been mapped in detail. Figure 4 shows vertical displacements in the northern San Fernando Valley between preearthquake (1968-1970) and, post-earthquake (1971-1972) surveys. Notable features are listed.

1) A west-plunging arch generally coincident with the south limb of the syncline extends westward into the valley and the reservoir area from its maximum development in the foothills east of the valley; vertical displacement ranges from more than 2 m in the foothills to

0.5 m in the center of the reservoirs and 0.2 m along their west margin.

2) An area of low hills just east of the reservoirs and north of the rupture zone was elevated 0.83 m; this uplift extends northwestward into the site of the proposed dam.

3) A linear zone of slight depression about 0.1 to 0.3 km wide trends across the valley immediately south of the 1971 rupture zone.

4) The east abutment of the upper dam was elevated 0.317 m and the west abutment 0.213 m; the east abutment of the proposed dam was elevated about 0.555 m and the west abutment about 0.323 m.

5) Areas that were elevated in 1971 coincide with pre-existing topographic highs underlain at or near the surface by steeply dipping bedrock.

FIGURE 4.--Map of northern San Fernando Valley showing contours of elevation change in meters, between 1968-1970 and postearthquake surveys (pre-earthquake survey of line D-D' made in 1955). Locations of survey stations shown by dots; accuracy of elevations ± 0.015 m. Locations of 1971 tectonic ruptures along San Fernando fault zone shown by fine sawtooth lines. Lines A-A' to F-F' are profiles of elevation change (see figure 5). UD-upper dam, PD-proposed dam, LD-lower dam.

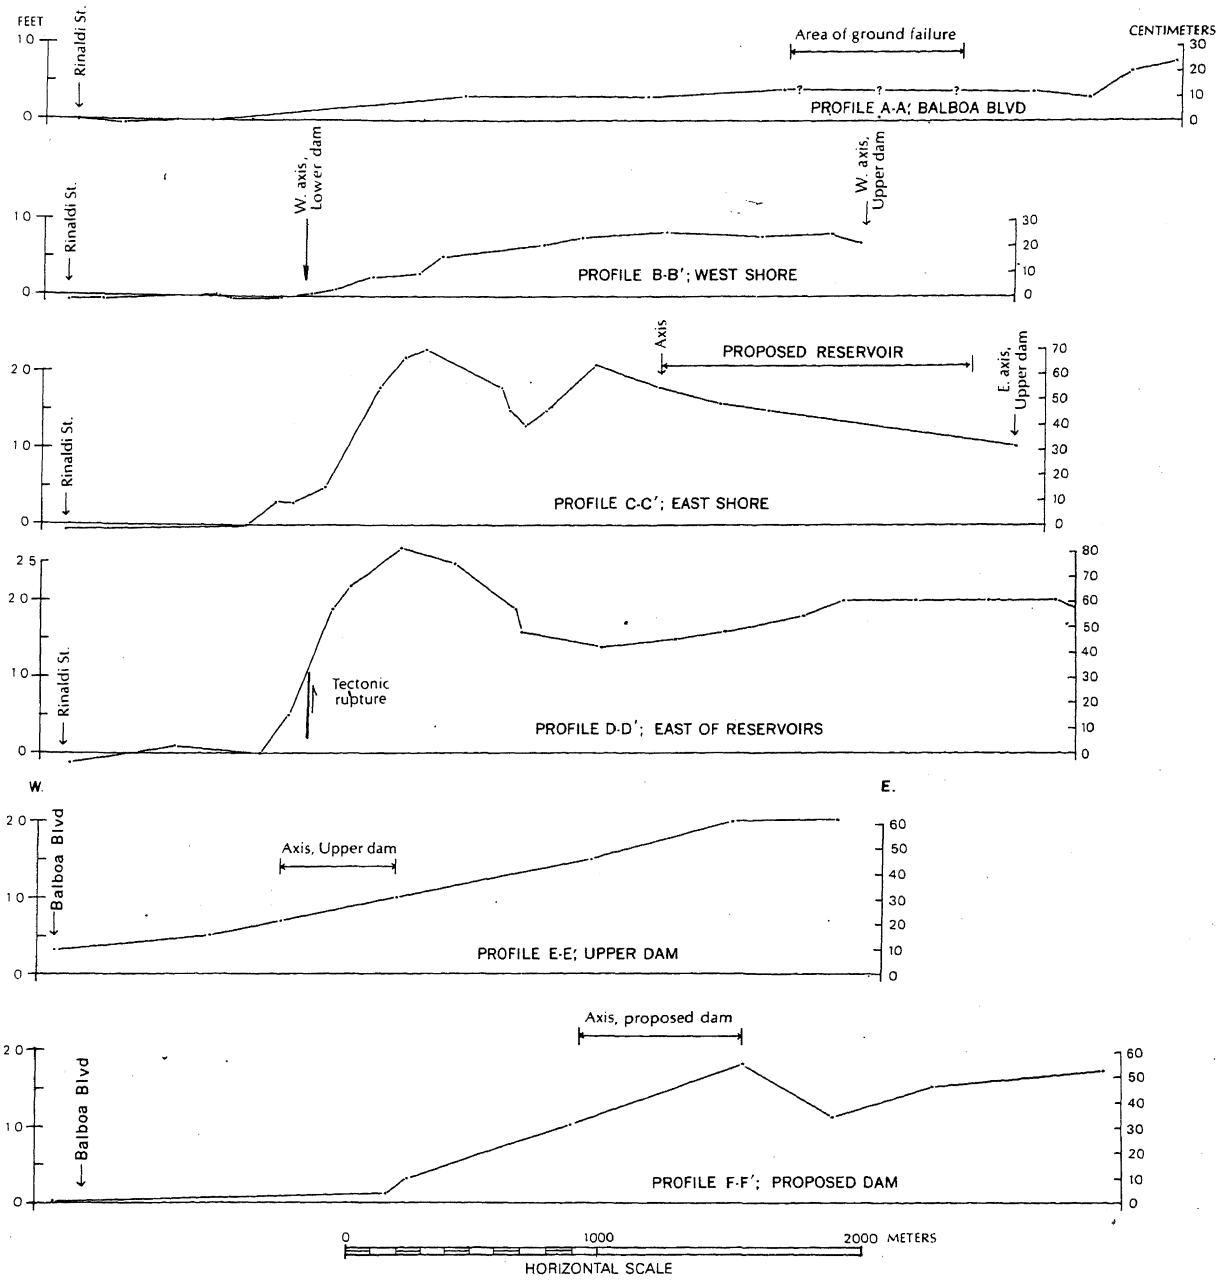
6) Abrupt discontinuities in the gradient of arching coincide with the 1971 rupture zone and its westward extension (fig. 5, profiles B, C, D).

FIGURE 5.--Profiles of elevation change between 1968-1970 and postearthquake surveys in Van Norman reservoirs area; pre-earthquake survey of line D-D' made in 1955.

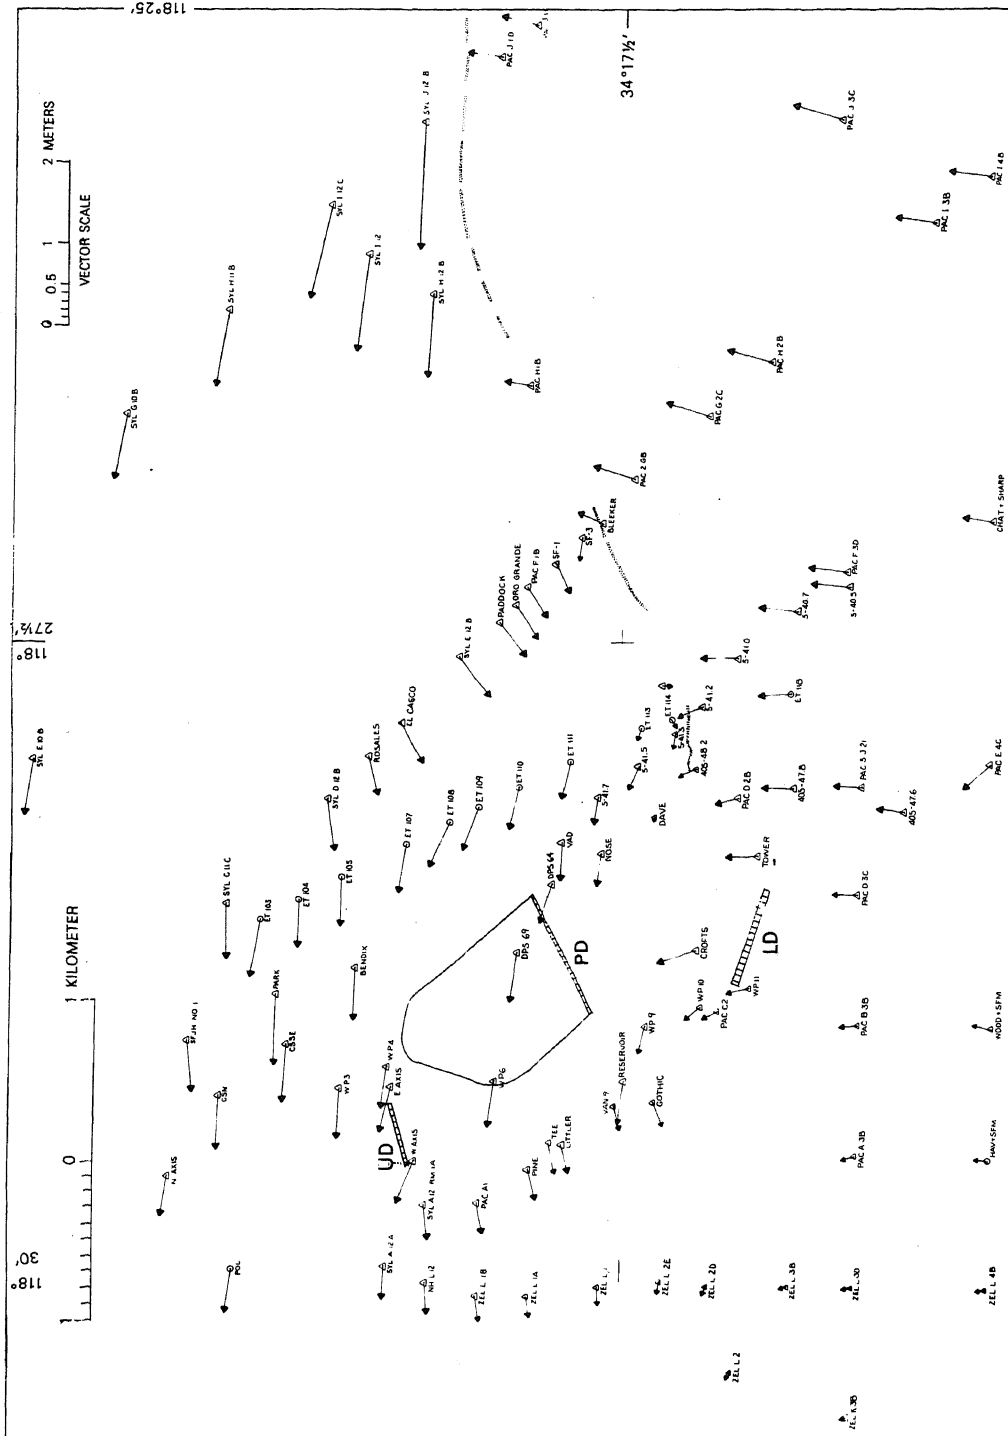
The map of horizontal displacements (fig. 6) defines the 1971 rupture zone and its westward extension as an abrupt discontinuity; north of the zone the displacement averaged about 0.5 m westward, whereas south of the zone it averaged about 0.3 m northward. Although the amounts of displacement decrease progressively westward, the discontinuity persists across the reservoir area, whereas the rupture zone did not. Differential displacements of the east abutment area relative to the west abutment for each dam site were determined:

Upper dam (between stations 472 m apart): 0.091 m S. 18° W.
and 0.136 m up;

Proposed dam (between stations 689 m apart): no significant
relative horizontal displacement, 0.232 m up;

Lower dam (between stations 808 m apart): 0.145 m N. 44° E.,
no significant vertical displacement.

FIGURE 6.--Map of northern San Fernando Valley showing horizontal displacements between 1940-1970 and postearthquake surveys; accuracy of changes shown by vectors about ± 0.03 m. Points held fixed for free adjustment by U.S. National Geodetic Survey are located 22 and 30 km southeast of the reservoir area. Locations of 1971 tectonic ruptures along San Fernando zone shown by fine sawtooth lines. UD-upper dam, PD-proposed dam and reservoir, LD-lower dam.
