DAMAGE TO REINFORCED CONCRETE BUILDINGS  
DUE TO THE OITA EARTHQUAKE OF APRIL 21, 1975

HIDEO TSUCHIYA, TATSUHIKO SAITO, MASAMI MIYAZAWA, NAGAHIDE KANI

Dynamic response of the main building of the K.L.Hotel, damaged beyond repair during the Oita earthquake, is analyzed and compared with the investigation after the earthquake, the principal cause of the severe damage is identified.

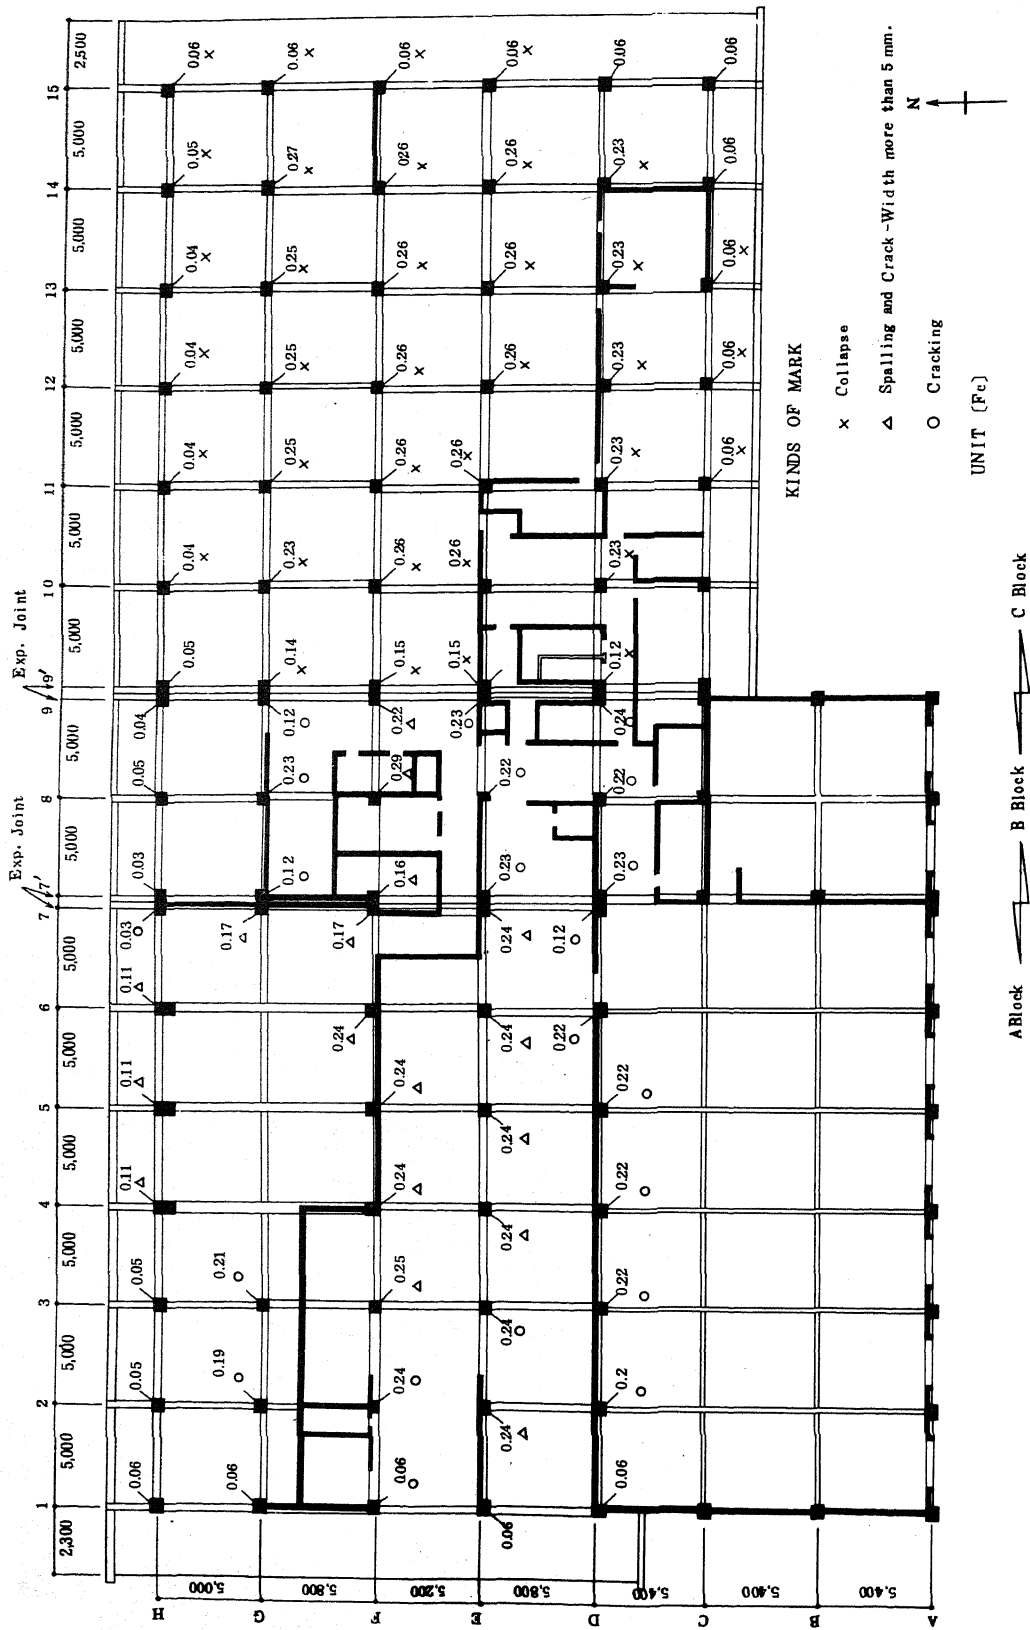
The severe structural damage to the building was concentrated in the first story of each block. The upper stories and the ground story were slightly damaged. C block collapsed due to brittle failure of the column in the first story supporting the upper three stories. The earthquake caused A block large permanent deformations which consisted of translation

towards the north-west combined with anti-clock wise rotation of the structure above the first floor. Permanent relative deformations between the first and the second story up to 3.0 centimetres, and sinking of a 7-frame column line with respect to a 2-frame column line of up to 4.0 centimetres were measured after the earthquake. Damage to the expansion-joint due to impact of each block was not detected. Similar failures in each block occurred in the tied columns in the first story supporting heavy permanent axial loads (Fig. 1, Fig. 3). Although columns and shear walls suffered considerable spalling and cracking, many of them except in C block, were able to develop significant ductility (Fig. 5). Since all of the spalling was inclined to the north side, the north-south component during the earthquake was considered to be more intensive than the east-west component.

where:  $V$  = variance of axial stress,  $A_v$  = vertical response acceleration of the model having first dominant period of 0.054 sec. to vertical component of the ground motion;  $A_h$  = horizontal response acceleration of the model having translational period of 0.162 sec (Fig. 5); and  $\chi$  = the ratio of the axial stress. Although the  $\chi$ -value is dependent on the rigidity of the frame, and whether shear wall exists or not, D and G column line are considered here to resist the overturning moment by the translational response shear. In this work  $\chi$  is 0.74, decided by the responses of the six-lumped mass model. The maximum variance is 2.7, obtained from responses to the Oita aftershock, it happens two seconds before the translational response leads to the maximum value (Fig. 8). These results indicate that axial stress of the outer column during the earthquake had suffered 3.7 times compressive stress as large as permanent axial stress (nearly equals to the compressive strength of concrete), and instantly suffered large tensile stress before yielding (Fig. 1).

FIG. 1 : K.L. HOTEL FRAMING PLAN OF FIRSTSTORY AND DEGREE OF DAMAGED COLUMNS

To protect buildings from damage such as that sustained by C block, it is very important to consider the average shear stress of columns and shear walls, and to consider the variance of axial stress in the column during the earthquakes, especially for buildings near the Fault.

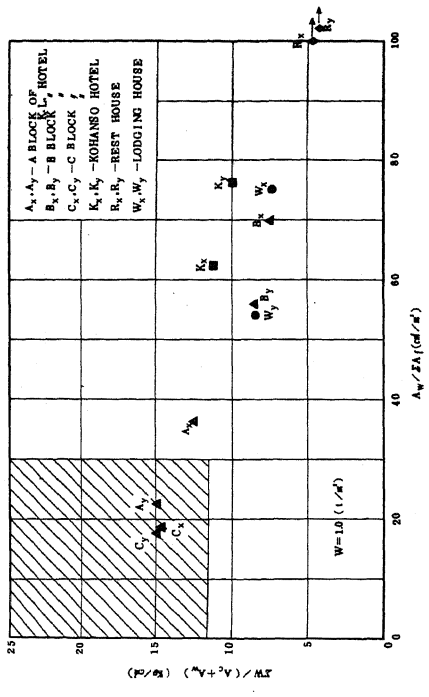
lacks in a number of ways, the response to the ground motions identifies some of the features of damage that occurred to each block. Drs. Shiga and Aoyama indicated after the Tokachioki earthquake that the damage is closely related to the ratio of sectional area of the shear wall to the total floor area (ratio of shear wall) and the average shear stress for gravity load of upper stories (average shear stress). Also they suggested that there is a fair chance of the building being included in the hatched zone of damage suffered during the earthquake. The relationships obtained from the data of buildings near the K.L. Hotel are plotted (Fig. 7). A and C blocks of the Hotel is included in the hatched zone. The other building out of the zone was slightly damaged.

FIG. 7 : DAMAGE AND RELATIONSHIP BETWEEN RATIO OF SHEAR WALL AND AVERAGE SHEAR STRESS
